Building Survey Report

Building Survey Report Contents:

About the Inspection:

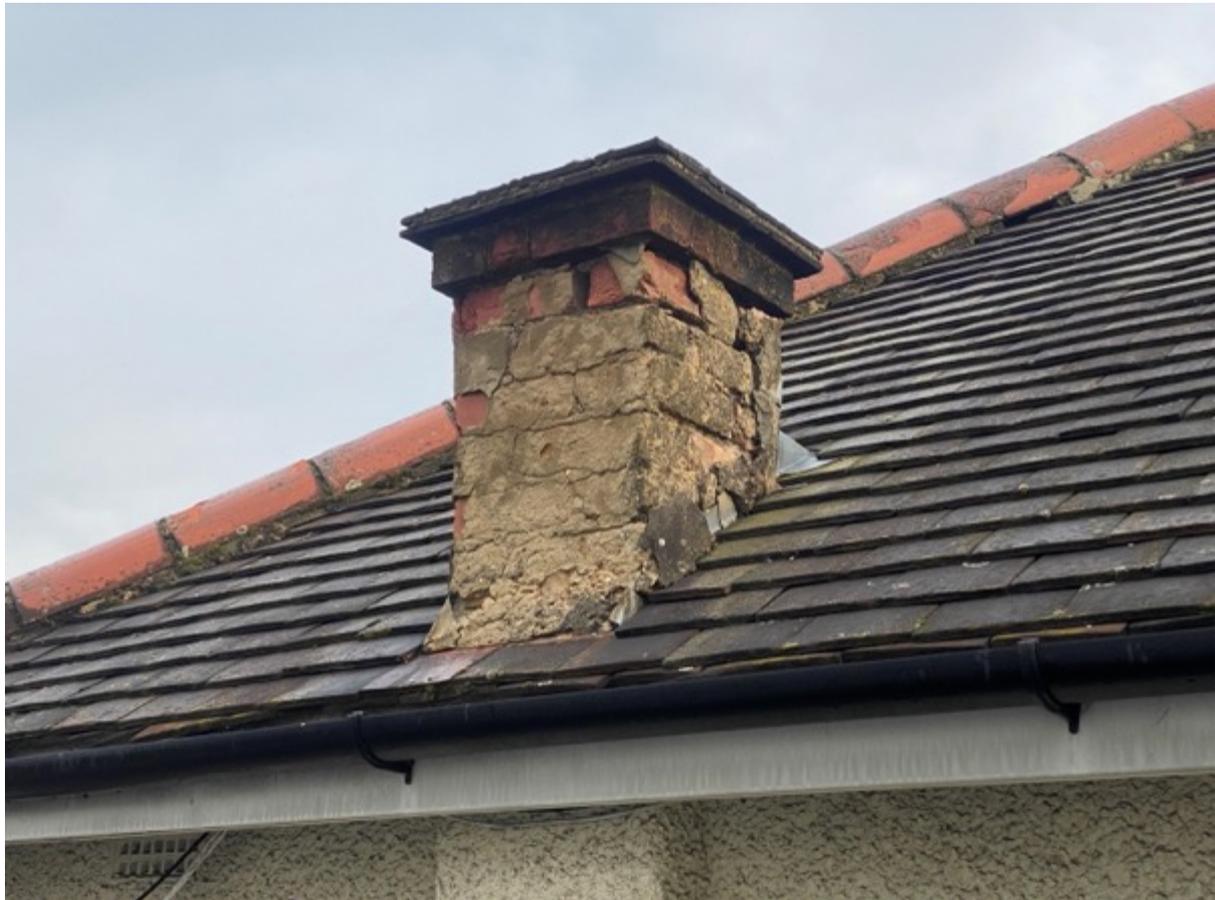
The chimney stack is of brickwork London stock solid construction. There are a total of eight pots on the stack shared with the adjoining property.

It is worth noting that there is a television aerial attached to the chimney stack itself. This can be an issue in windier weather and during the time of the inspection the street itself was relatively windy so in very strong days of wind this could be a potential hazard and could peel away or be blown off the chimney stack.

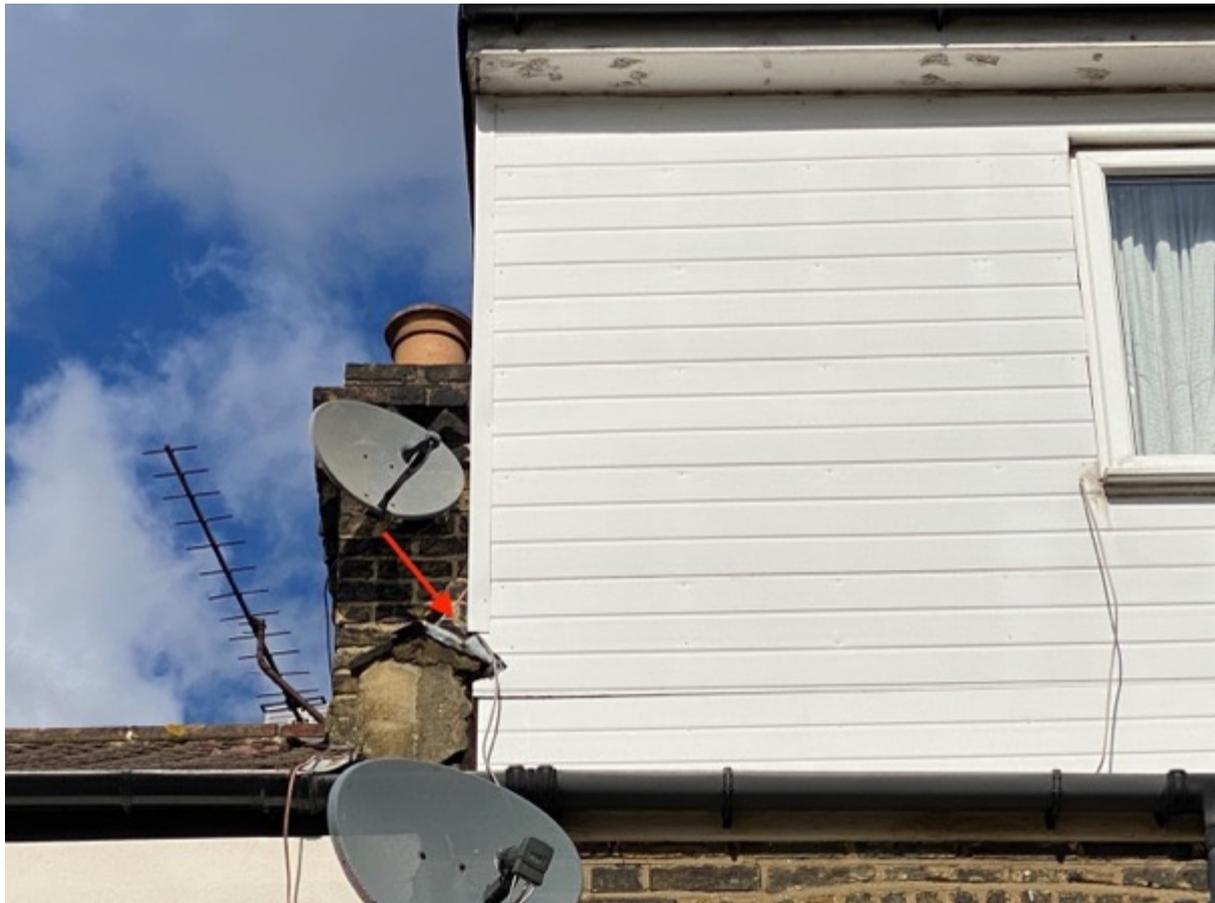
Generally speaking, this is a poor installation, and the conventional way would have been to remove the ridge tile and have a lead flashing dressed onto the party parapet wall itself with some form of considered final finish.

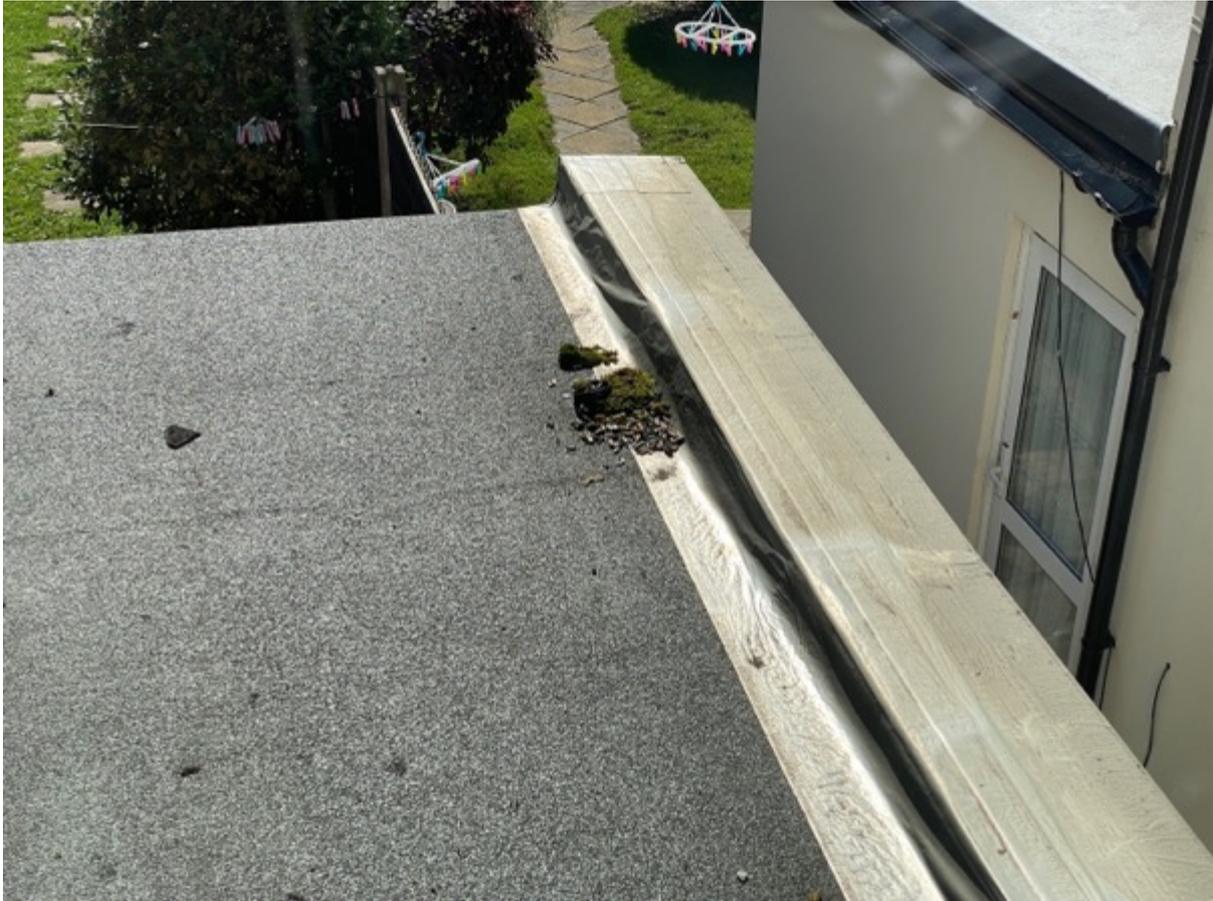
Flashband, generally speaking, has a very short lifespan and ideally this would have been done with a lead flashing which increases the longevity of the abutment itself.

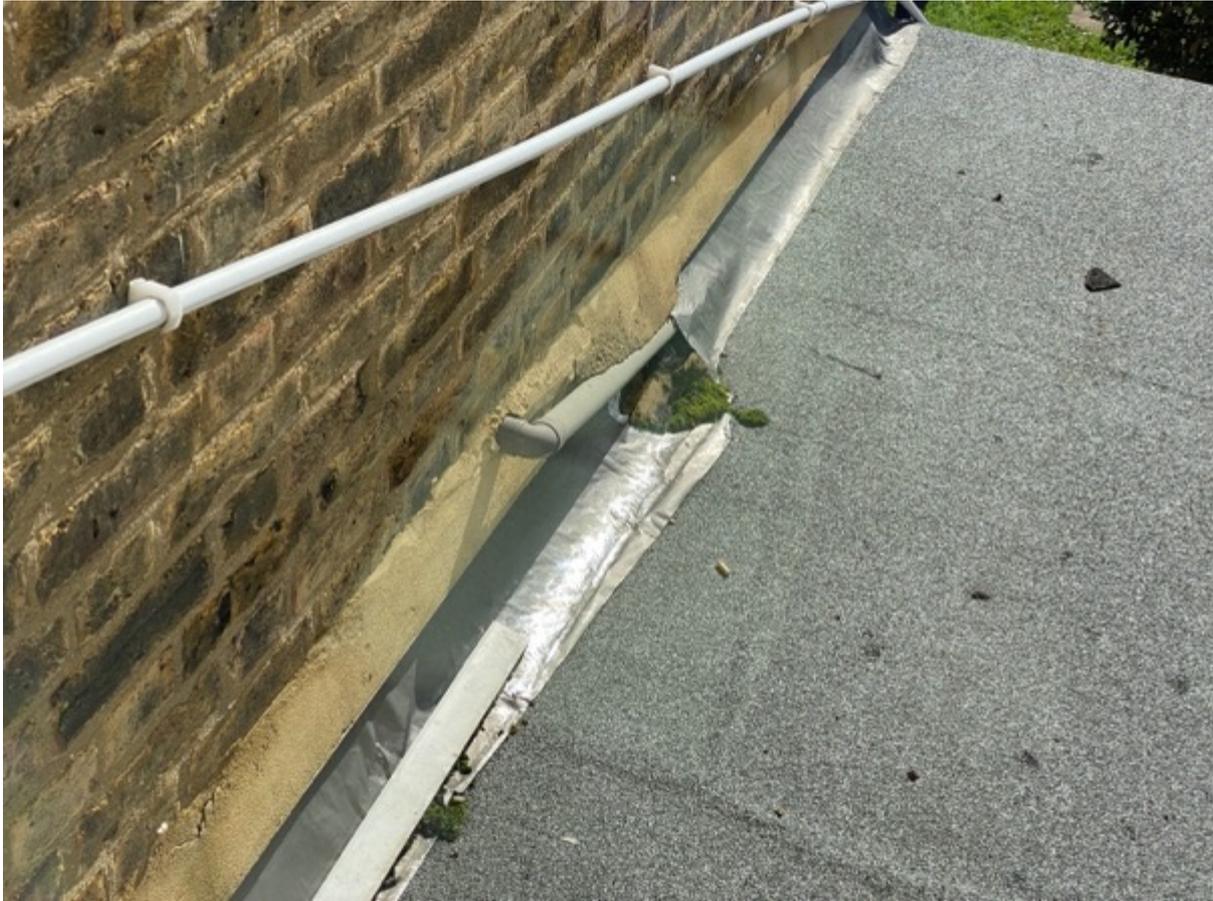
Towards the rear of the roof covering there is an area of damp staining noted at one of the junctions of the mineral felt.

This is an indication that the Flashband could be failing, and water could be starting to pool. In the colder months of the year, I would expect this to freeze, and you could have a freeze/thaw effect whereby the imperfections in the roof covering are widened and expanded as a result of the water freezing and thereby reducing the longevity of the roof covering.

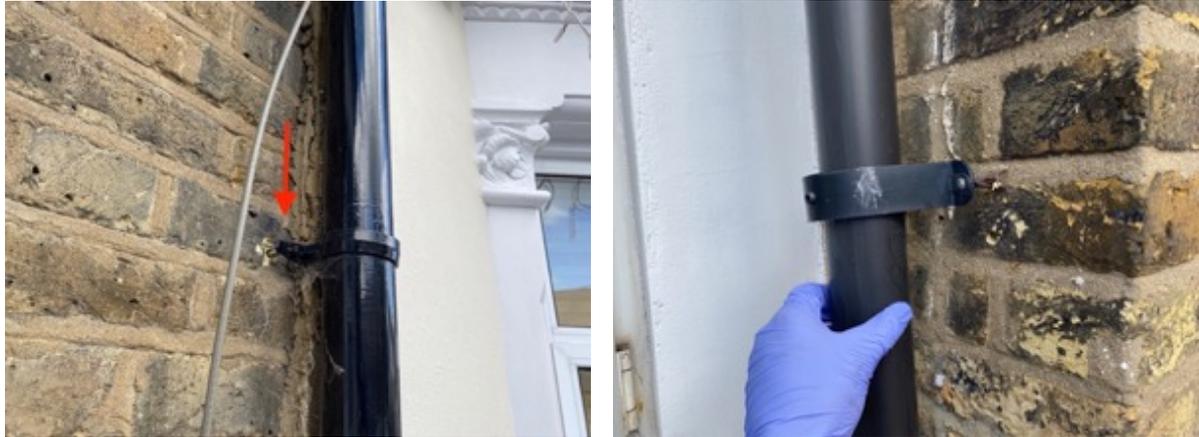
The upper clip screws have pulled loose from the wall itself and this will need to be re-secured to ensure that it is firmly screwed against the wall itself so that in the wetter months there is not an overflow of the gutters or that the gutters do not miss the hopper head and discharge water onto the wall itself.

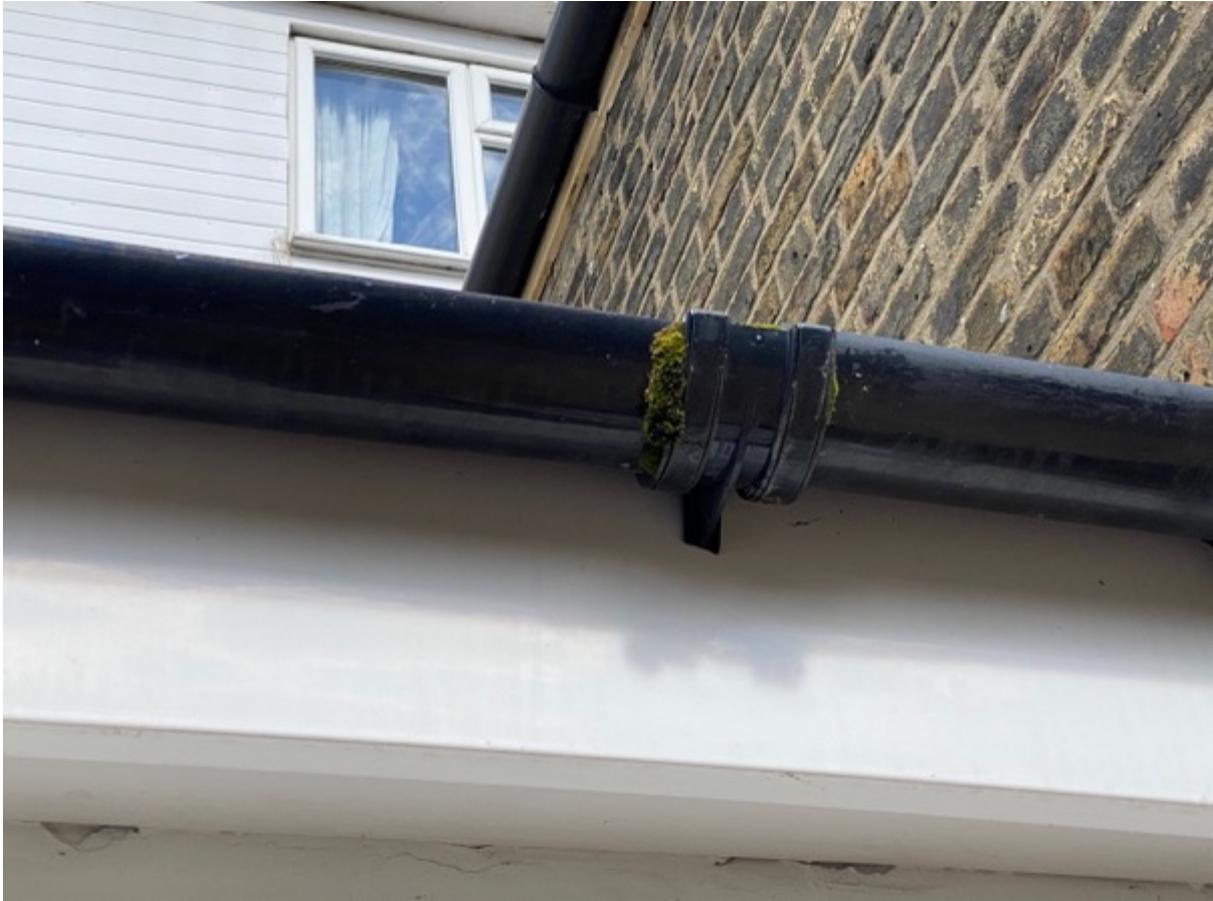
The gutters towards the rear of the ground floor extension are showing signs of moss growth and are unlevel throughout and I suspect in periods of heavy rain this could likely be spilling onto the fascia and rear extension itself.

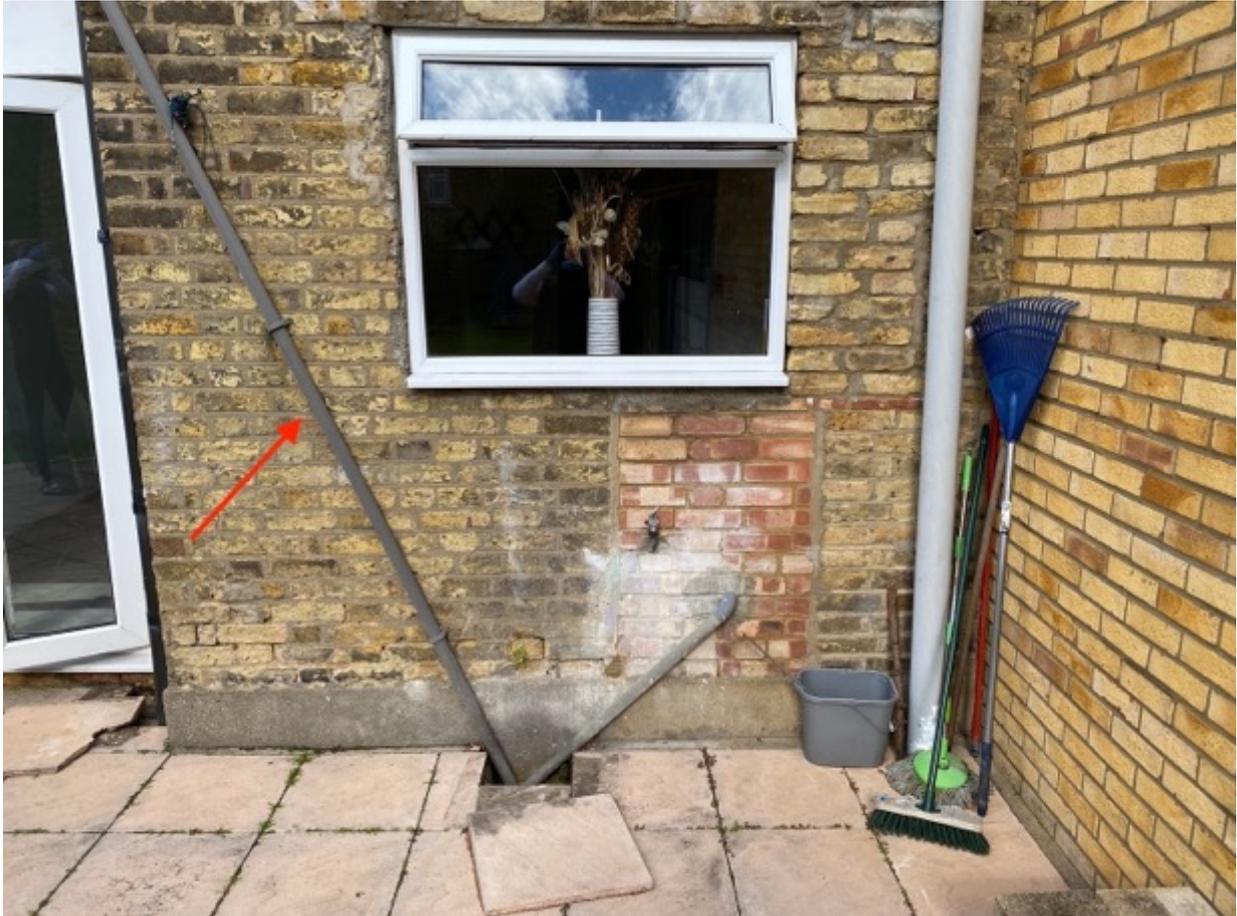
The rear wall of the rear addition has a large diagonal pipe which runs from the upper level and down towards the centre of the rear drainage gully.

This is an unconventional installation, and I would advise it is modernised to ensure that there is a more properly considered solution.

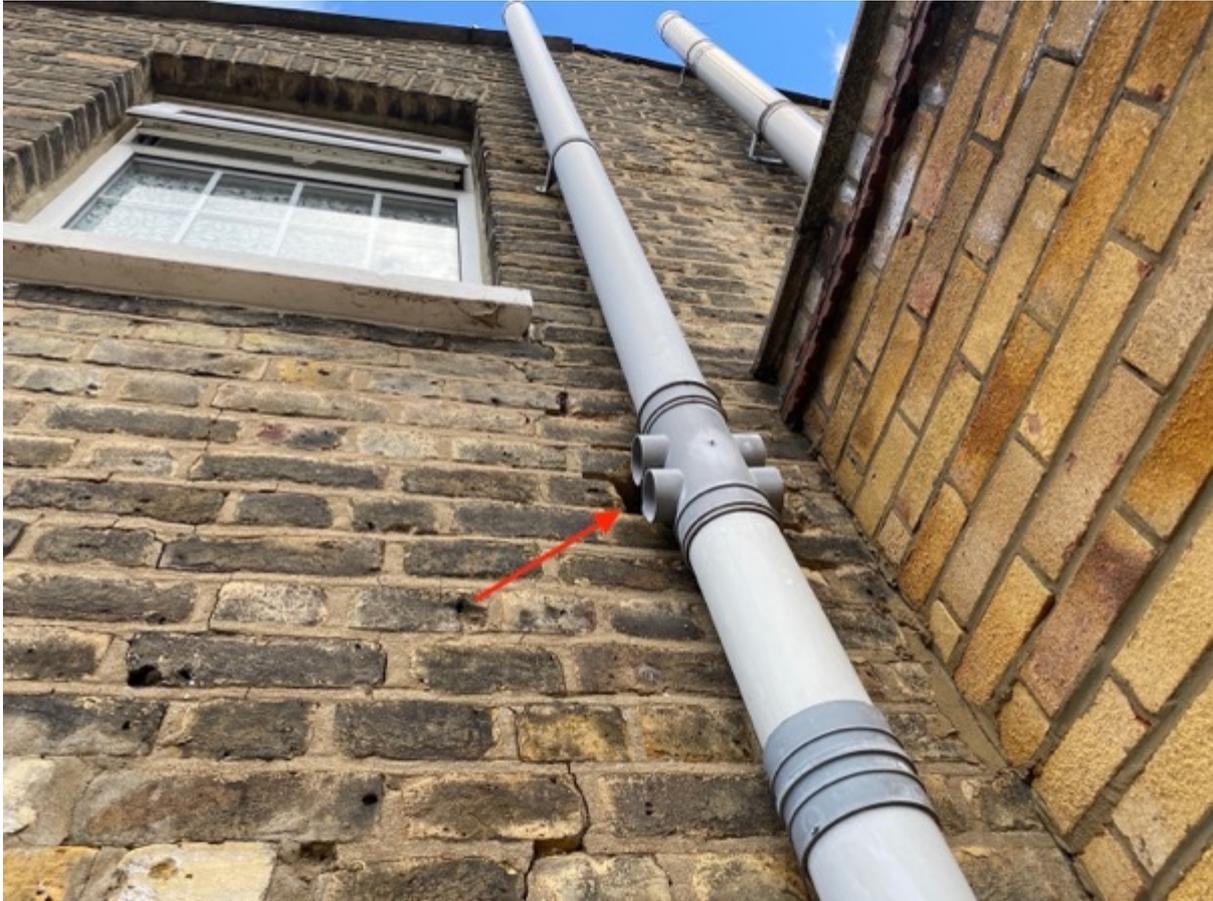
This is both a weather and pest ingress issue and I would therefore advise, prior to proceeding with the property, that this area is suitably filled.

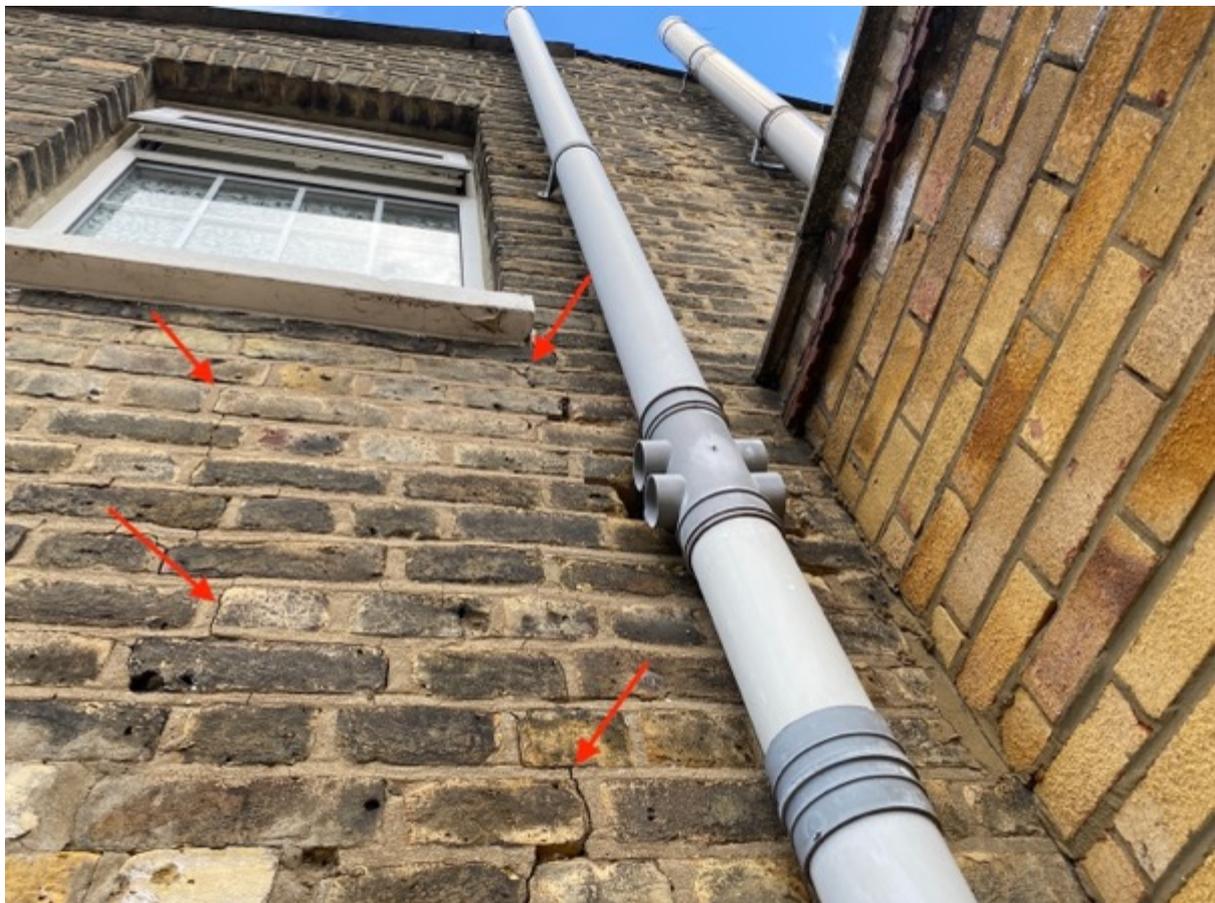
Brickwork to the rear is likewise London stock, towards the rear addition rear wall there are a number of movement cracks to the underside of the first-floor window which run downwards in a diagonal stepped cracking direction towards the flank of the property and the upper right corner of the kitchen window.

These types of cracks are relatively normal and generally speaking the gap between windows at ground and first is a soft spot and is susceptible to movement.

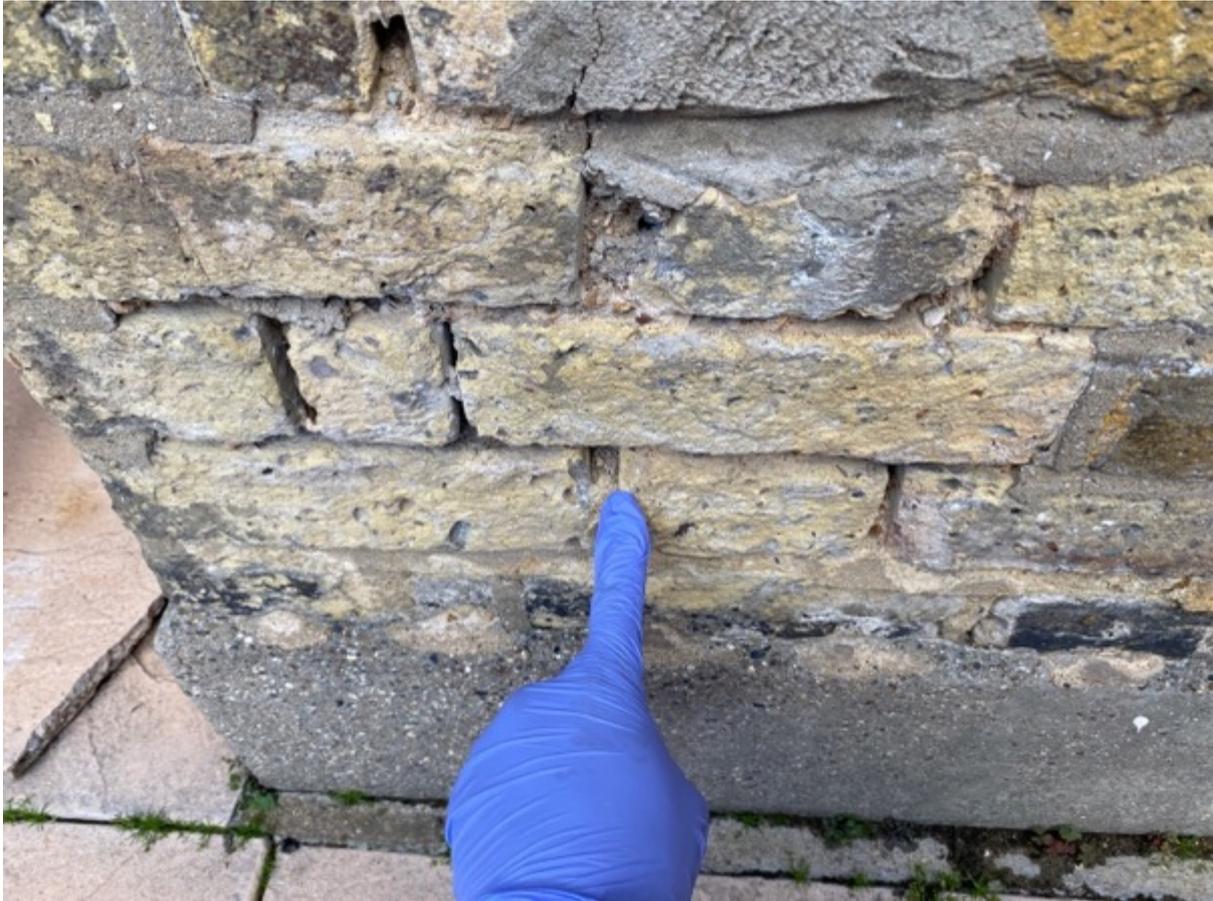
The brickwork to the rear elevation has been re-pointed at some point in the past, however, towards the lower section above the rendered plinth there are areas where the pointing is completely missing and further areas where pointing is popping or chipping away.

Generally speaking, this is usually a sign that the pointing that has been done is insufficient and I suspect in due course defective pointing will need to be raked out and filled to ensure that there is a sound weather break between the external areas of the property and the internal walls themselves.

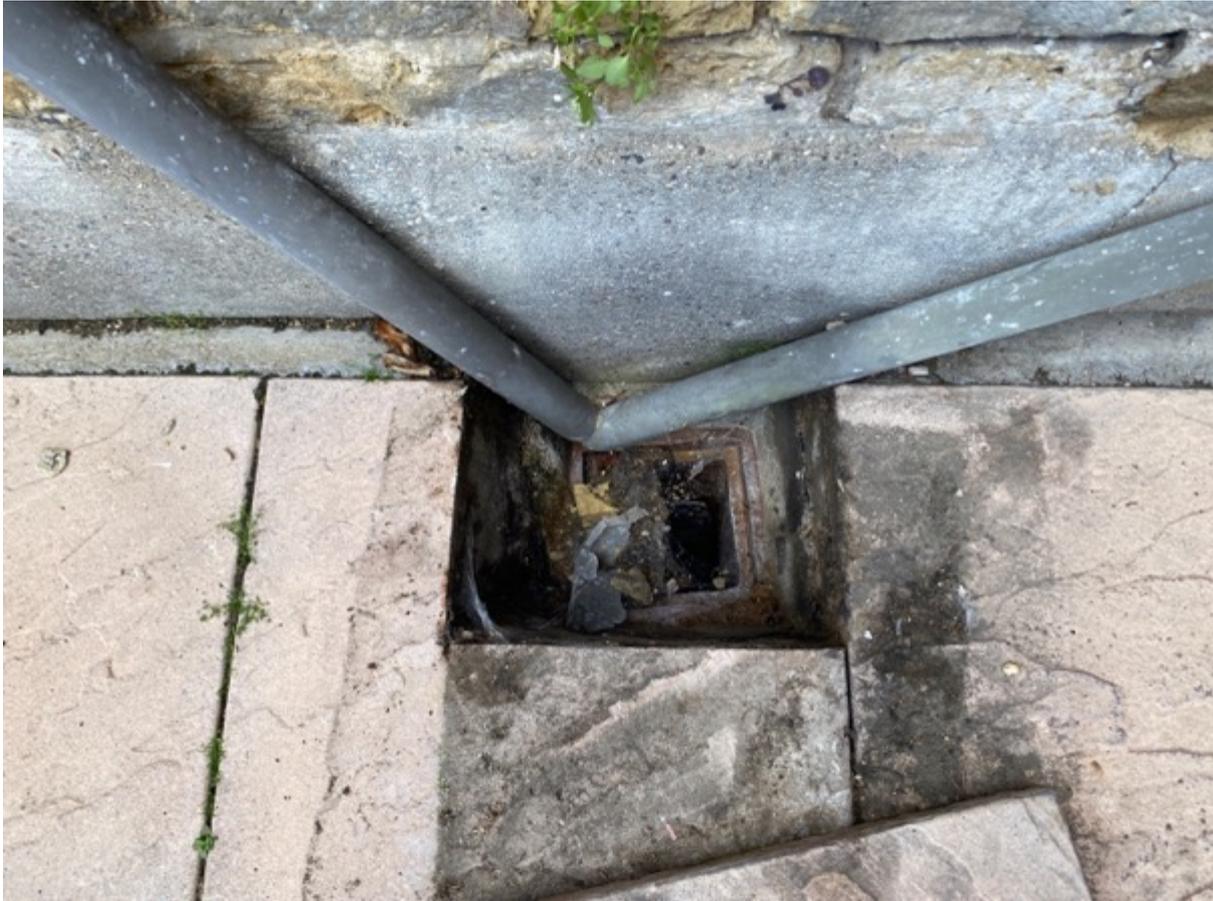
It is also worth noting that during the inspection I noted areas of vegetation and crumbling brick to the head of the drain at the rear.

This whole area will need to be re-pointed as a matter of urgency.

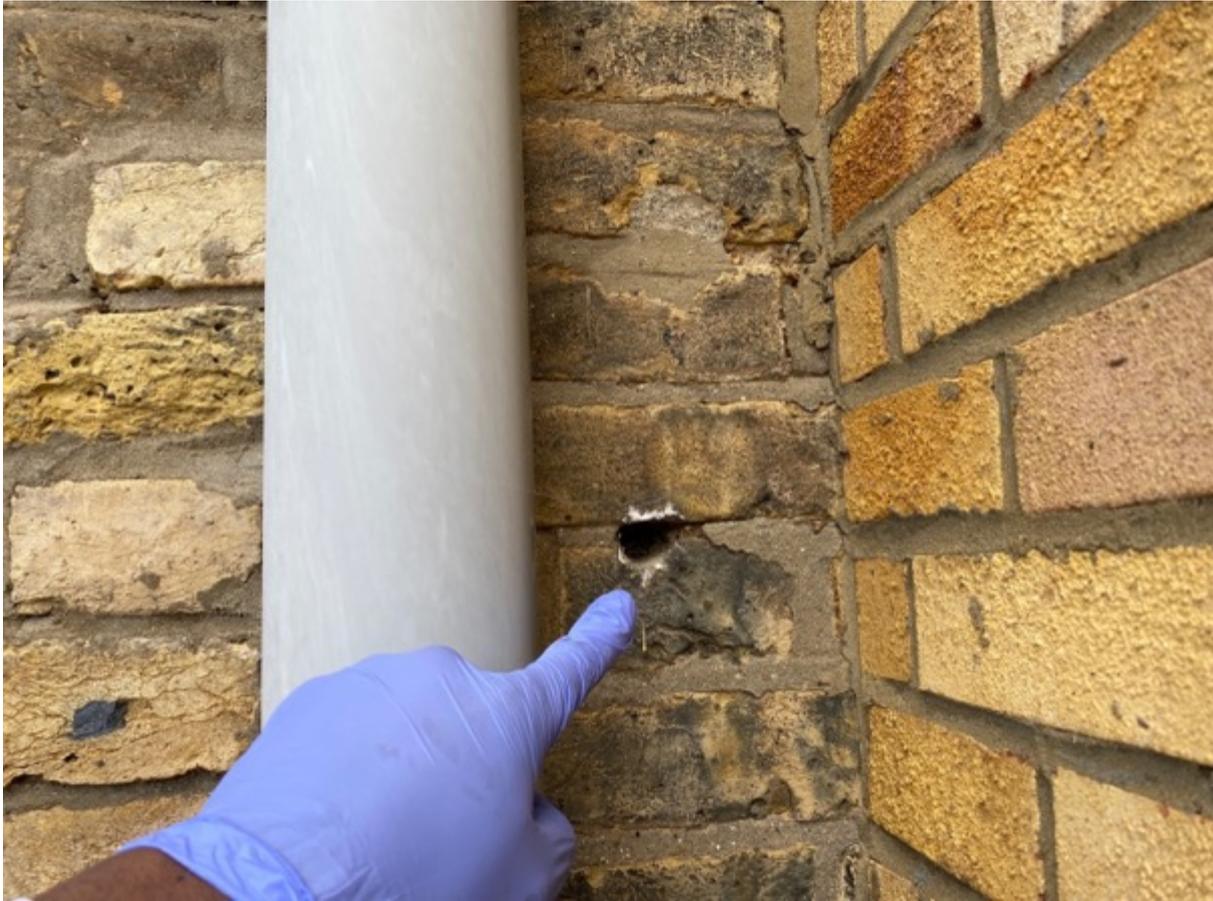
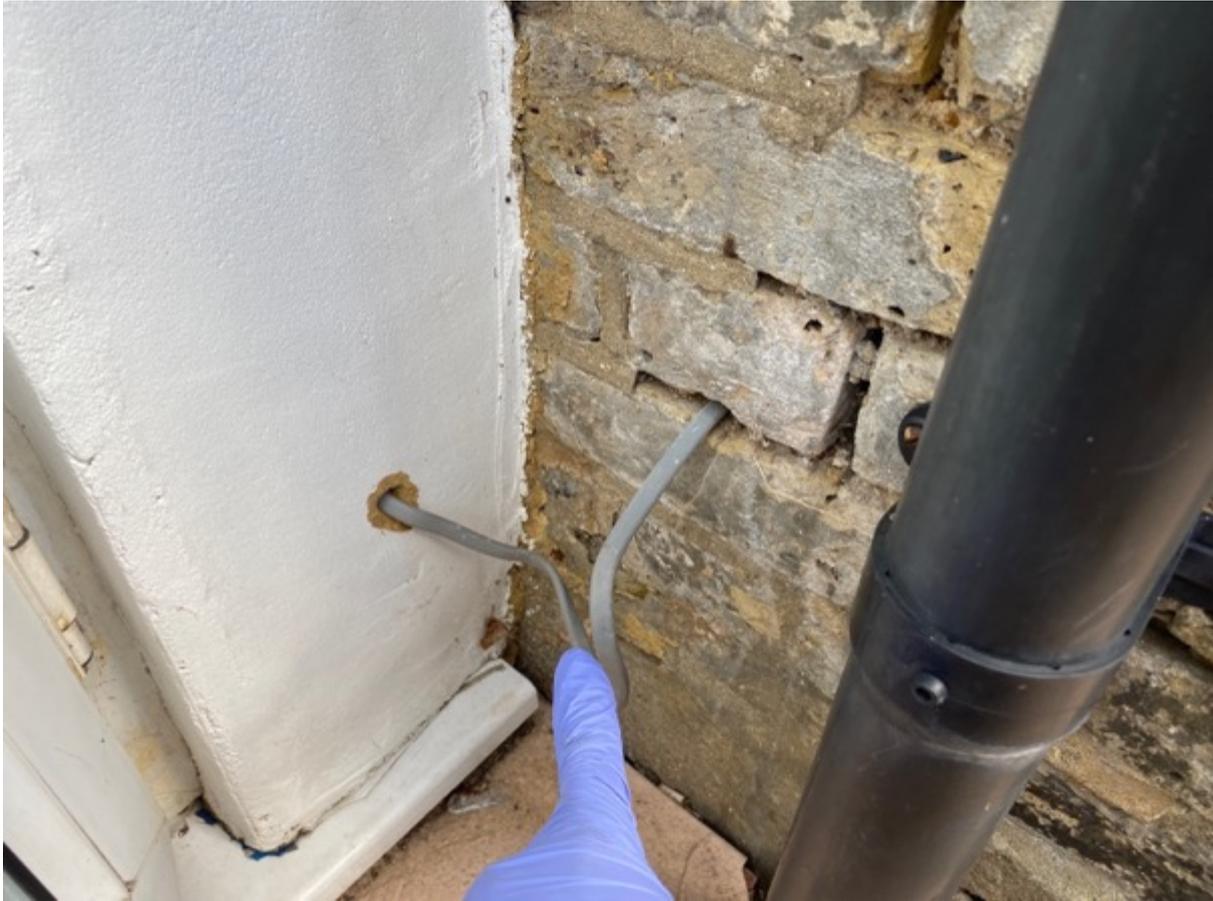
It is also worth noting that on the rear wall of the rear addition there is a drilled pole through the lower right corner whereby a wire is protruding and then running back into the flank wall of the kitchen itself.

This would not be Health and Safety or Building Regulations compliant as the wire can be pulled and moved, and I would advise that this is either boxed in, trunked in or the conventional wires are run through the internal voids of the property.

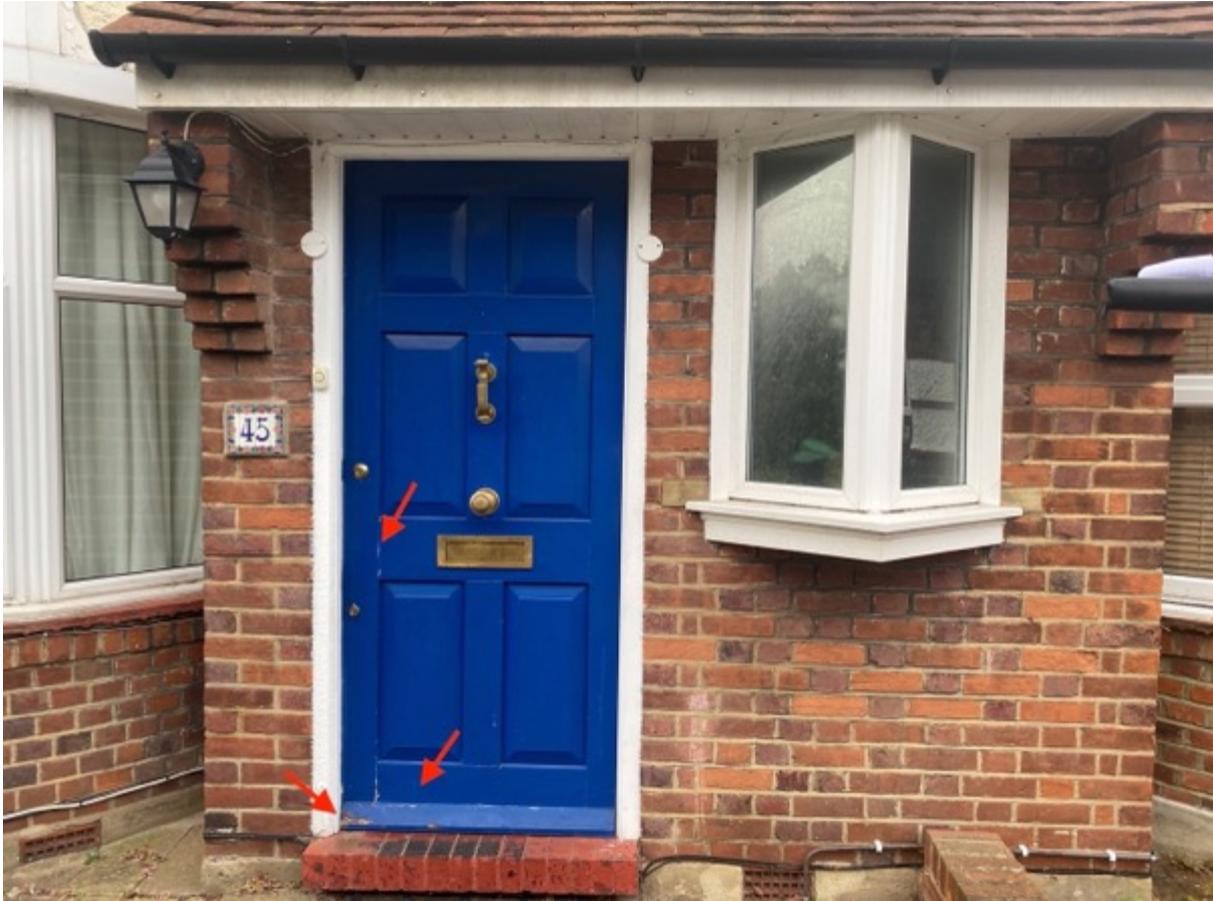
The front door is a uPVC double-glazed type, when the door opens and closes, the latch does not catch which means that the door needs to be manually locked internally via lifting the handle and turning the deadbolt.

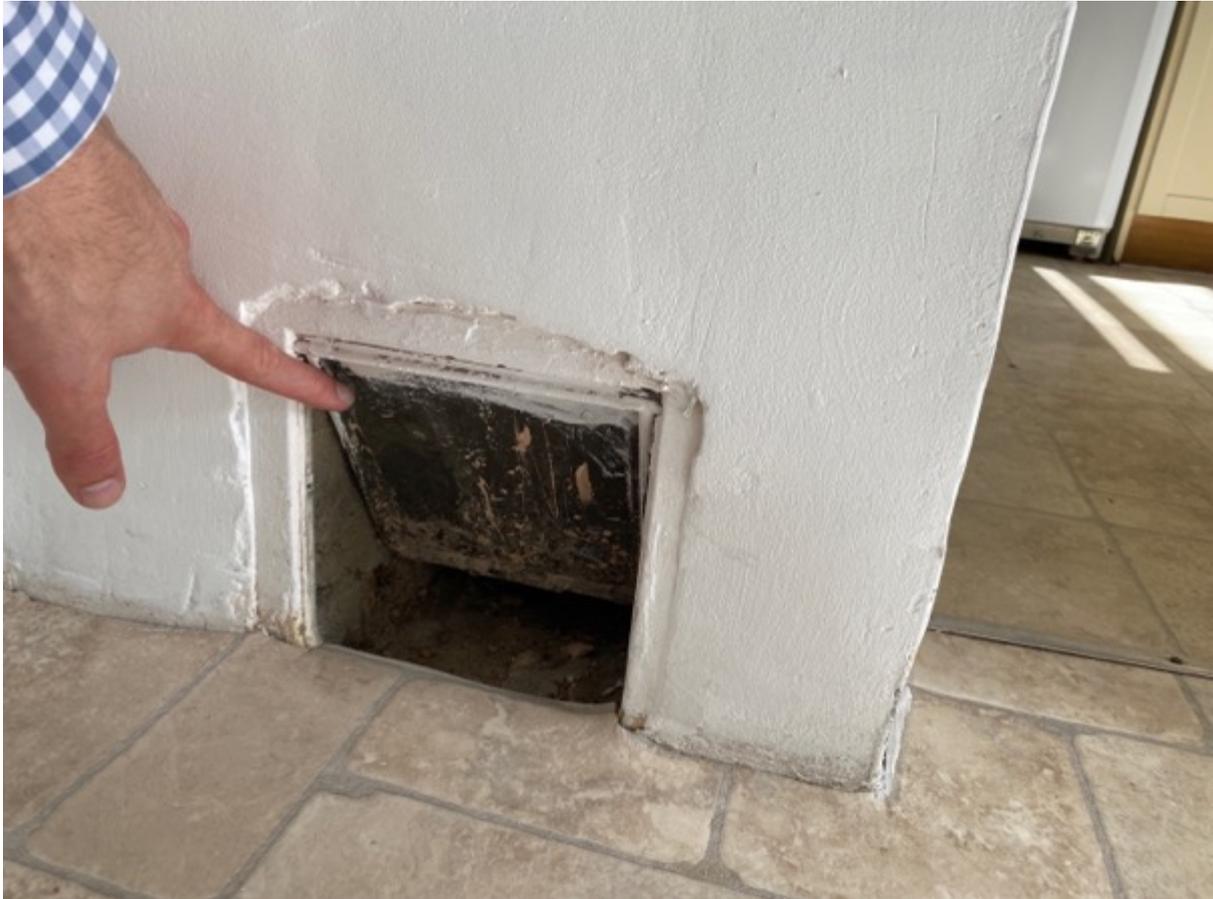
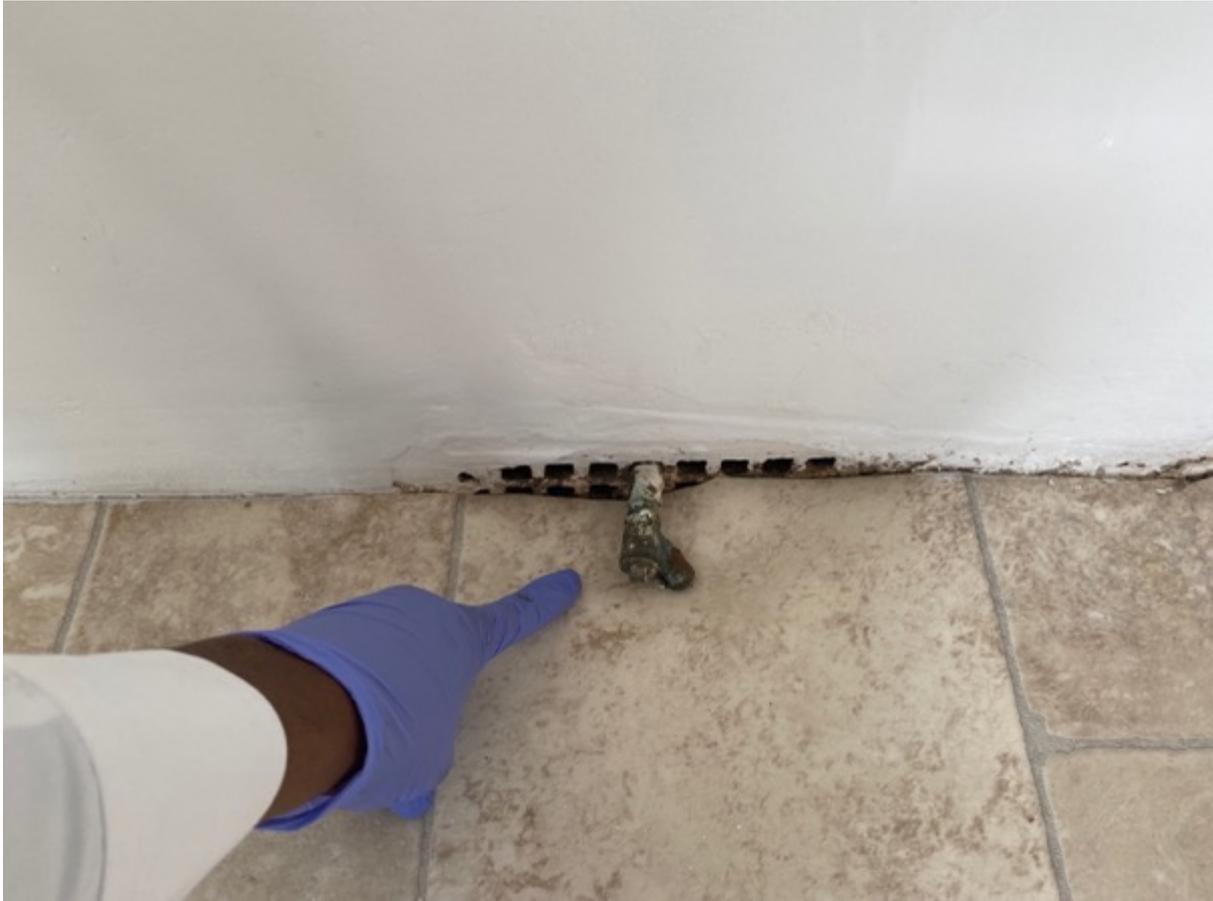
This is a relatively unconventional arrangement, and I would have expected that these would have been blocked and bricked up and therefore, as they no longer serve any purposes, that is something that will need to be done to ensure a neat and conventional finish.

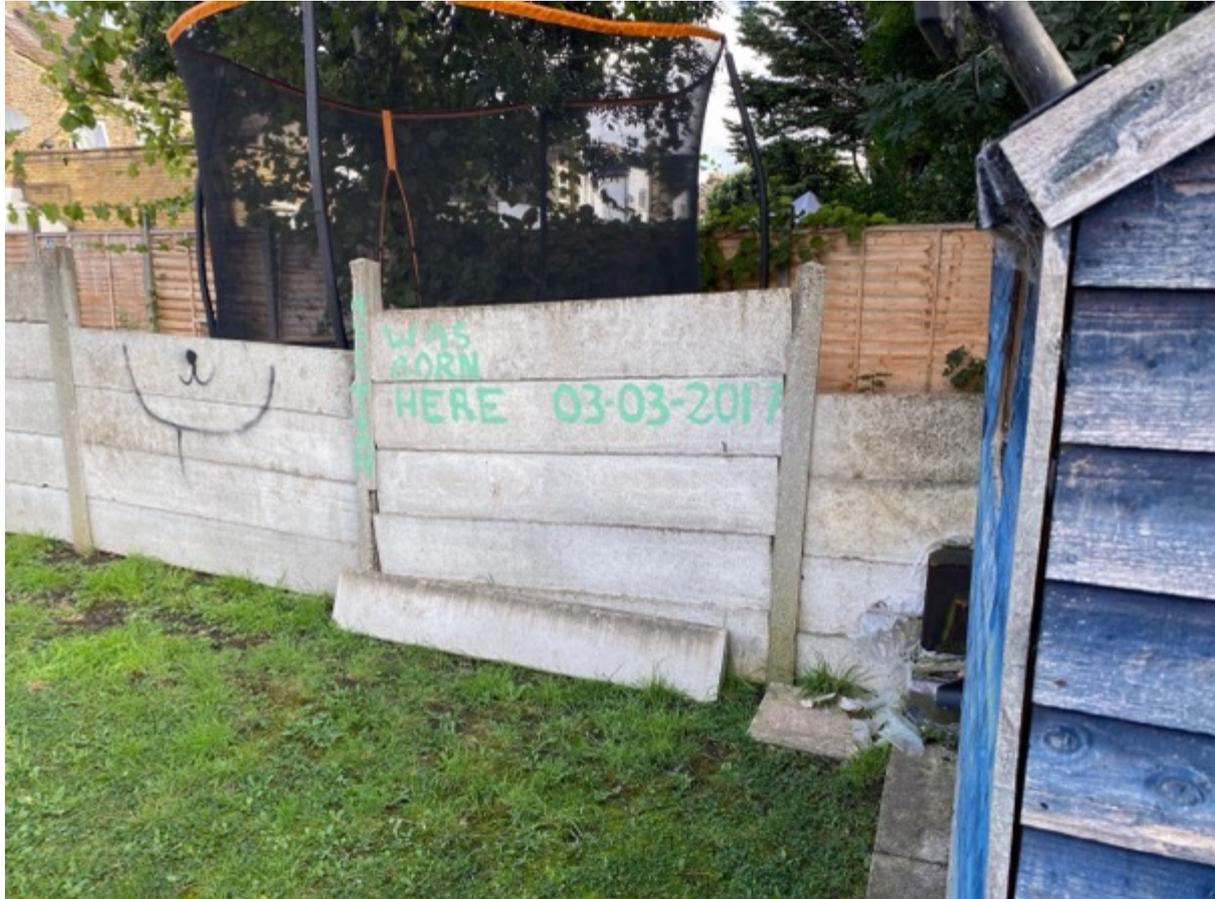
Fences towards the rear garden are a mix of concrete panels and concrete posts and concrete posts and timber panels. Overall, the fences themselves are out of alignment and with a number of panels having failed.

The fences to both the left and right sides appear to also meander both on and off the boundary wall and I would therefore advise making enquiries as to whether there have any boundary line disputes in the past.

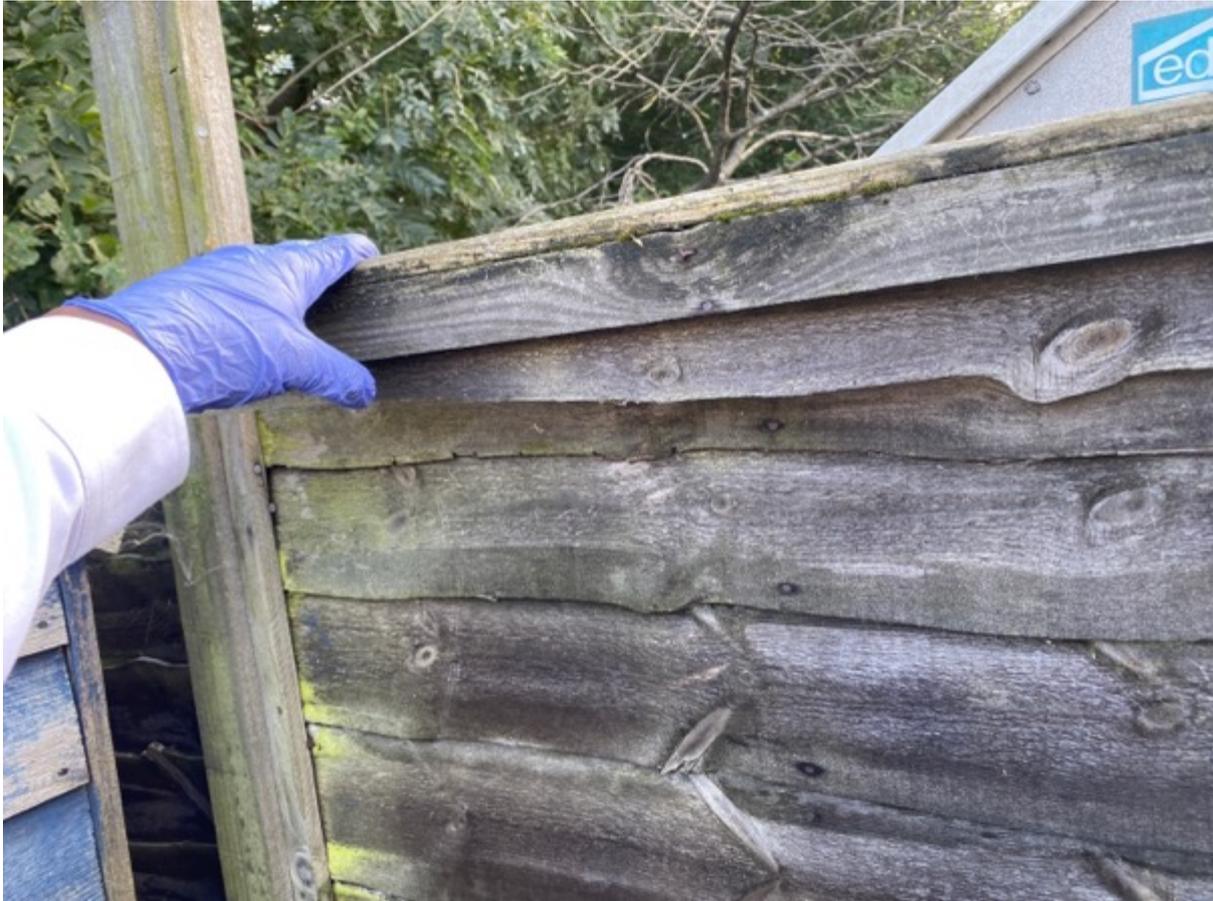
The fence panels themselves have completely failed and are significantly suffering from weather ingress, these will need to be replaced in the immediate future.

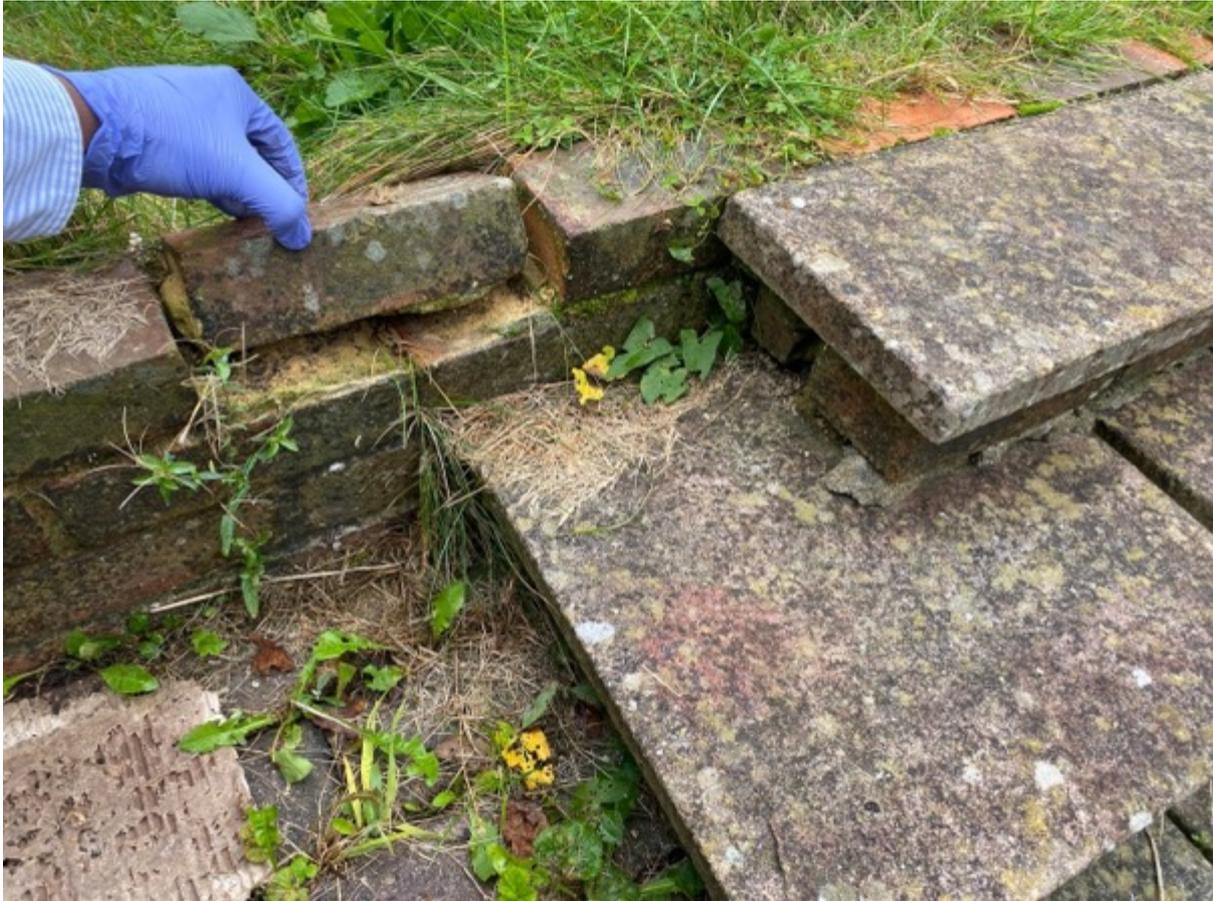
Towards the front of the property the boundaries to the left and right are set out by a single skin brick construction wall.

The wall itself appears to be out of line with the boundaries, there is also an historic timber fence which is completely weathered and suffering from wet rot and will need to be replaced.

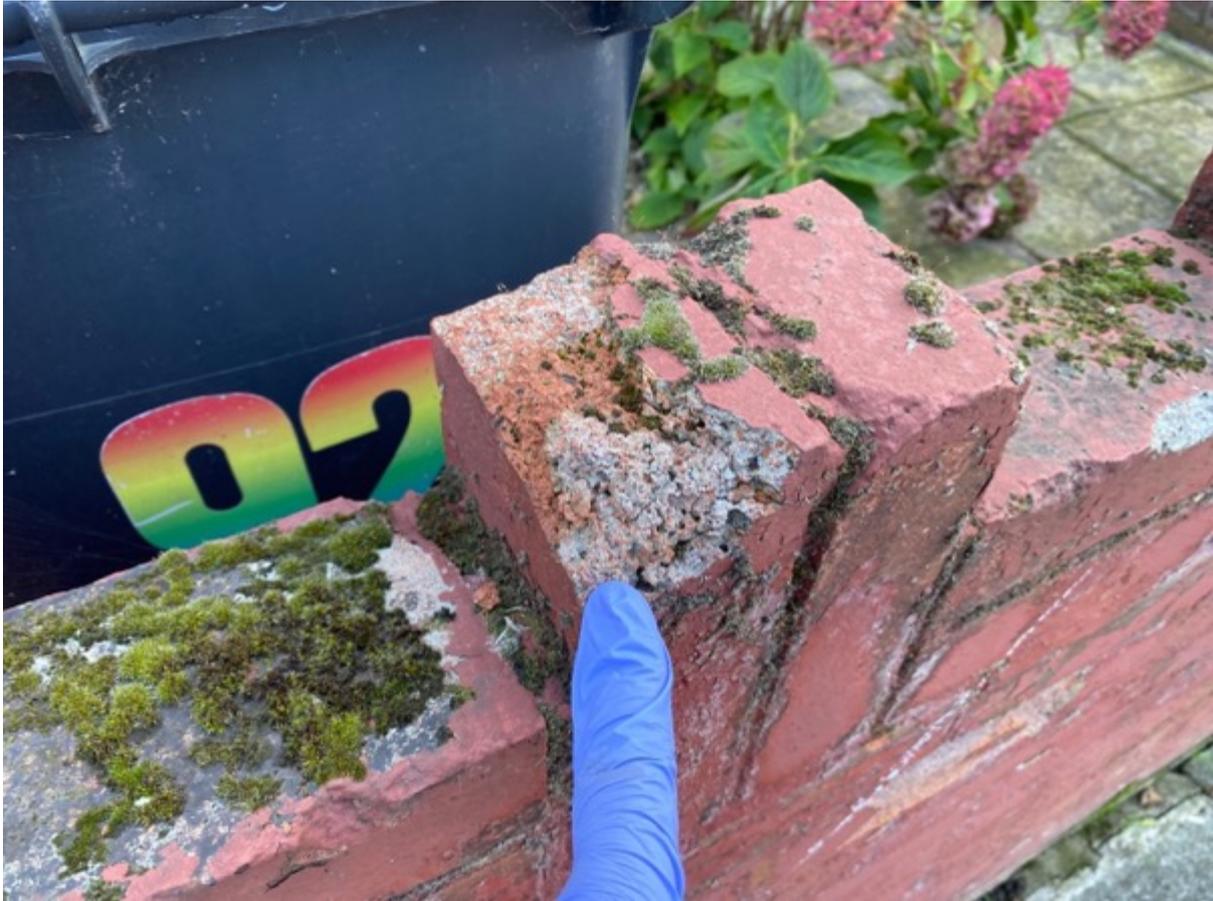
The boundary wall towards the front of the property adjoining the street is of the same single skin brickwork construction with bricks suffering from spalling and weather ingress intermittently throughout.
