Building Survey Report

Building Survey Report Contents:

About the Inspection:

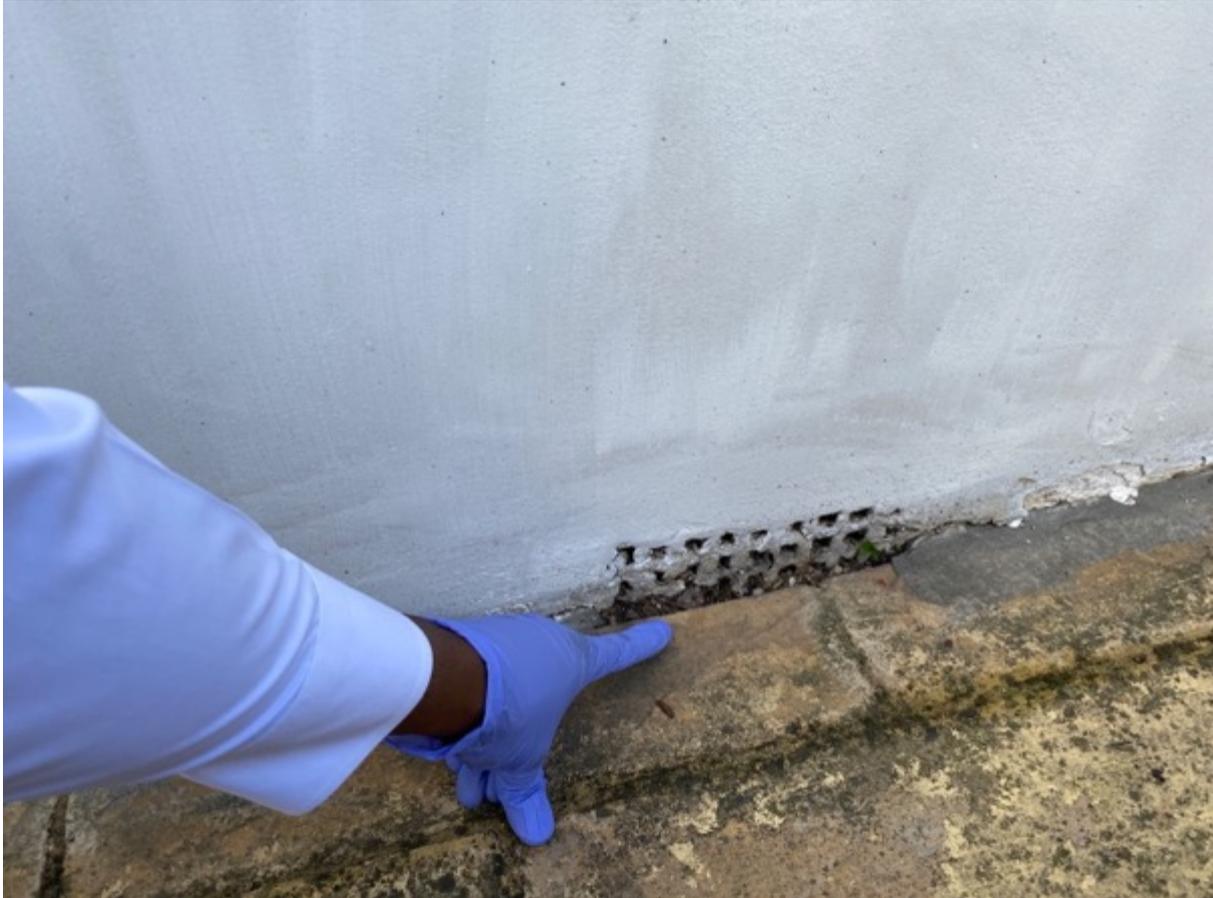
Generally speaking, the perimeter of all properties should have a sufficient void between the property itself and the ground to ensure that weather ingress and damp penetration does not penetrate the internal parts of the property.

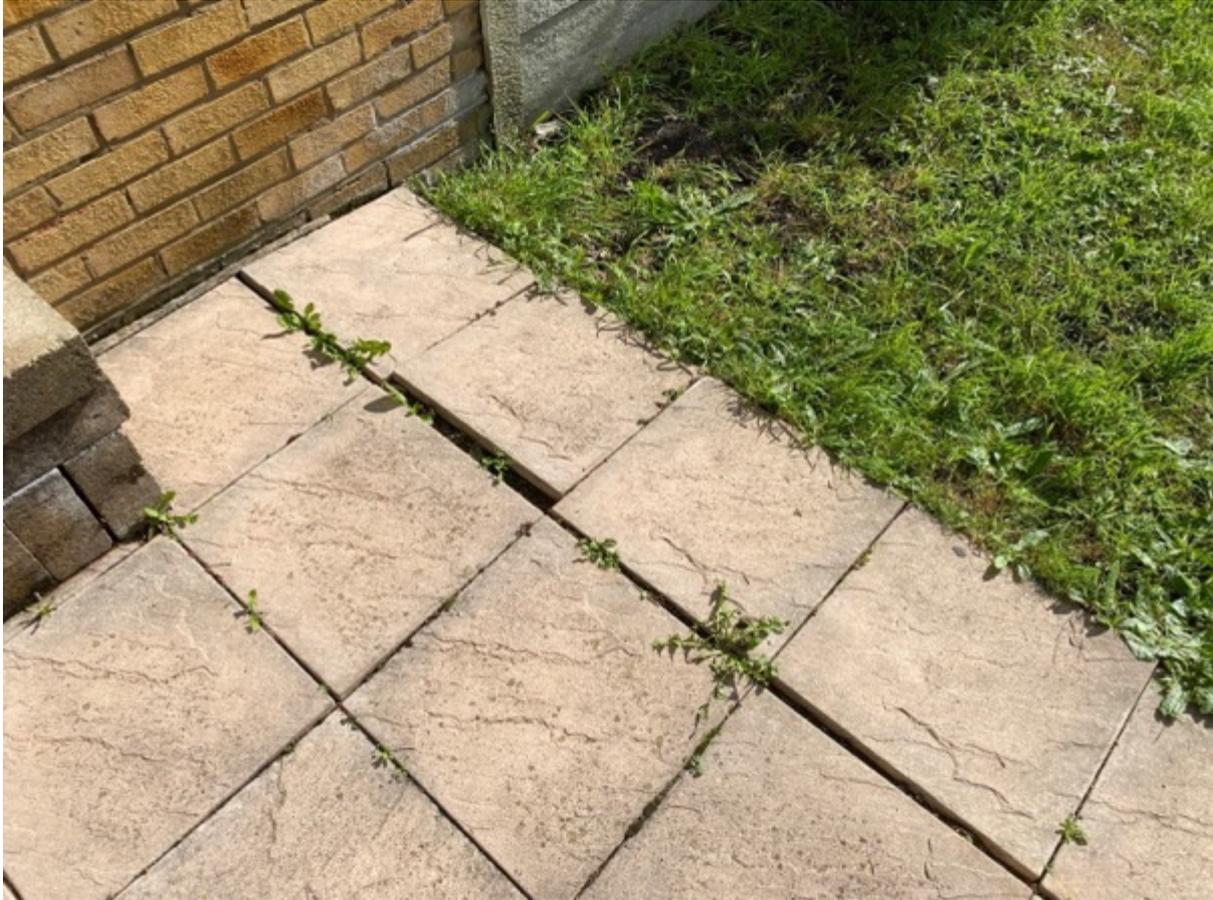
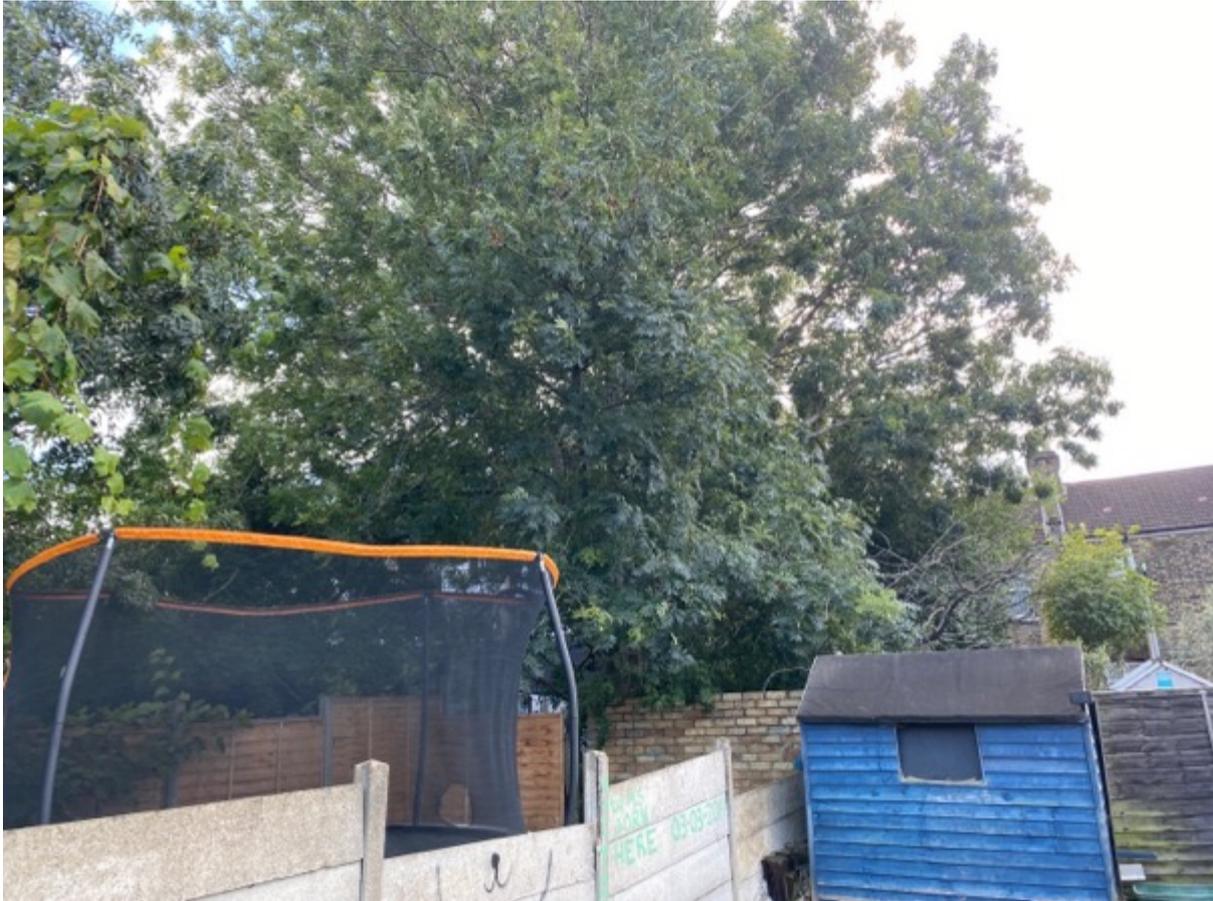
It is also worth noting that there is a very large tree towards the rear of the property's garden to the left of the subject property.

A tree of this height and stature will likely be drawing significant levels of moisture from the soil each and every day and therefore, should you proceed with the property, I would advise that you make your insurer aware of the presence of this tree so that they can take that into account.

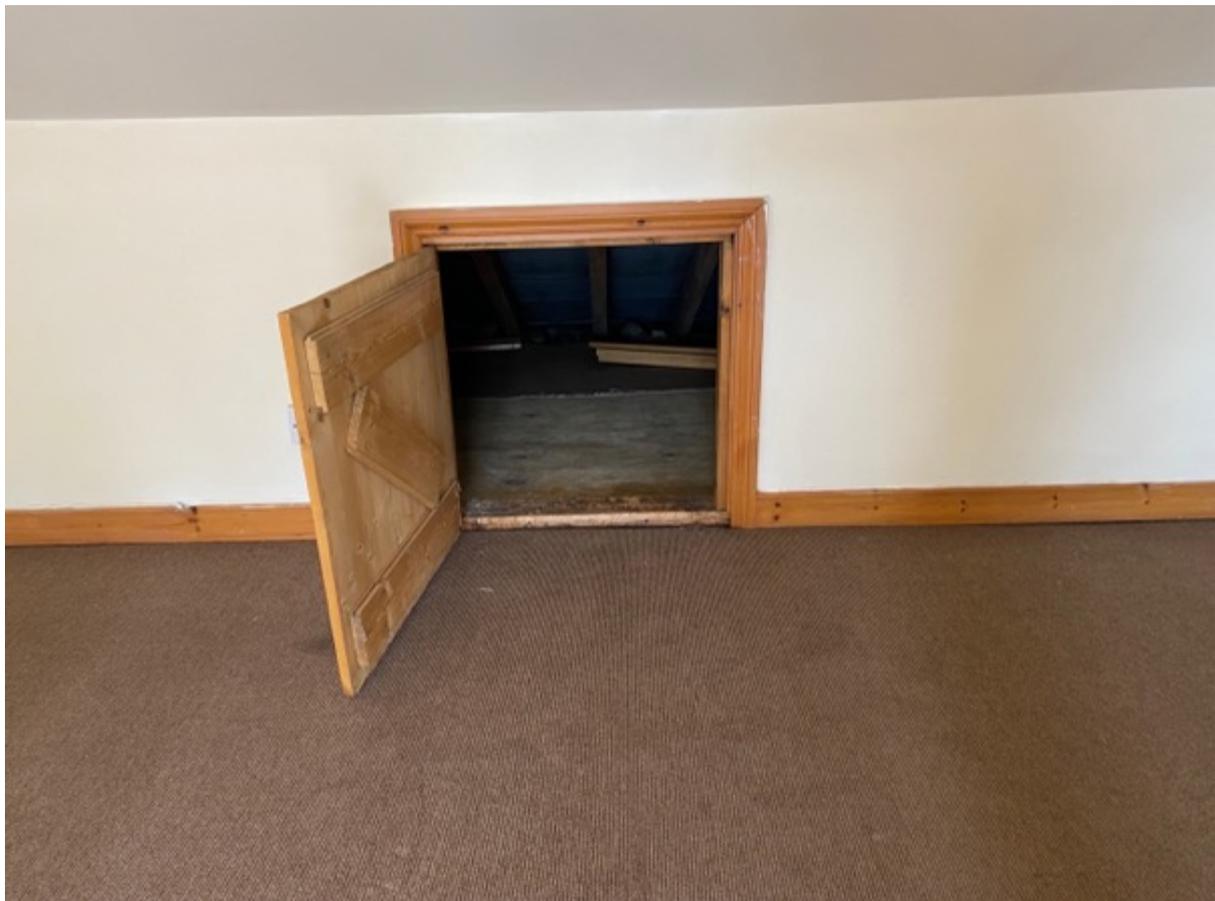
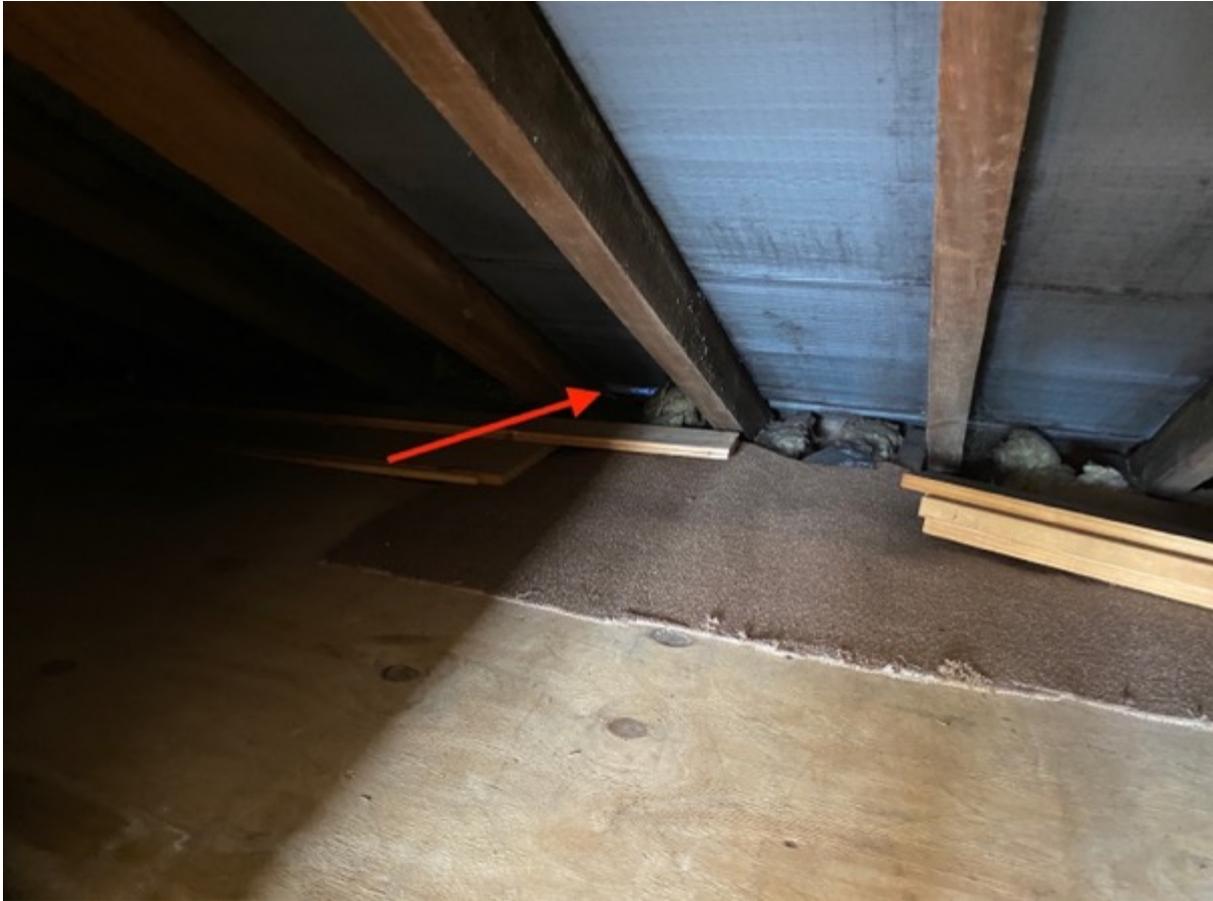
Within the eaves itself I was able to note that there is a sarking felt beneath the tiles and there were also signs of light coming through which is not ideal as it likely means that some tiles have become undulated and are sitting proud.

This could result in pest ingress and weather ingress and therefore I would advise that a competent roofer inspect this area to ensure that the tiles are properly laid and level throughout.

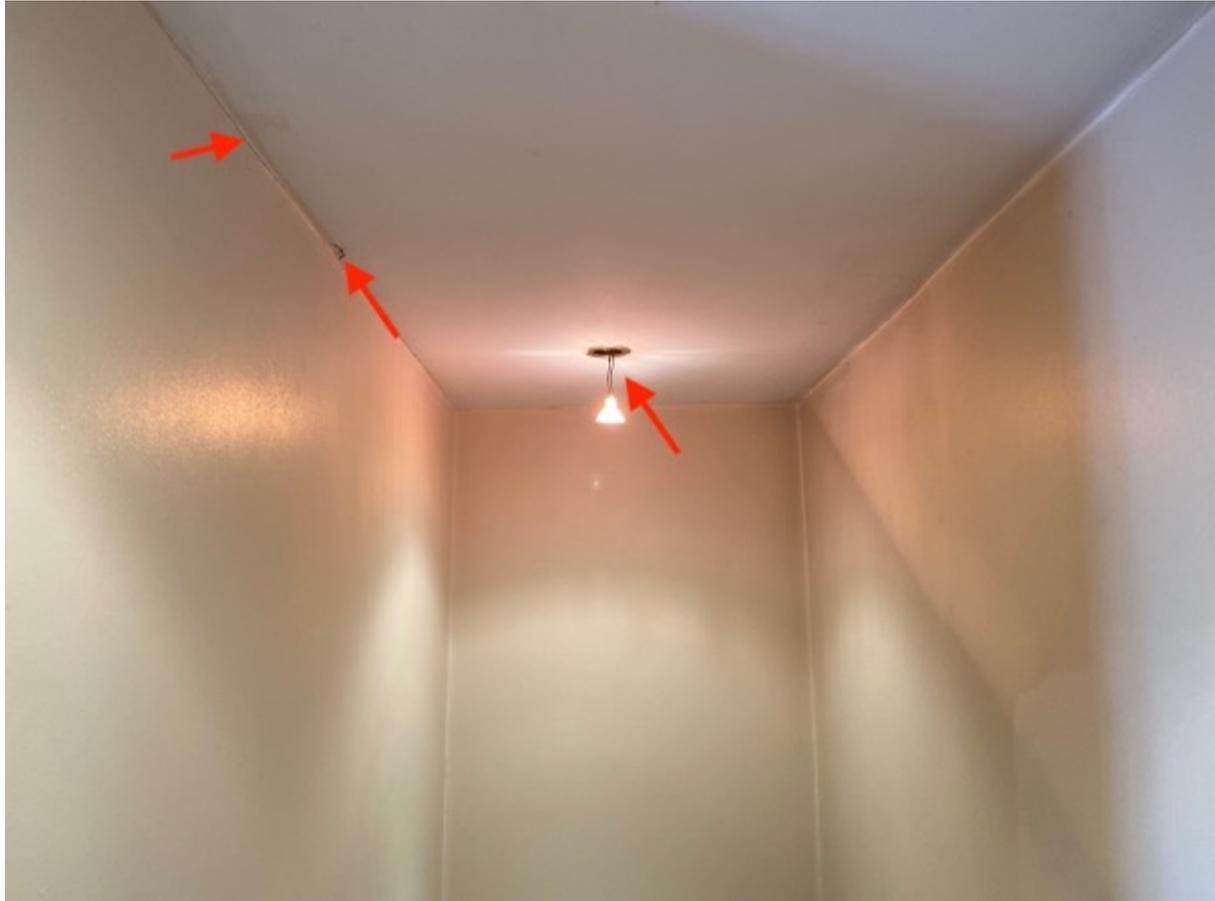
There were some signs of historic popped fixings/screws or nails as well as light separation cracks noted to the junction of one board to another.

These are all relatively normal decorative defects and will need to be addressed through the normal course of painting and upkeep.

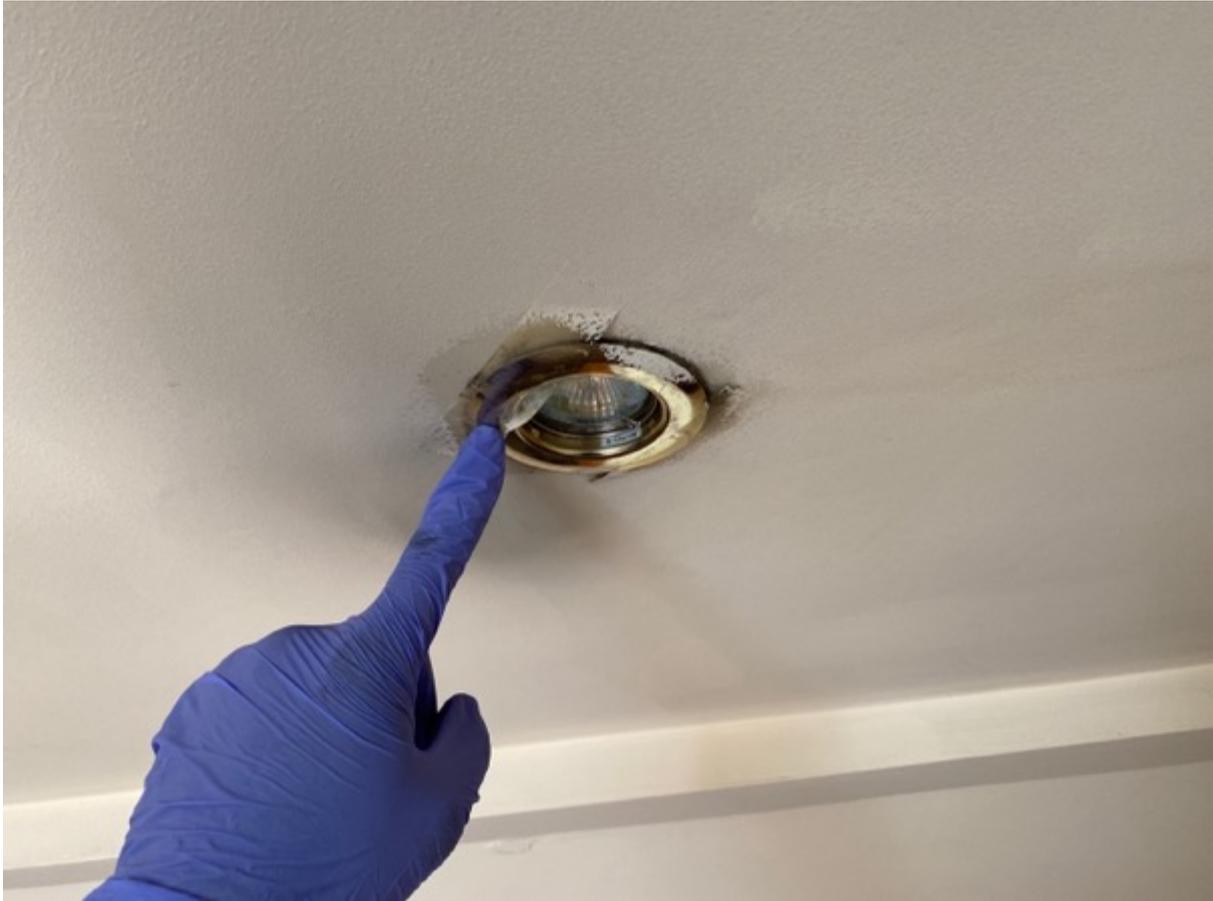
The spotlights within the loft room are taped and sellotaped in place meaning that the clips holding the spotlights in place have likely failed and will need to be replaced.

It is also worth noting that the light fitting towards the centre of the room projects from the ceiling itself meaning that for anyone in the region of 1.7m to 2m high they will have to lower their head, or travel around this light fitting.

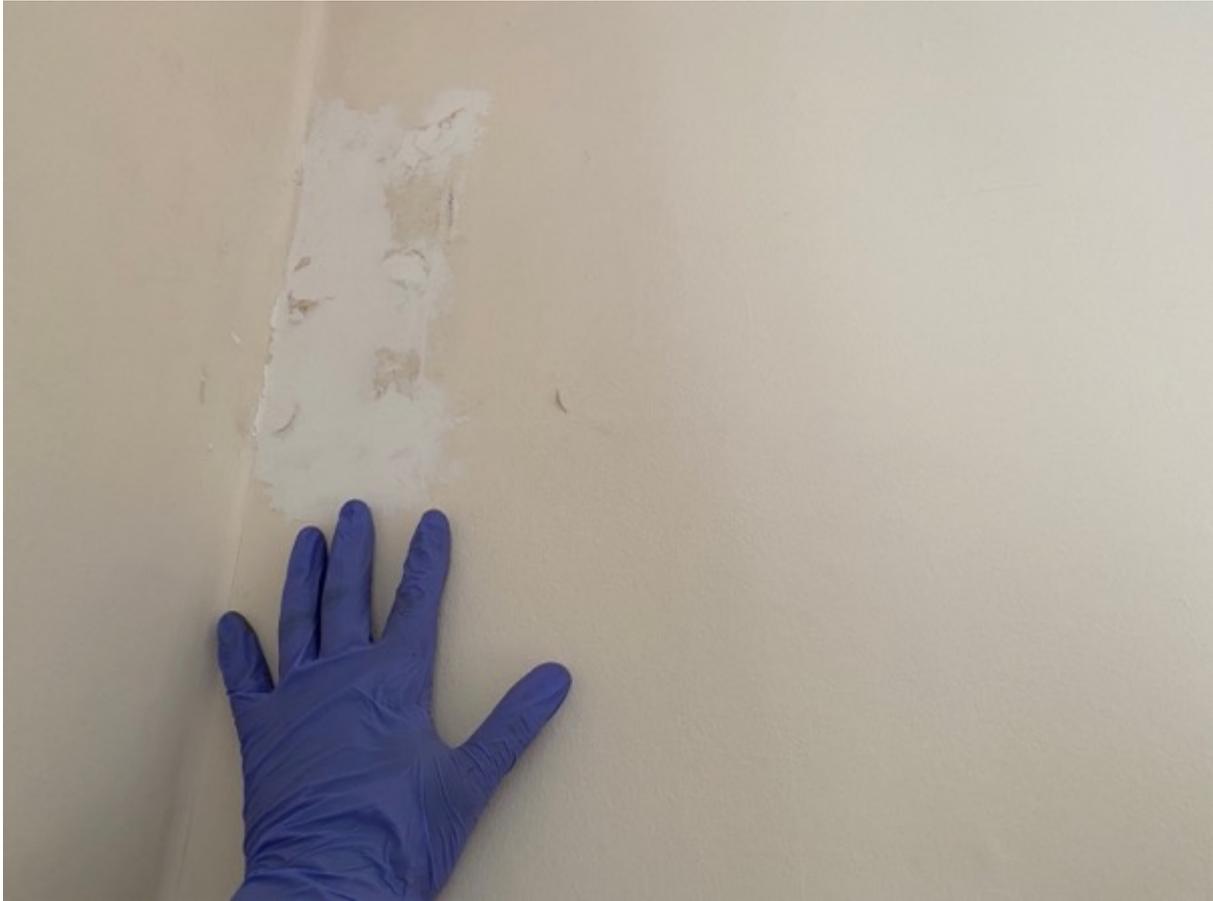
The rear chimney breast in the kitchen has been removed and it appears to be supported by a gallows bracket which is likely plaster boarded and skimmed over, I would advise making enquiries as to whether the necessary Building Regulations consents were in place in this regard and also the necessary Party Wall permissions and consents in regard to the property that this chimney breast adjoins.

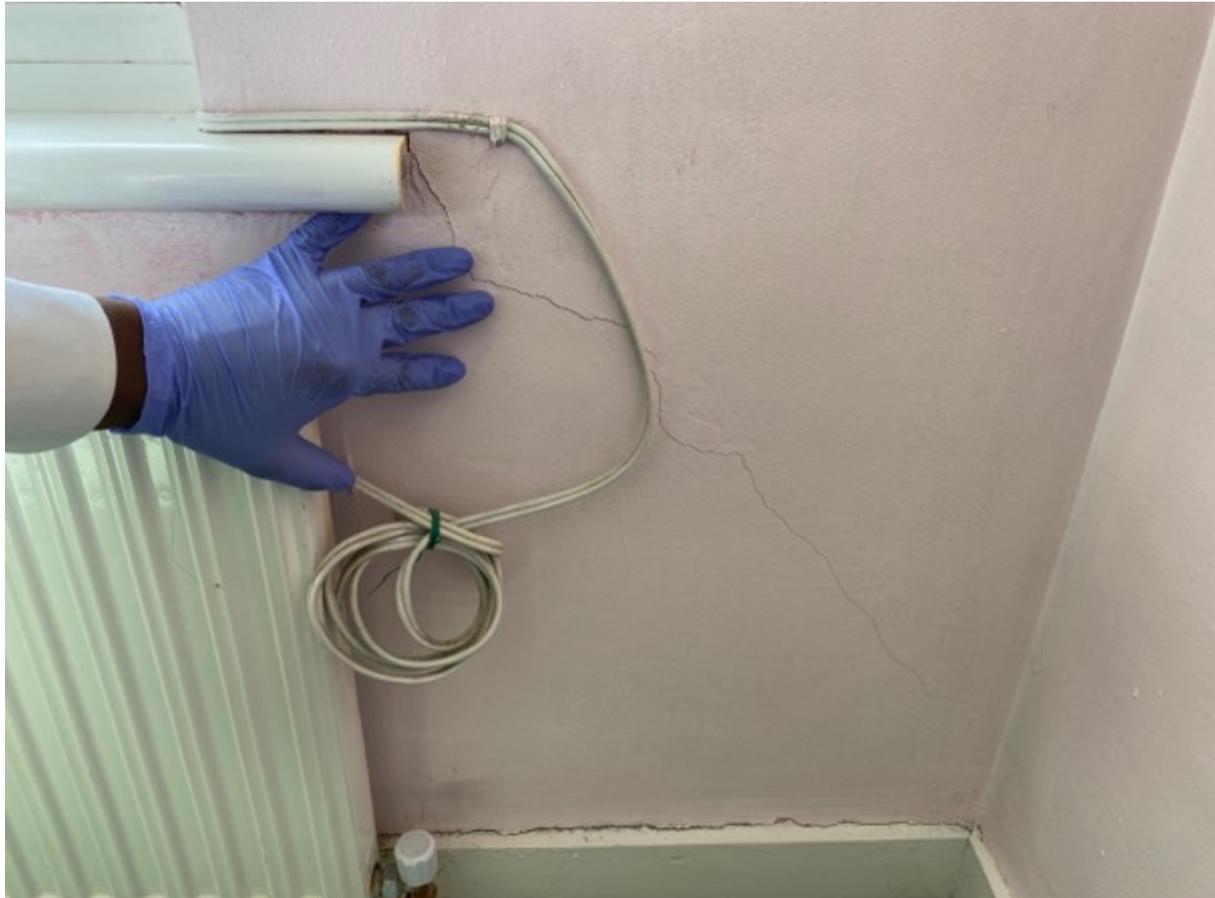
Within the rear bedroom at first floor level there is a diagonal crack to the lower right corner of the windowsill.

Cracks of this nature are relatively common and to be expected in a property of this age, however, I would advise making enquiries as to when this room was decorated as the crack itself pops and penetrates through the decoration and that would be a very good way to ascertain how recent and modern this crack is.

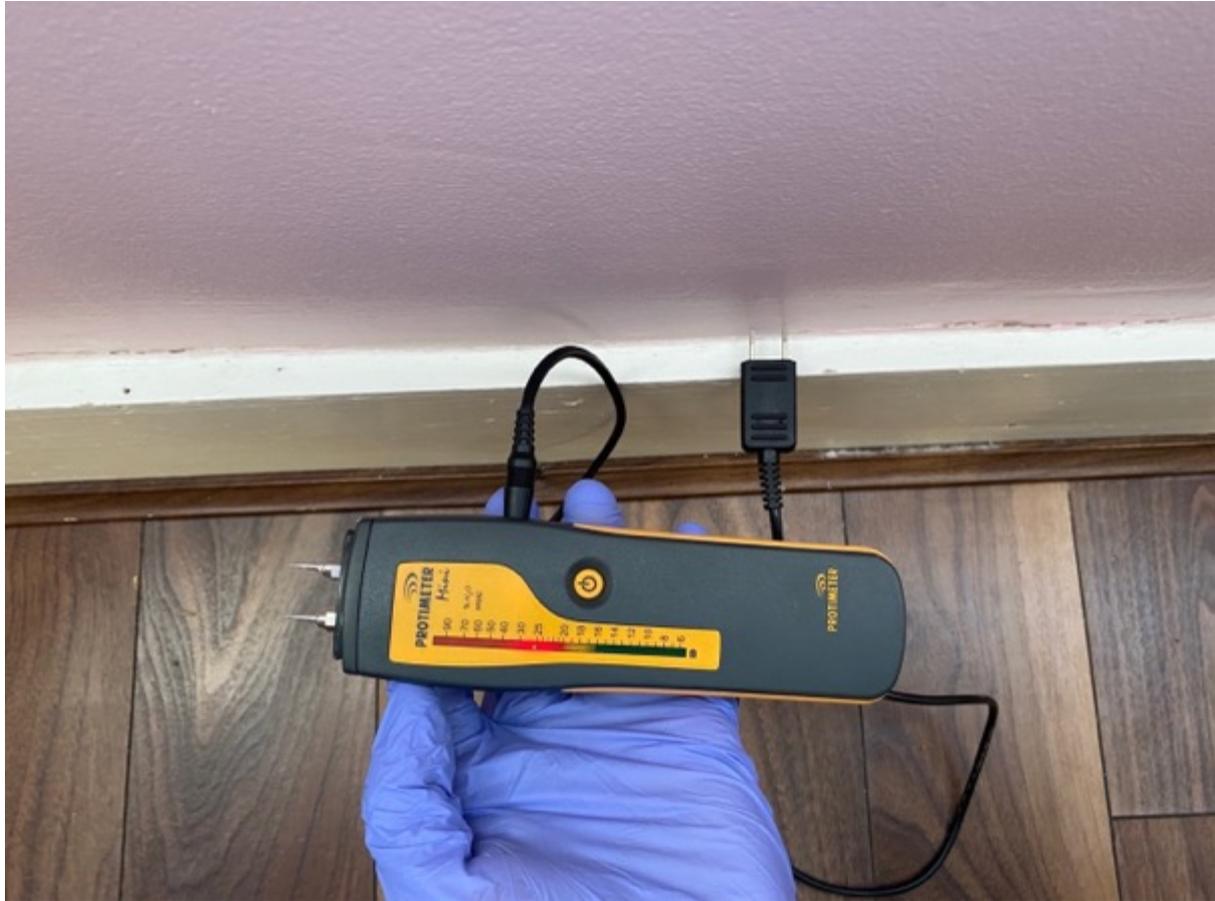
A red reading on the Protimeter confirms that the percentage level of moisture within the wall is at the higher end of the spectrum and in this case, I suspect the damp penetration is a result of the bridging of the damp proof course.

A red damp meter reading was also returned to the front area of the flank rear extension wall and it is likely that the damp proof course or damp proof membrane to that wall has failed.

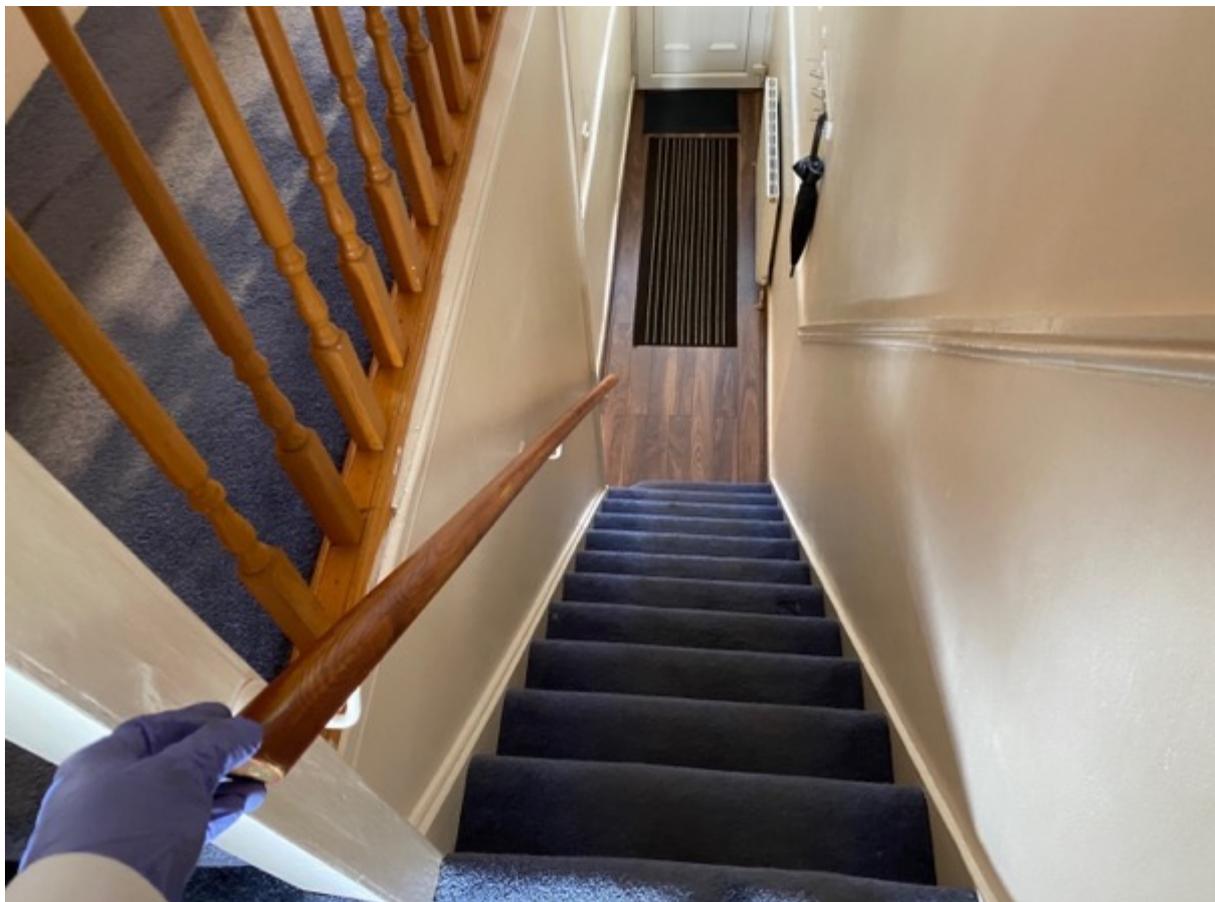
Furthermore, I would suggest making enquiries as to when the modification and adjustment to the stairs was undertaken and if there are any contractor's Guarantees in place for the workmanship that has been done.

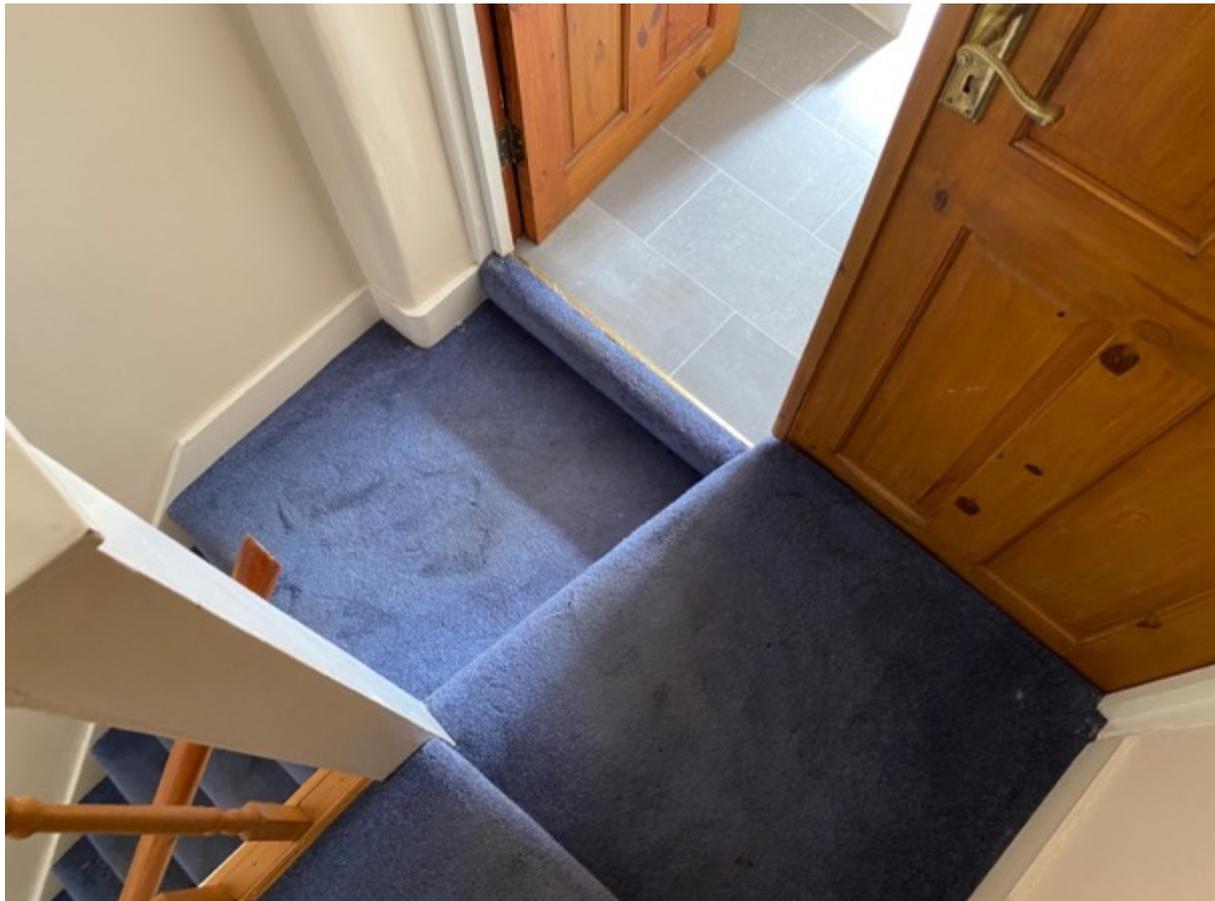
This is relatively unconventional and generally speaking, when development works do take place to a property, Architects tend to design around and avoid this type of issue as they can be tripping hazards and generally are quite awkward to work around and I would therefore suspect that the works that have taken place were poorly considered at the time of their conception and that could be an indication that the necessary statutory consents could not be in place.

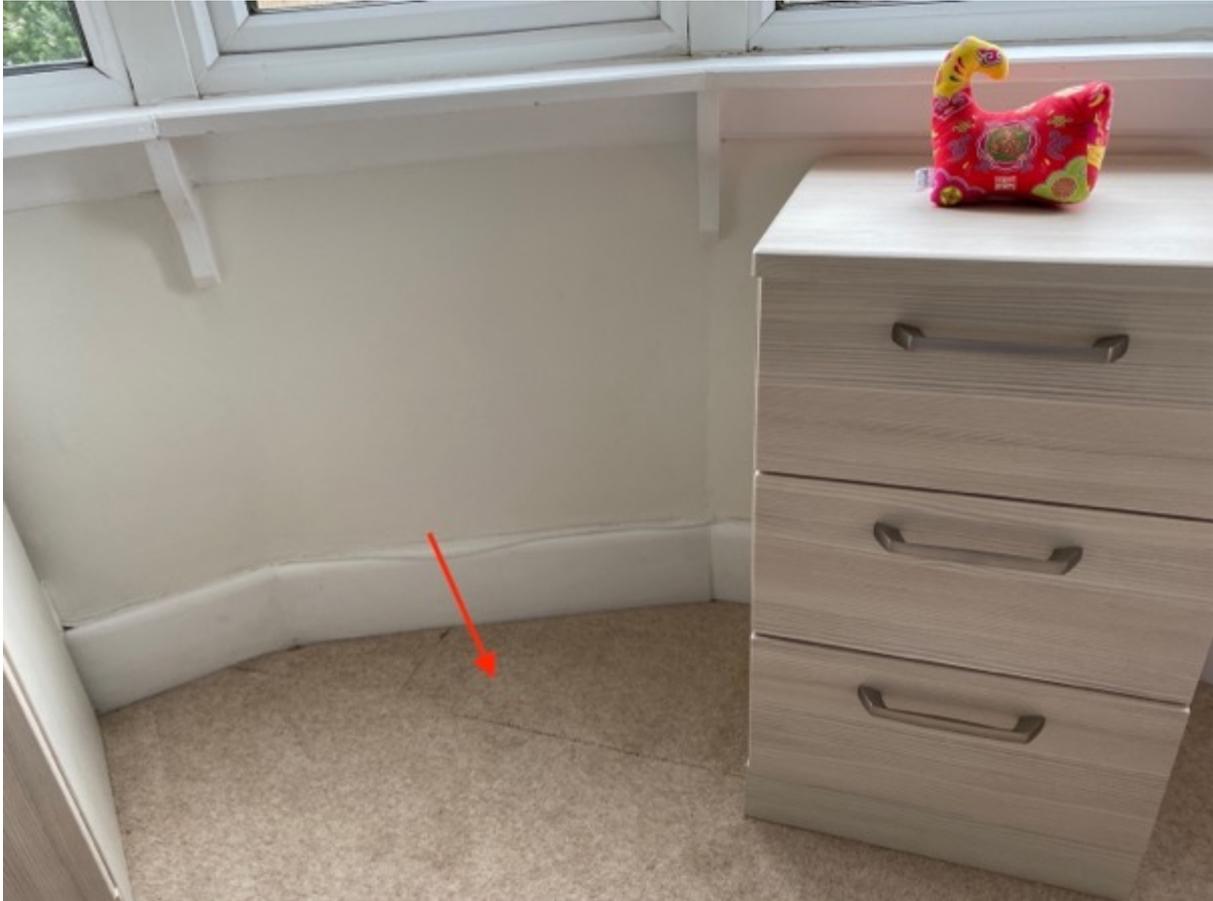
Within the first-floor front bedroom the front of the bay there are a number of different carpet joins noted and generally speaking, for a room of this size there should have been one continual sheet of carpet which would have then been cut to size.

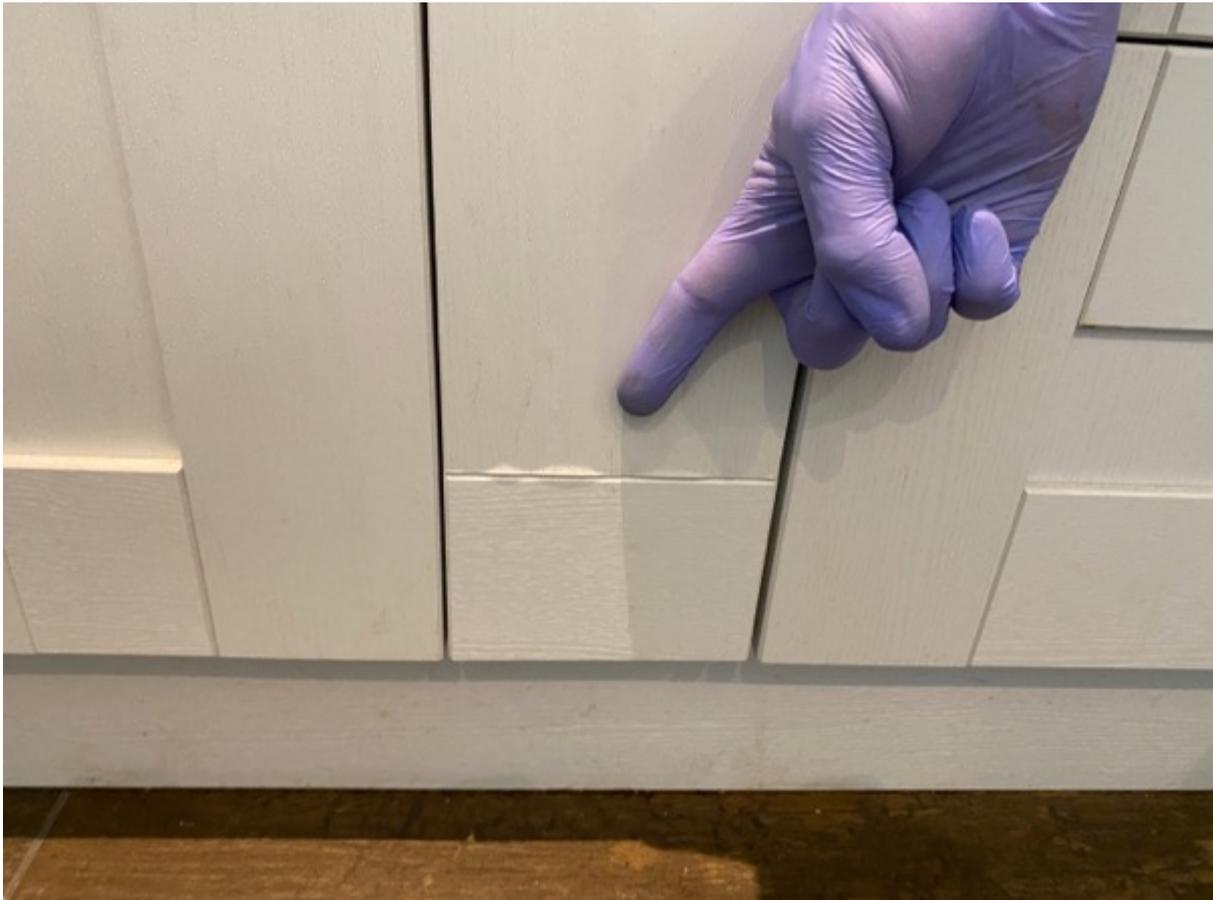
This is likely a manufacturer's error, and you could find that in due course further areas of the kitchen will likewise peel and raise in this manner and therefore you may want to consider that in respect of any Warranties that may exist.

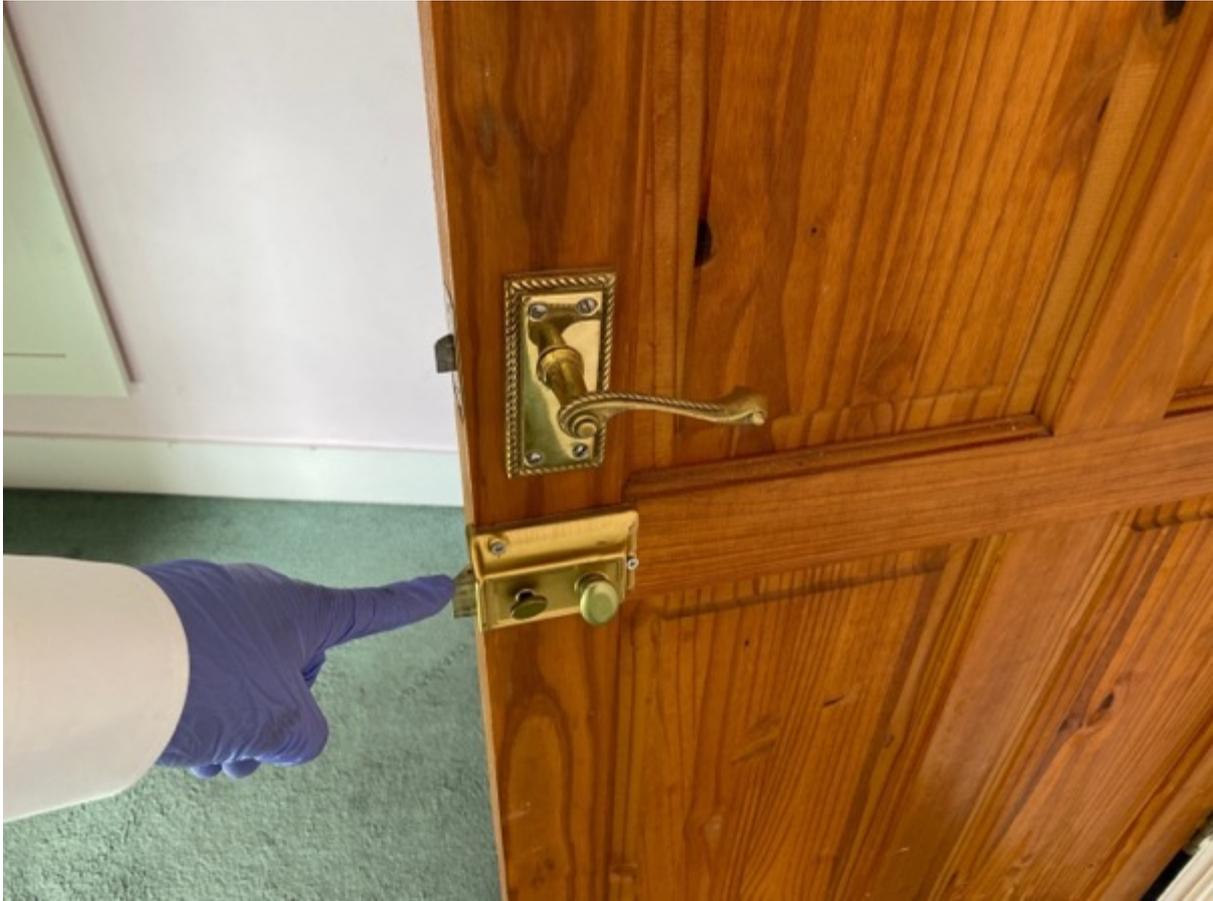
This is a relatively unconventional installation for a house, and it is likely that at some point in the past this property was a flat share or joint occupancy property. In any event, should you proceed with the property, I would advise that the locks are removed so that the property can be used in a conventional way.

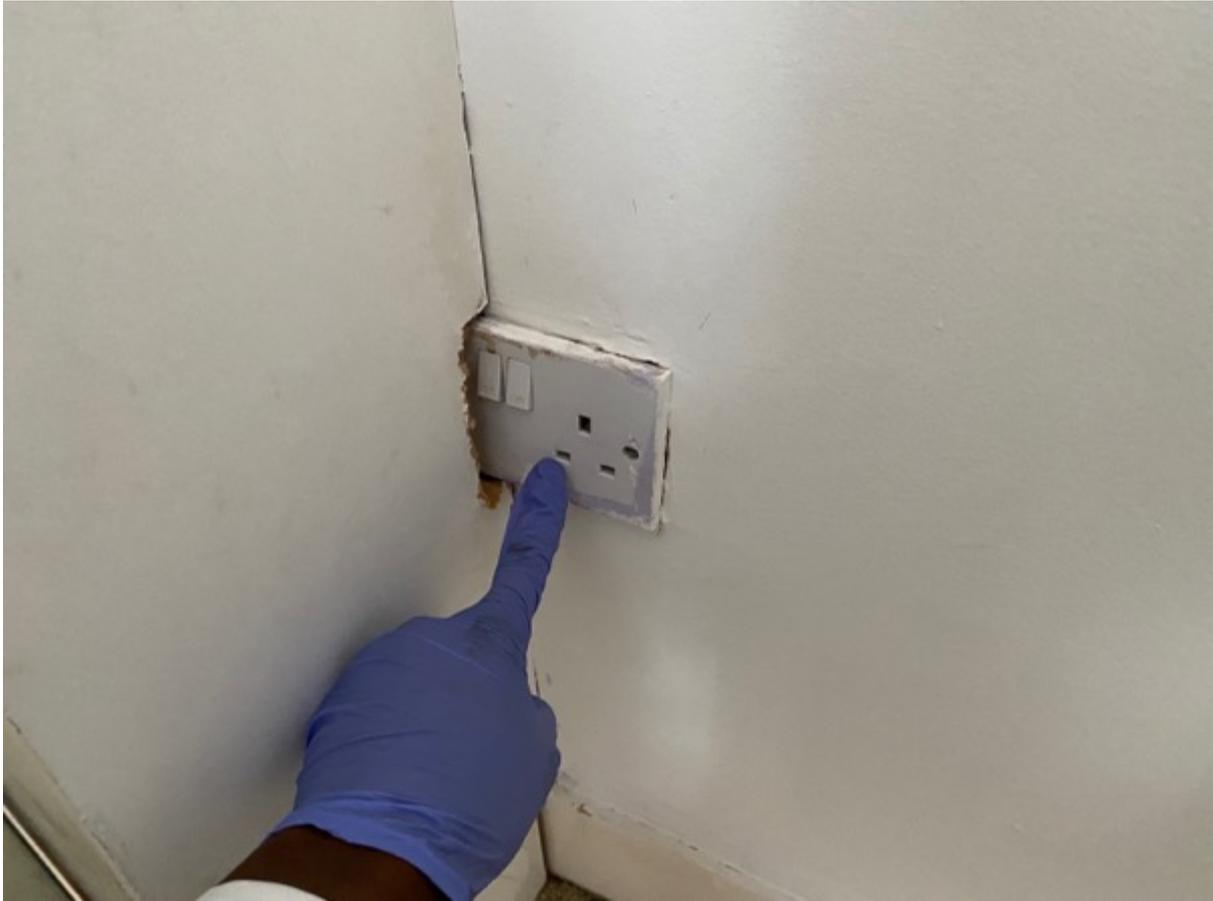
This would not be health and safety compliant and in any event, would mean that there are insufficient sockets within the front bedroom area and therefore to accommodate modern day use you will need to have further electrical sockets installed.

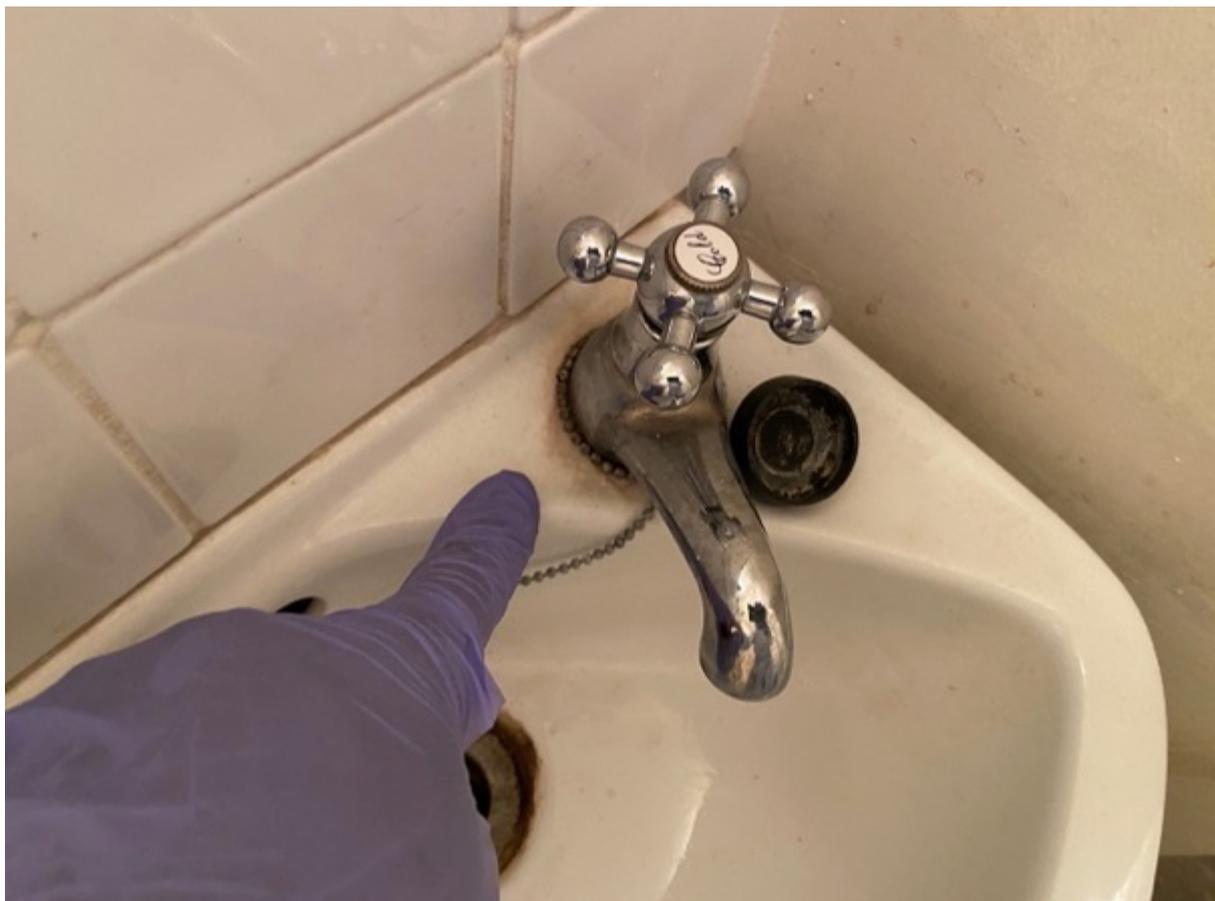
The property benefits from mains fitted water in both the kitchen and bathroom areas. At the time of the inspection the shower was tested and there was no water running as were the taps which likewise had no water running through them.

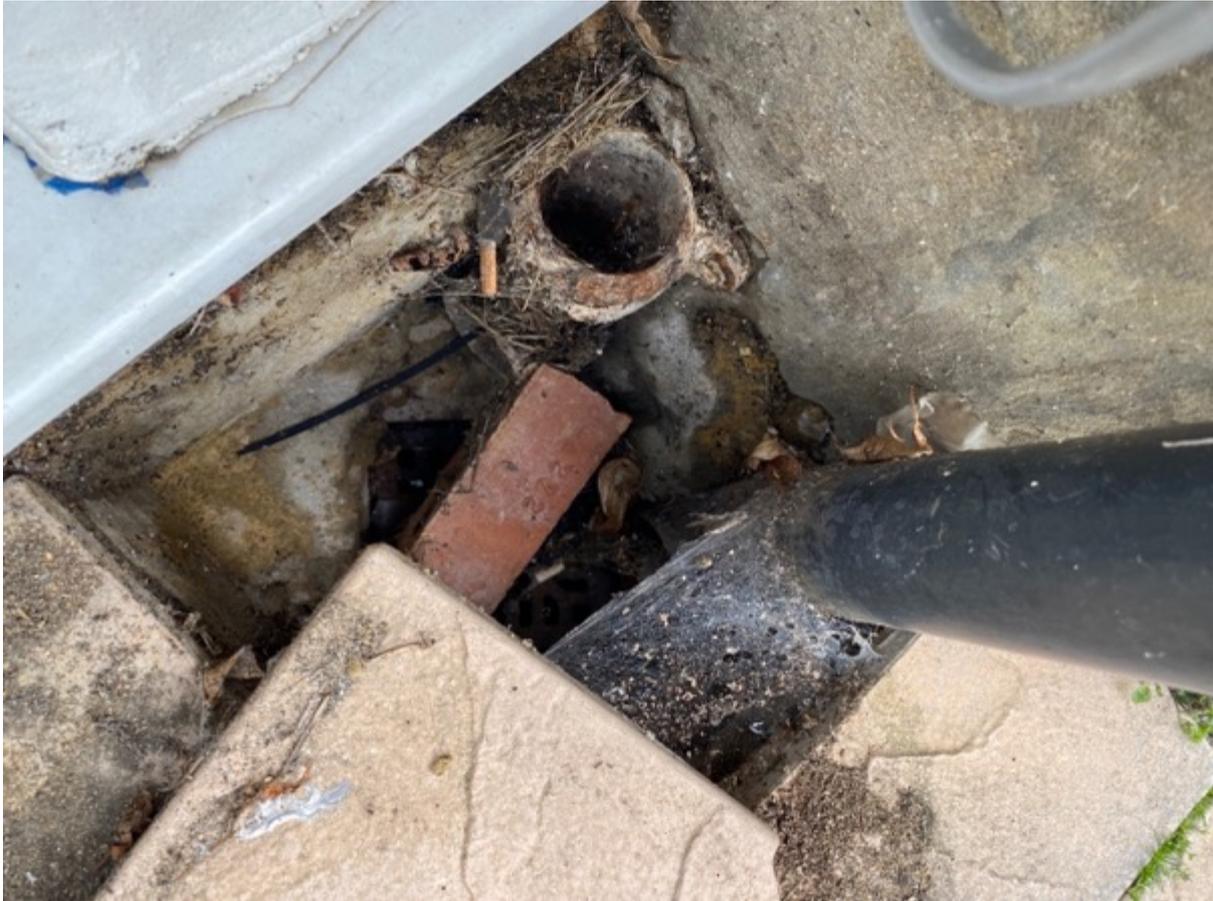
This is a slightly unconventional finish and generally speaking, they should be covered with a grate or drain cover.
