## RICS Home Surveys RICS HomeBuyer Report

## **RICS HomeBuyer Report Contents:**

Surveyor's Name:	Surveyor Name
Surveyor's RICS Number:	000000000
Company Name:	Stokemont
Date of the Inspection:	00-00-0000
Report Reference Number:	SR00000
Related Party Disclosure:	None
Full Address and Postcode of the Property :	Address of Property
Weather Conditions when the Inspection took place:	Sunny and Clear. At the time of inspection, it was dry.
The status of the Property when the Inspection took place:	Tenanted and unoccupied.

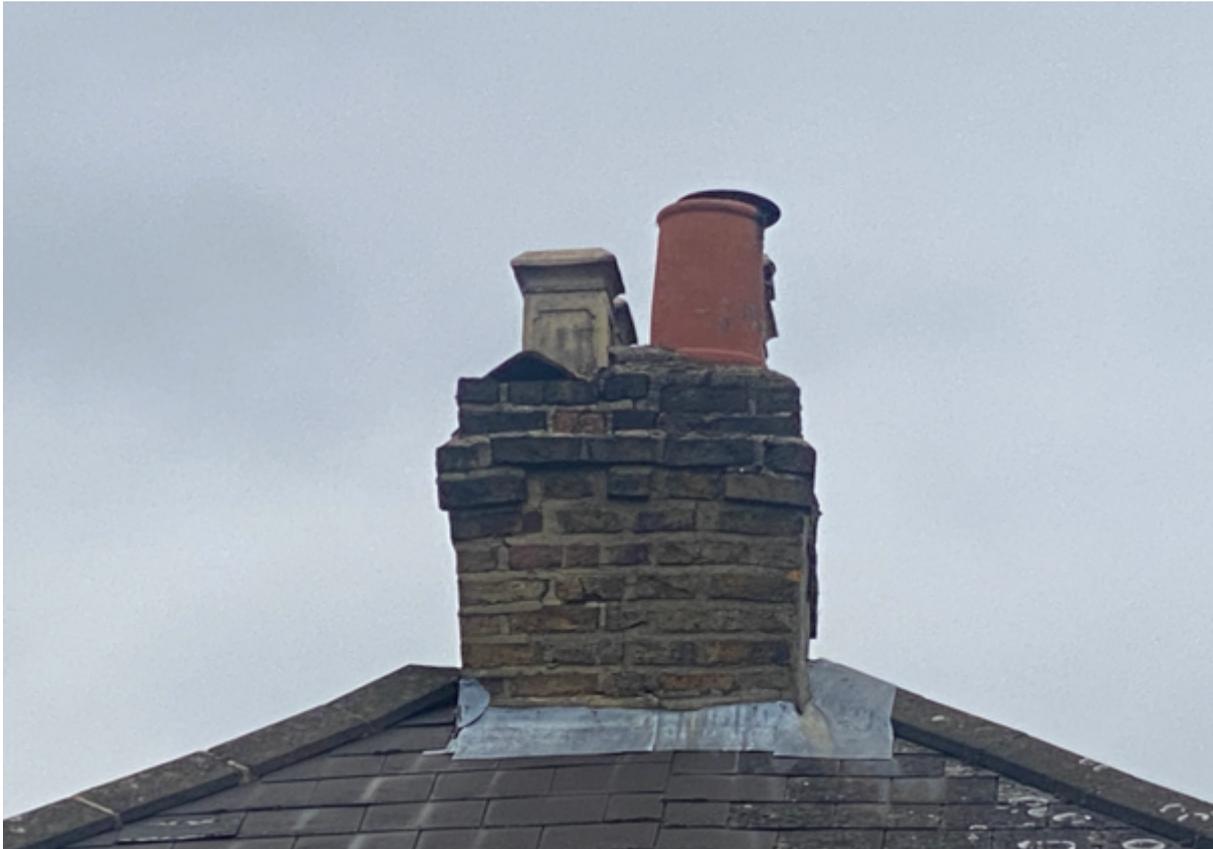
Brickwork, London stock solid construction. The front face of the chimney stack appears to have been partially repointed at some point in the past. There are also signs of undulation and movement towards the upper section of the stack itself where it adjoins the flaunching.

The chimney stack movement is a relatively normal thing as they tend to get the full brunt of the weather. In this case, while there are historic signs of issue, it doesn't appear to be untoward and would be relatively normal considering the age of the property.

Flashing to the chimney stack is a lead type. This appears to be quite crudely dressed over the roof itself, and in my opinion, hasn't been done very well and could have been done in a more aesthetically pleasing way. That being said, the flashing does appear to be sufficient and doesn't appear to be lifting or bulging at the time of inspection.

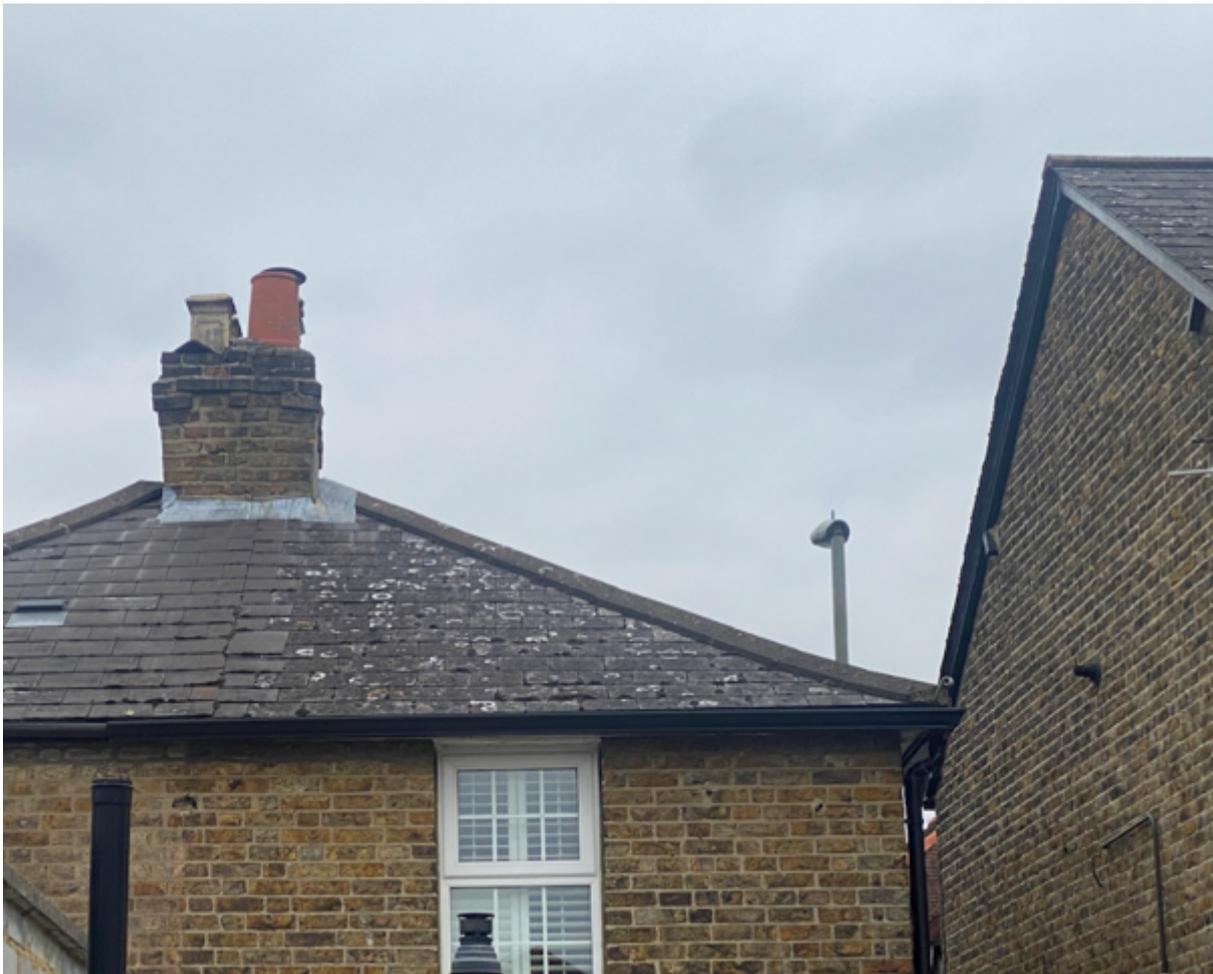
The slate tiles are severely weathered with signs of moss and lichen growth noted throughout. The tiles also appear to be showing signs of delamination throughout, and it is my opinion that the tiles have likely reached the end of their useful life.

I would advise budgeting for replacement of tiles shortly after the sale of the property, as it is likely they are at the end of their useful life and will require action in the immediate future.

I would advise that in advance of the purchase, that a roofer puts a roofer's ladder up there so a full inspection can be undertaken to ascertain if it is any worse condition than the front and rear pitches.

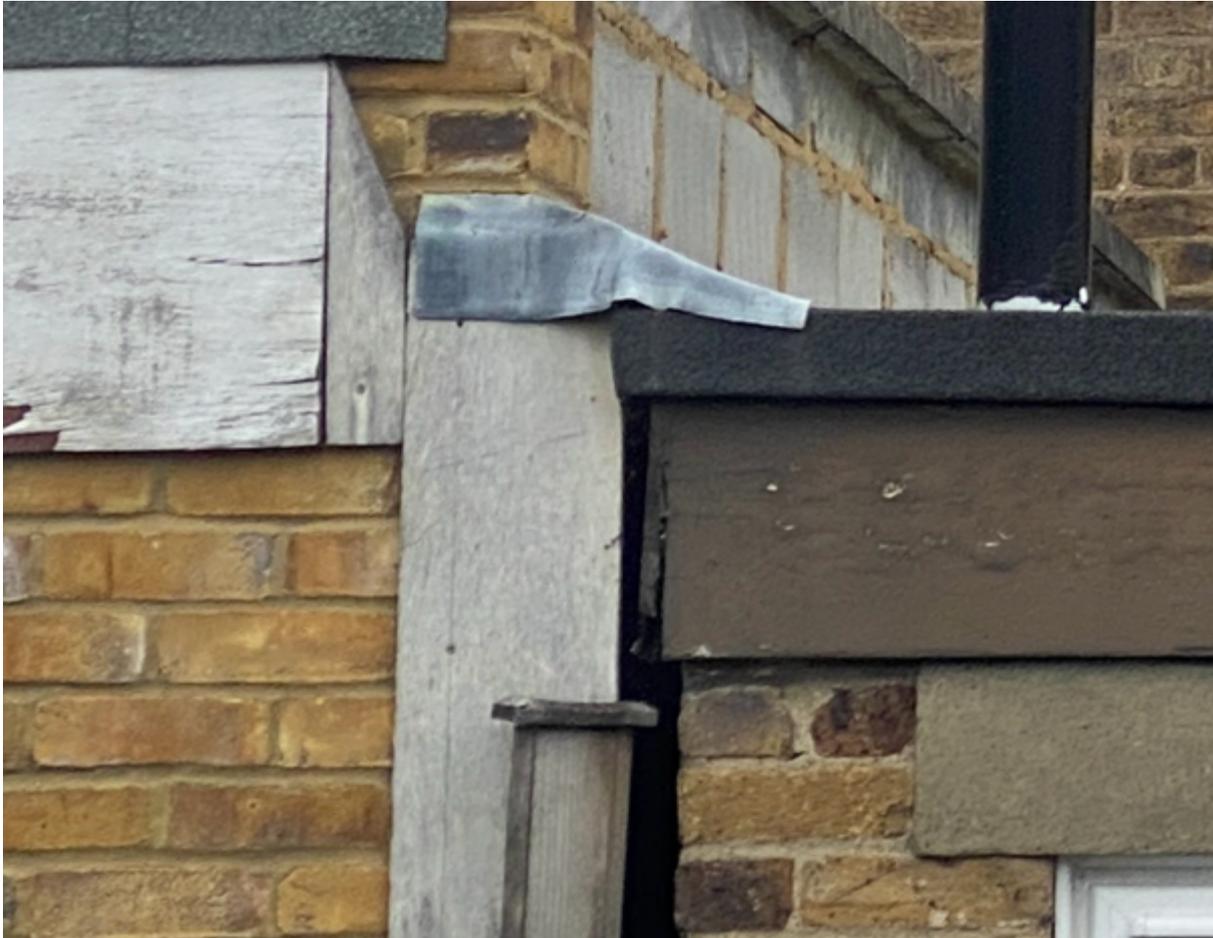
The roof to the rear extension, the fascia board towards the flank of the property itself, where it adjoins the semi-detached property, is showing signs of weather ingress and the fascia boards themselves are also showing signs of blistering and peeling paint throughout.

This will need to be partially cut away and replaced with new timbers, or potentially replaced in the entirety of the fascia board to ensure longevity and a waterproof finish.

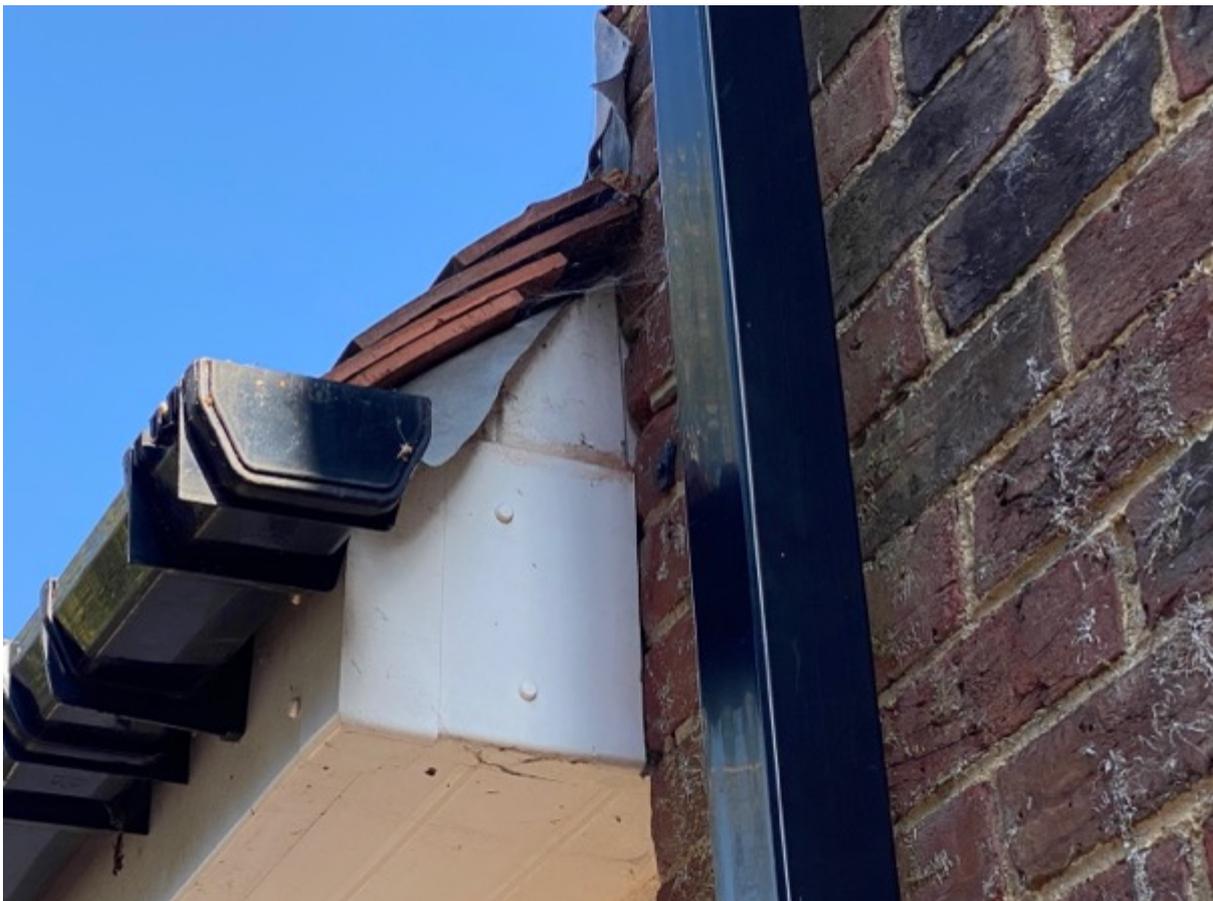
Rainwater pipes and gutters are uPVC plastic type and appear to have been replaced at some time in the near past.

At the time of inspection, these appeared to be level throughout and free from any signs of leaks or issue noted.

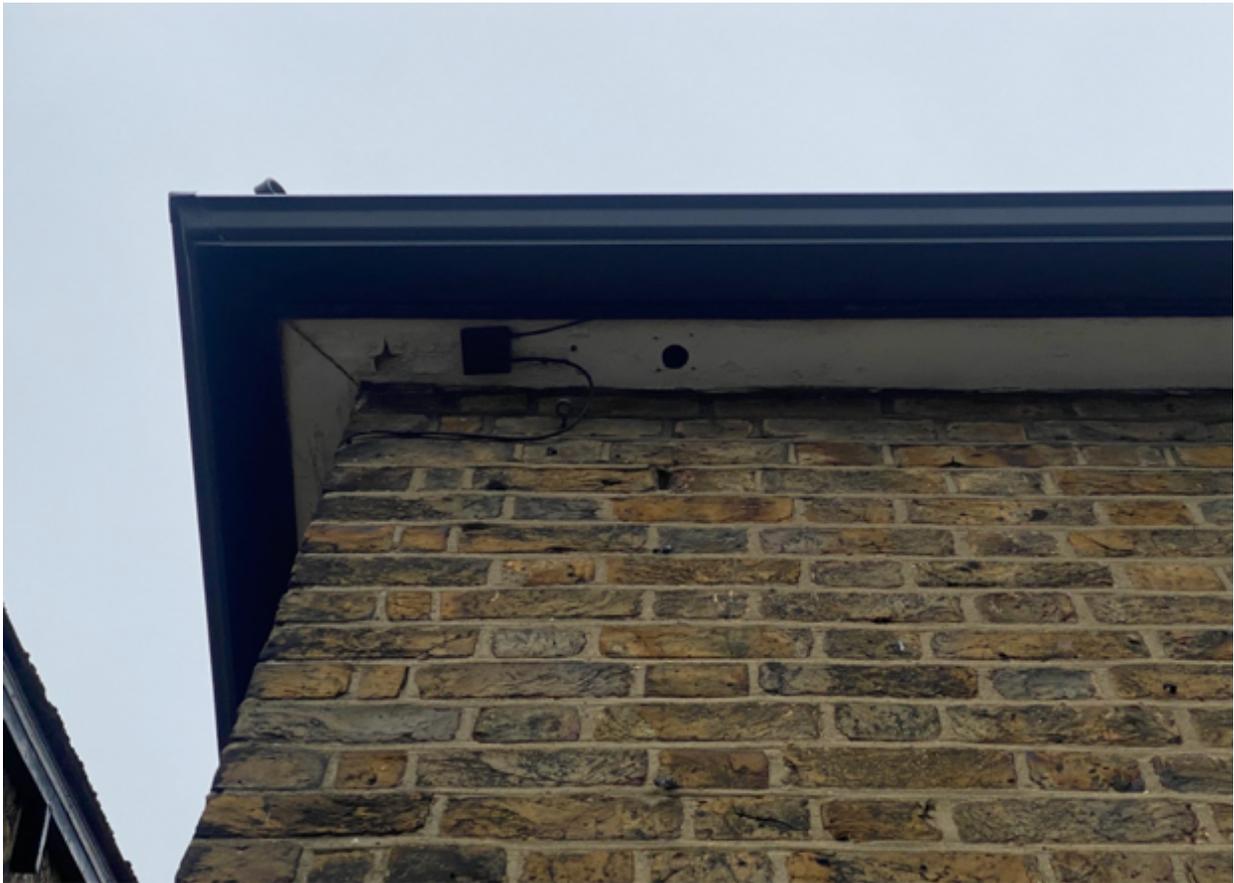
The soffit beneath is a timber type and was showing signs of blistering and peeling paint noted throughout, prominent to the rear left side and front left corner of the property. It is likely that these soffits will need to be treated and painted to ensure their longevity and reduce the chance of water ingress to the property itself.

The rear rainwater gutter has been installed whereby it rests under the gutter to the other semi-detached property.

I would suggest that this is inspected by a competent roofer to advise further as to a suitable solution with regard to this.

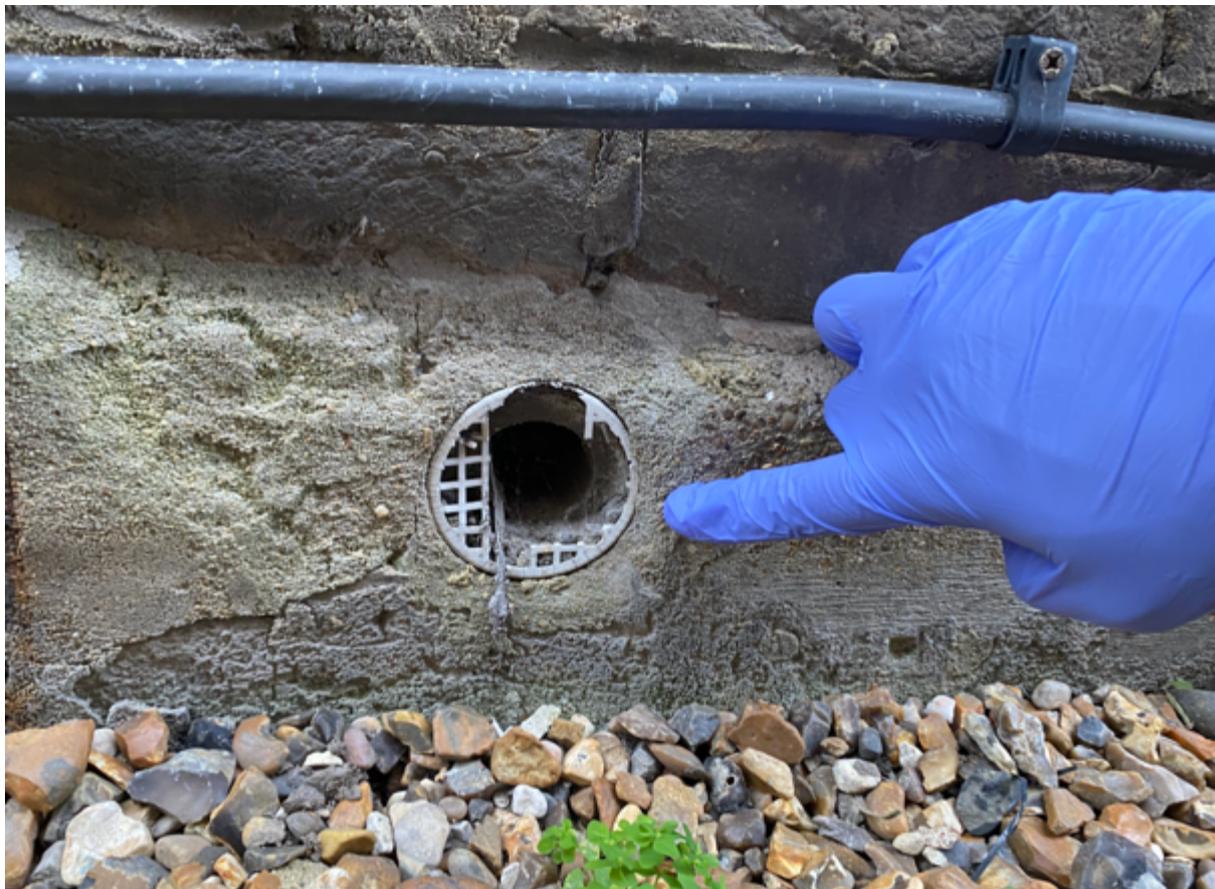
There appears to be a number of retro-fit circular core drilled air vents that have been inserted into the front and flank walls of the property.

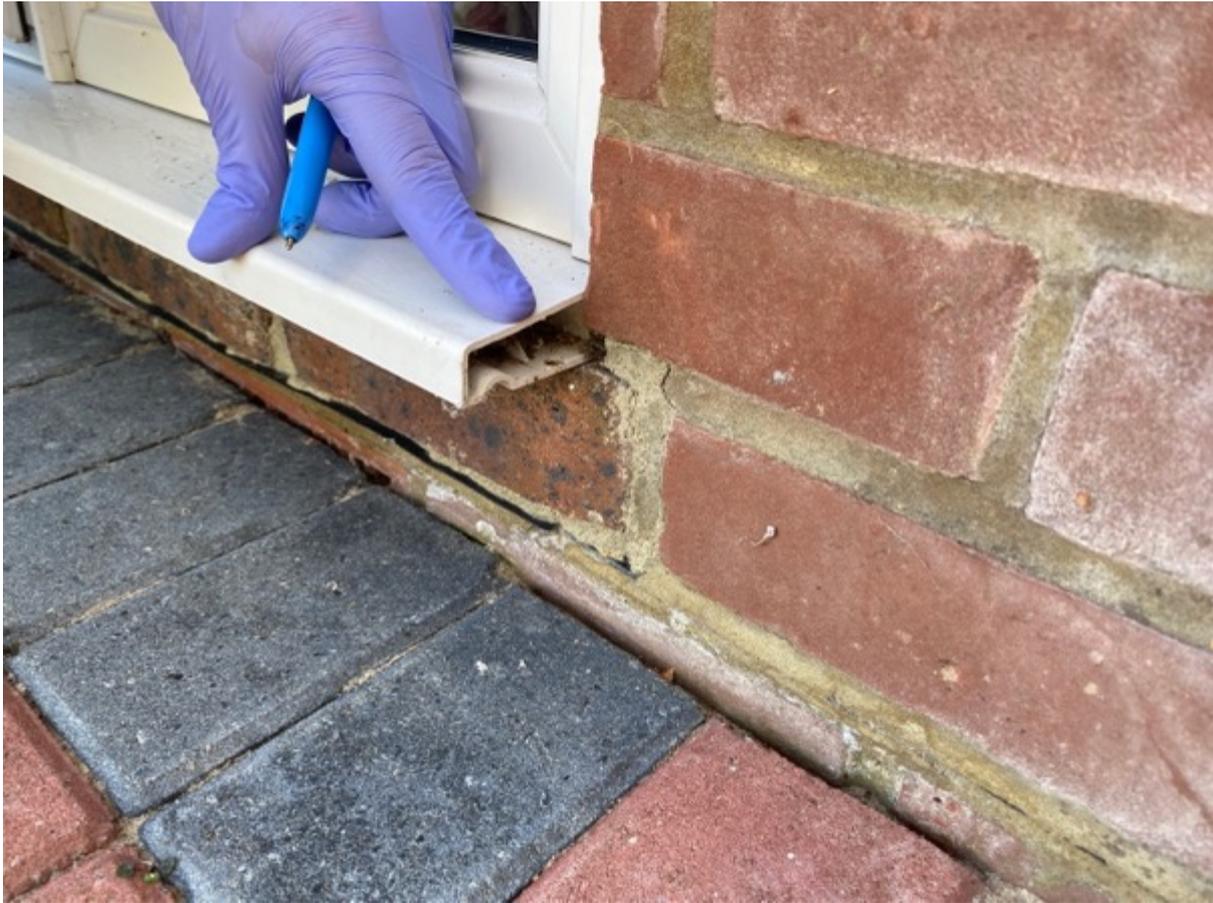
I would advise making enquiries with the sellers to ascertain if indeed that is the case, and as well as any contractor's installation warranty that may exist. Some of the window sills were missing the outer edge covering to the window sills.

These will, over time, allow pests to build up and can be a mucky clean, and I would therefore advise that these are filled in with the appropriate end caps.

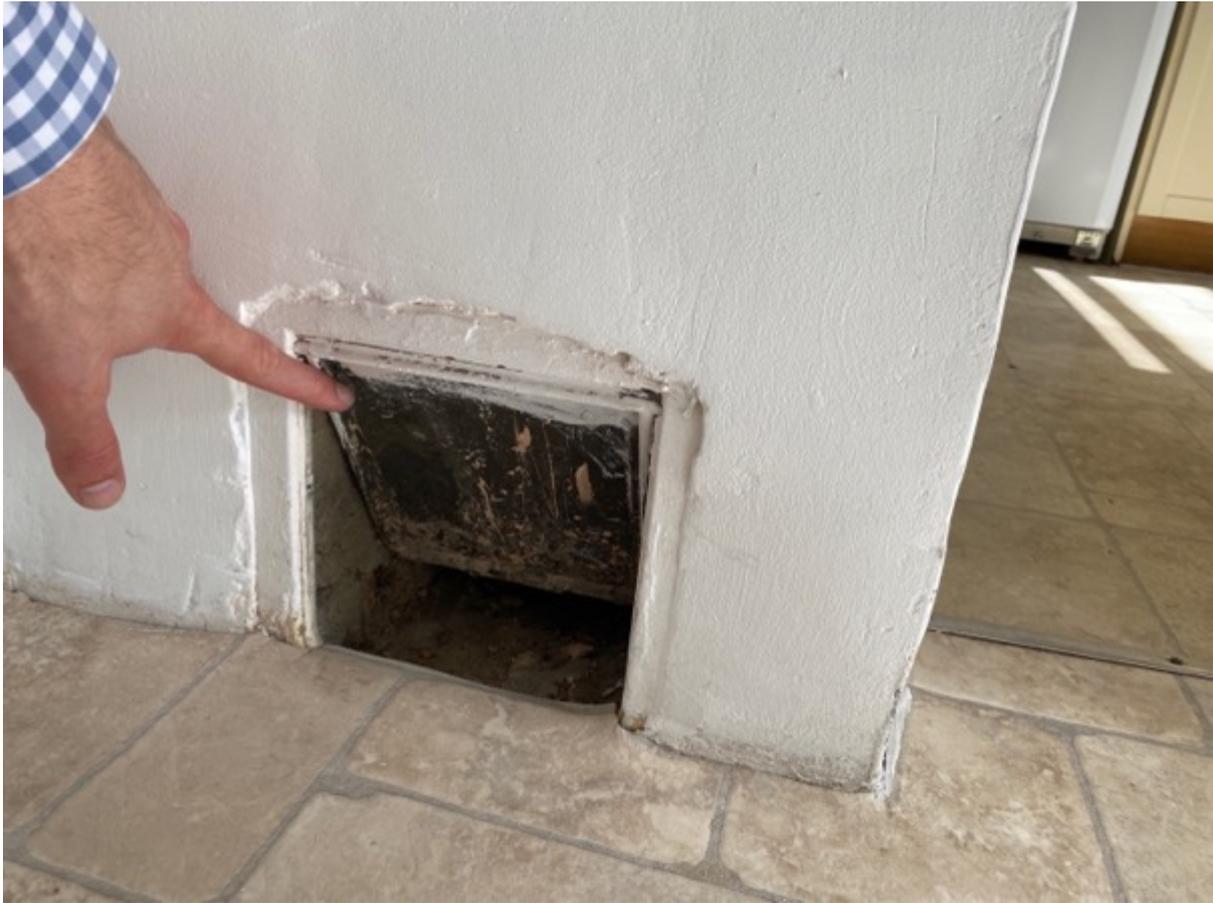
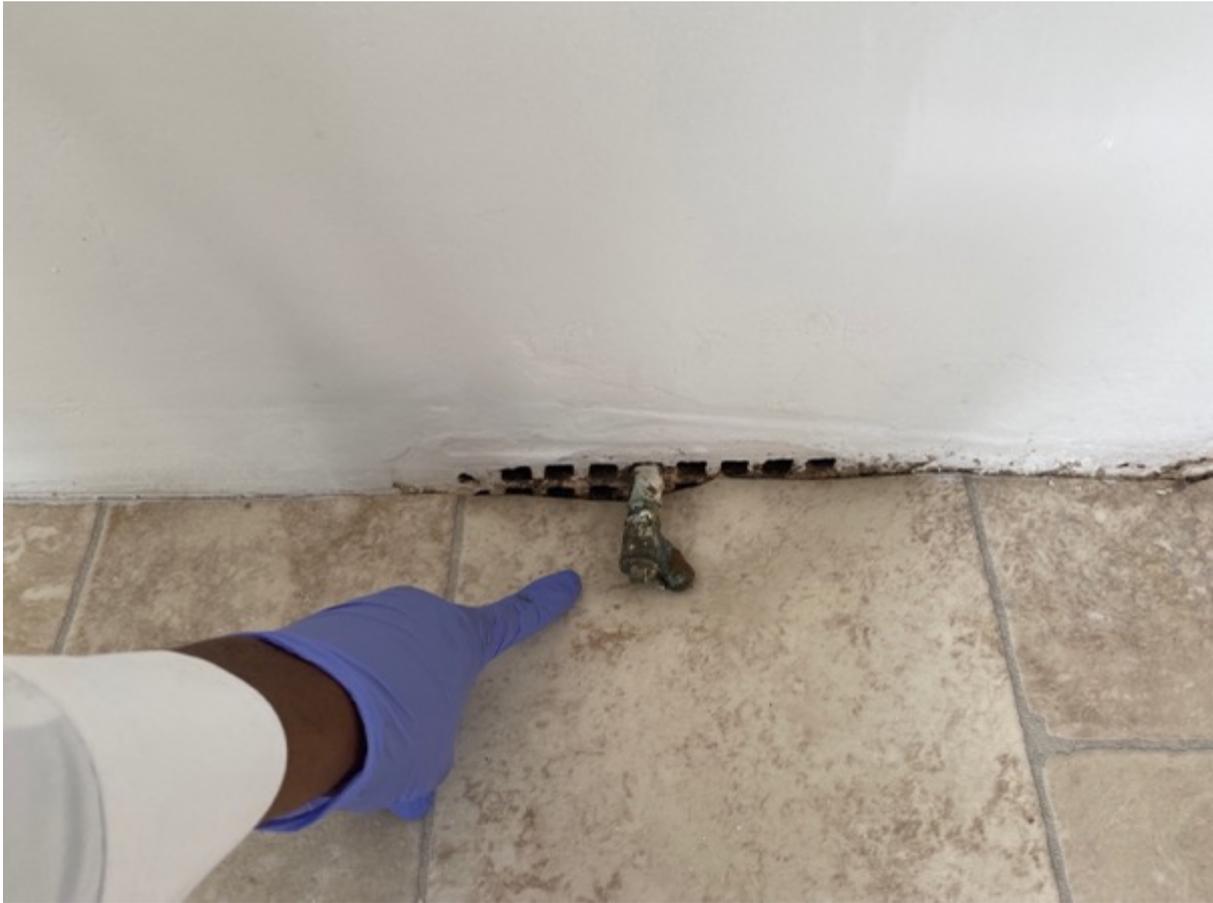
To the flank rear of the property there is a single level rear extension built, to the extension itself, there are signs of historic parts of the original building remaining, in particular an air brick and a cat flap.

This is a relatively unconventional arrangement, and I would have expected that these would have been blocked and bricked up and therefore, as they no longer serve any purposes, that is something that will need to be done to ensure a neat and conventional finish.

I would also advise making enquiries as to whether the rear extension itself has the necessary Party Wall compliance, Building Regulations compliance, Health and Safety compliance, and statutory consents in place as it would appear to be built as a party wall astride the boundary line.

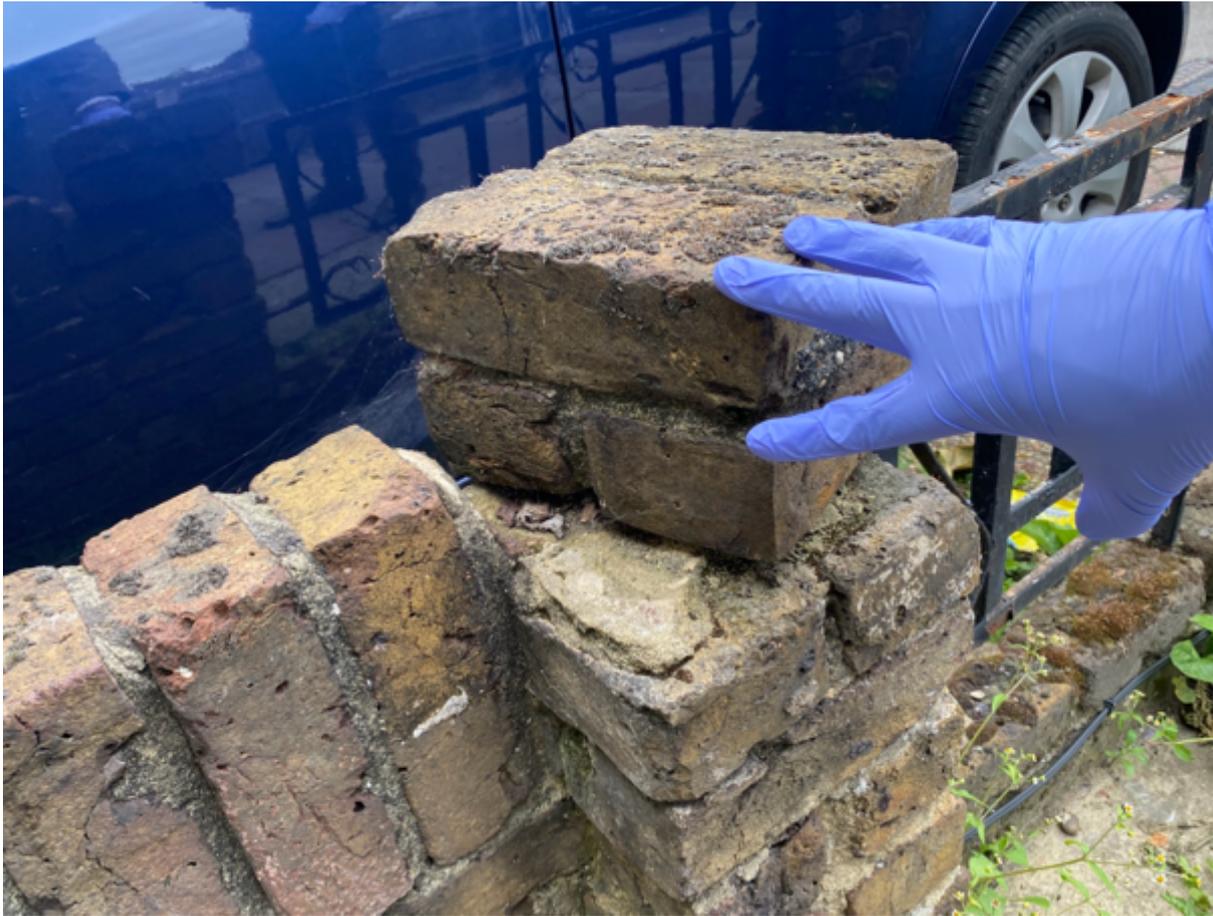
The central pier/buttress, the upper section of the brickwork is loose when tested and is not held in place firmly. This is a danger and will need to be bedded in with suitable cement.

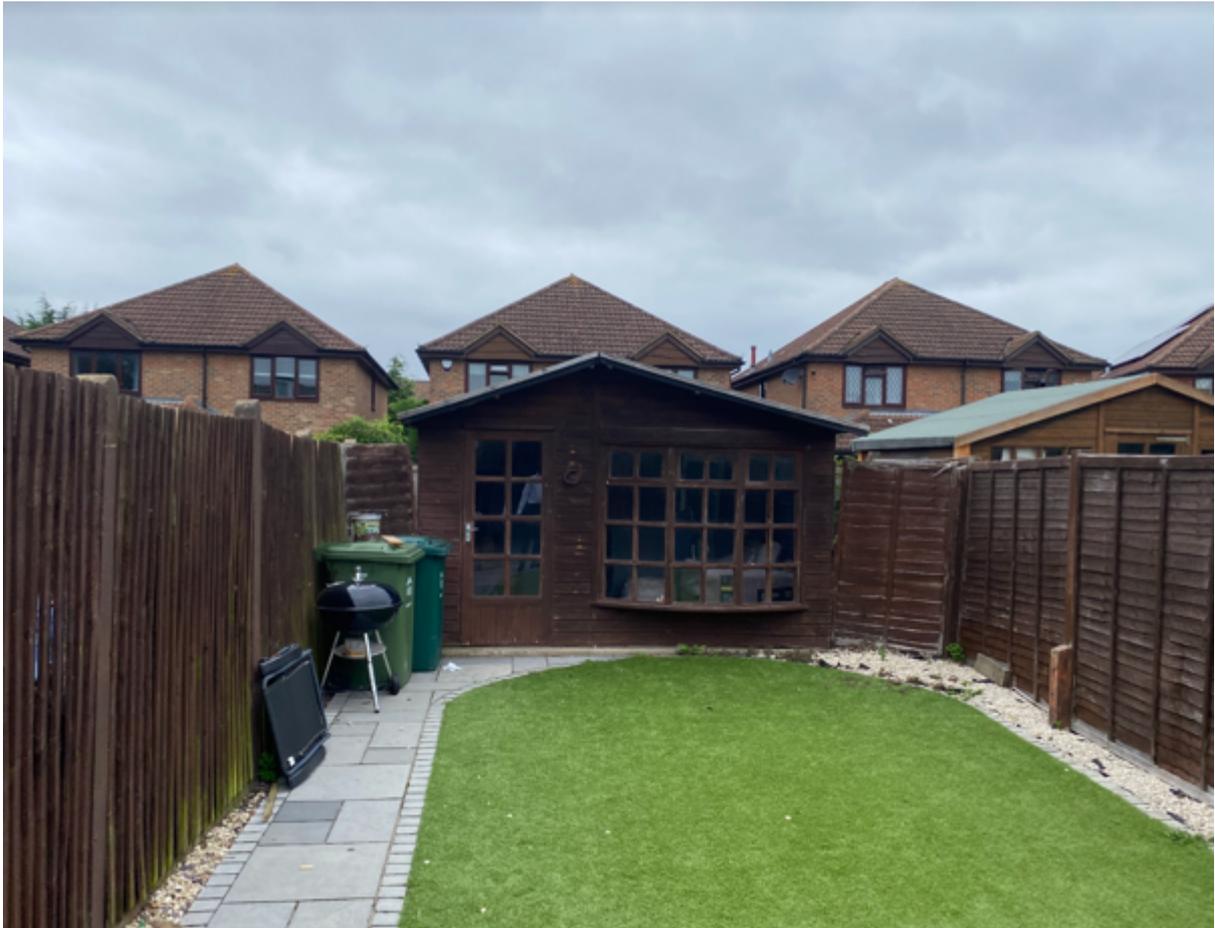
At the rear, there are timber fences with a mix of concrete posts, and timber posts to the left and right of the garden. These have been stained. The fence to the flank of the summer house is severely weathered and is seemingly installed to ensure that the tenant's pet doesn't escape the rear of the property.

The fence beyond that point has fallen over and has reached the end of its useful life. This will need to be replaced in due course, and would therefore advise budgeting for the costs of an experienced contractor or fencer to visit and correctly install any fence.

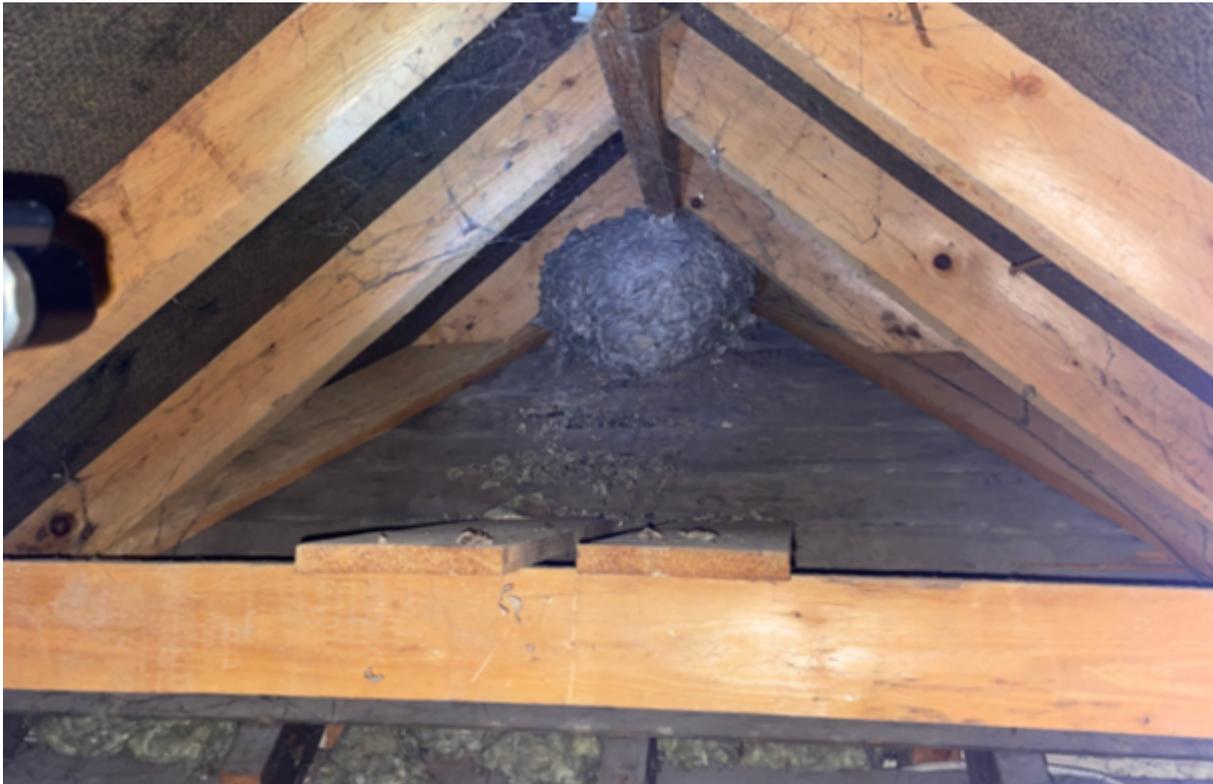
The roof structure is timber framed type. There is sarking felt visible beneath the outer slate roof covering and internal area of the roof void. The party wall appears to have been built up in breeze blockwork.

I did note a couple of different wasp's nests within the loft area which is normal for a property, however, it is worth noting that wasp's nests are seasonal and a nest will be used once and therefore this could be an ongoing issue. It is also worth noting that I did locate a wasp on the first floor level which was dead and that is usually a sign that there is an ongoing wasp/pest problem.

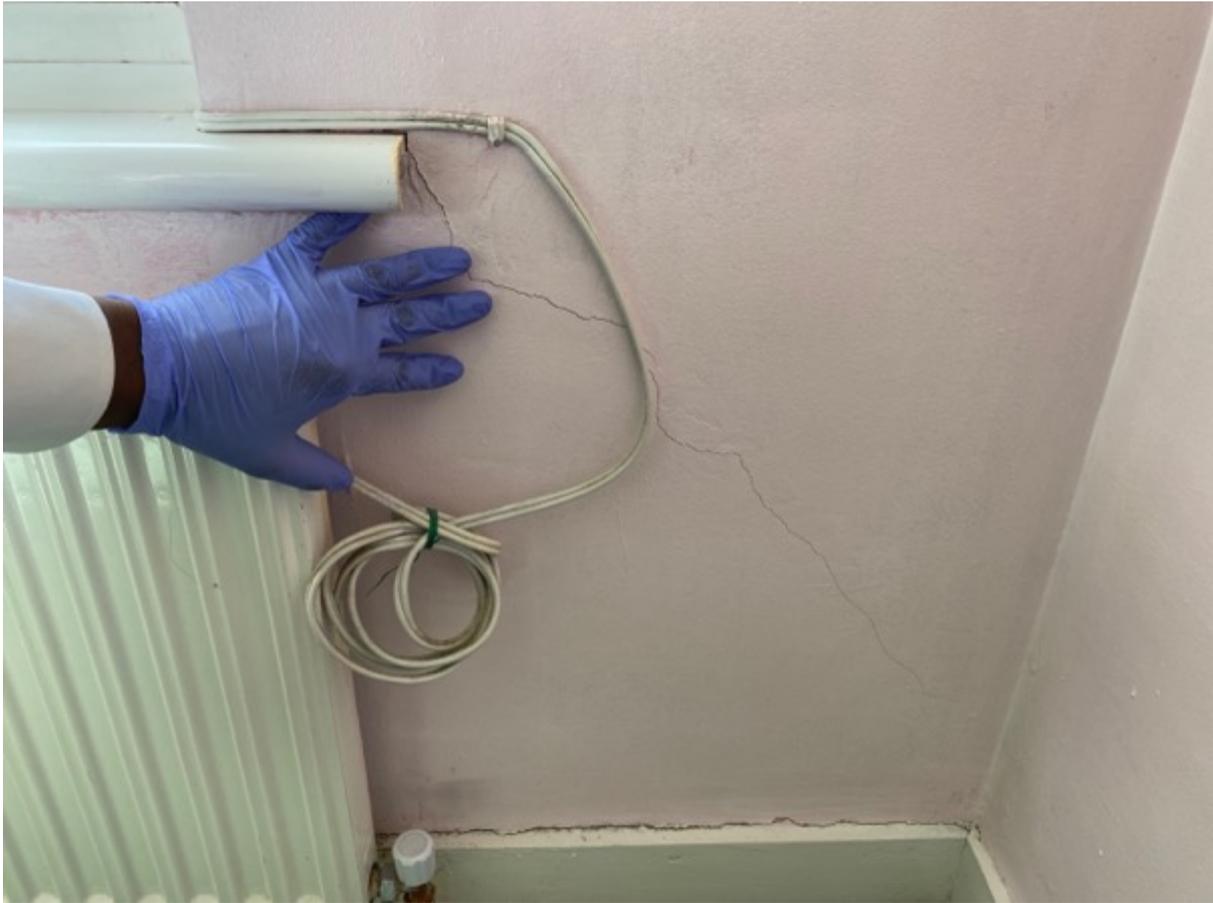
Within the rear bedroom at first floor level there is a diagonal crack to the lower right corner of the windowsill.

Cracks of this nature are relatively common and to be expected in a property of this age, however, I would advise making enquiries as to when this room was decorated as the crack itself pops and penetrates through the decoration and that would be a very good way to ascertain how recent and modern this crack is.

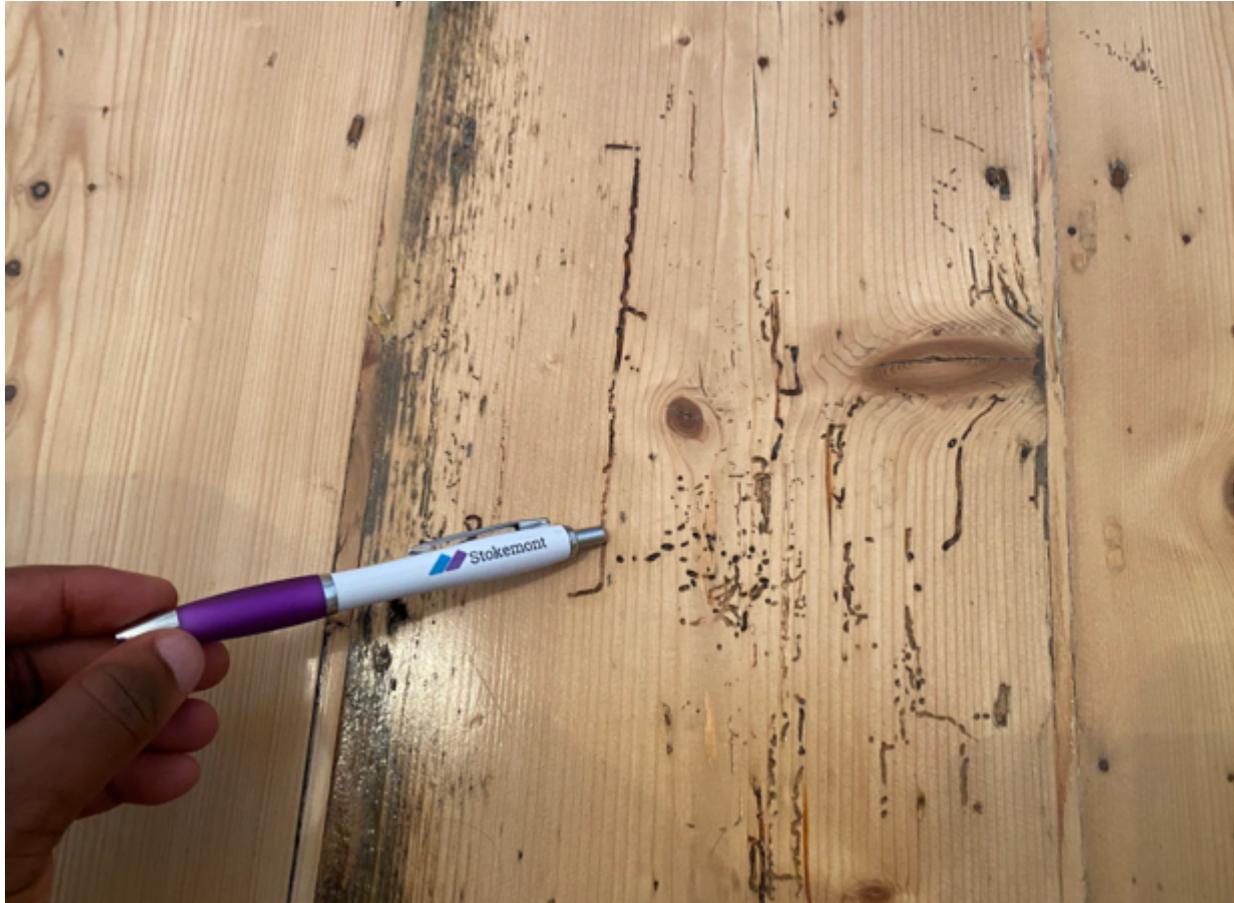
On all timber floors, predominantly on the first floor level, there are signs of historic infestations, whereby it appears to have been some form of woodworm, or woodboring beetle, or weevil problem. It is hard to tell whether these are historic issues, or whether this is live, as there was no sign of any frass or signs of it being a live infestation.

In advance of proceeding with the sale, I would advise that a timber specialist is appointed to give you sound and firm advice as to whether this is a historic or live infestation and whether the matter has been resolved.

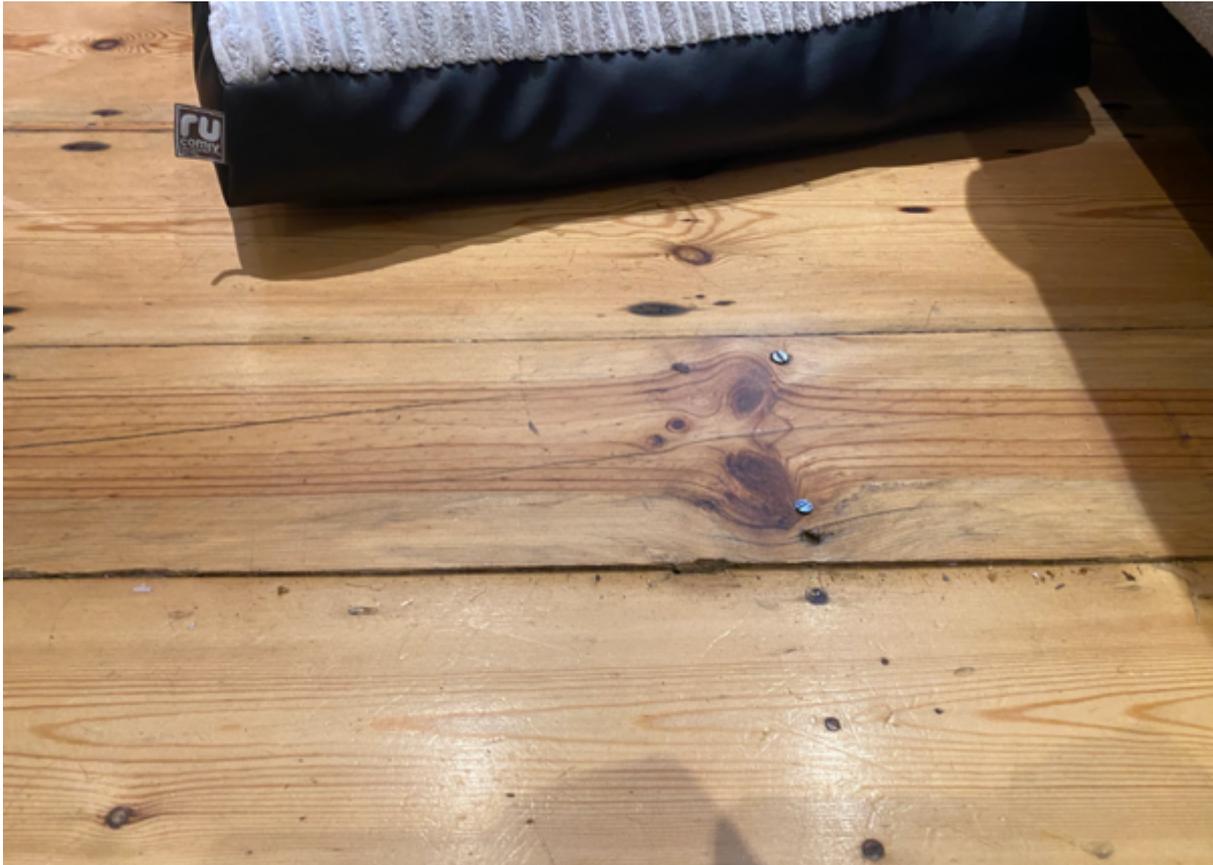
To the ground floor, the central wooden board, approximately 2.5m from the junction of the entrance, has been screwed down, and the screws themselves were sitting proud from the ground.

These are a safety hazard and you could easily catch your toe on these, and I would advise, that if you do proceed with the purchase, that these are recessed into the board itself and infilled to ensure a smooth and neat finish.

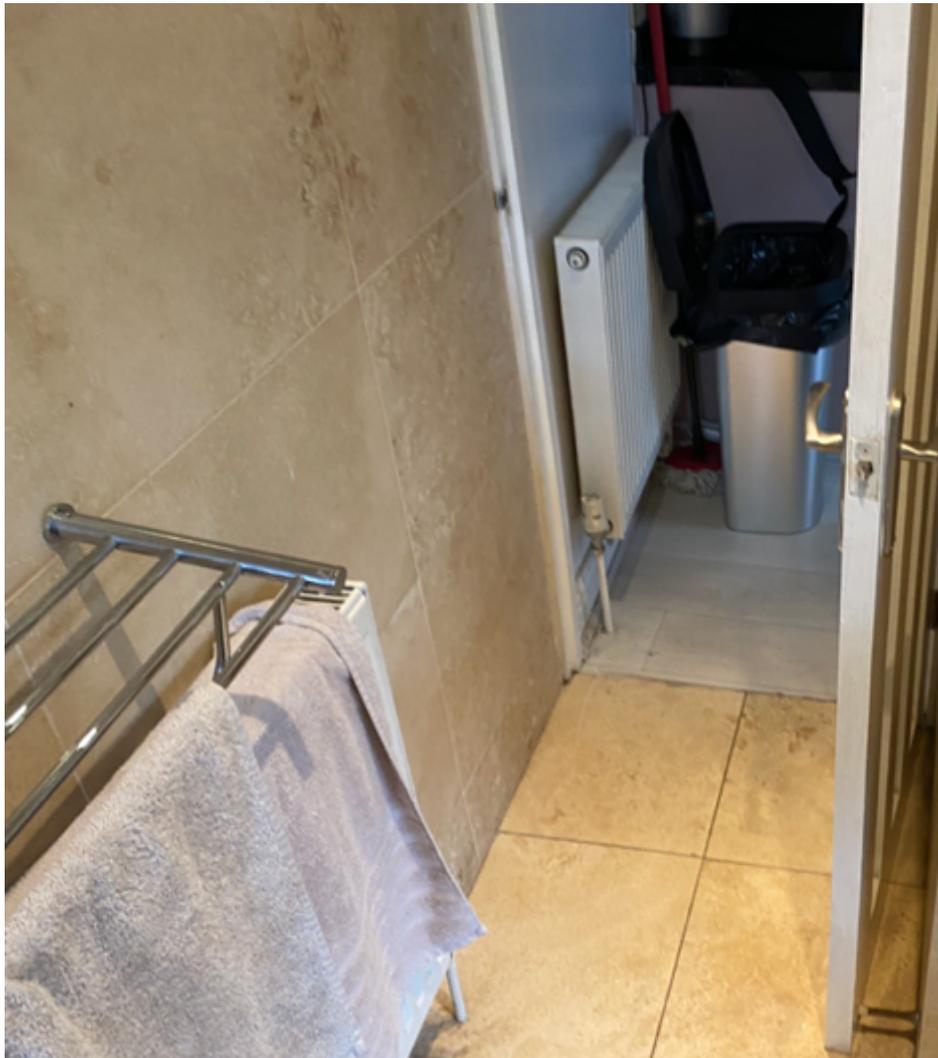
The bathroom is a modern, decorated type. The pressure was tested on the tap, shower and bath respectively and appears to be of a suitable standard. All taps also provided hot and cold water when tested. The toilet seat is broken and detached at the junction where it meets the toilet basin and will need to be repaired or replaced.

The towel rack that is wall hung above the radiator, projects into the entrance of the room itself, beyond the radiator. So as you walk into the room, it is likely that in the dark, you could catch yourself on the towel rack. The rack itself was wobbly and detaching from the wall and I suspect it is likely to be due to being bumped/knocked through normal use of the bathroom.

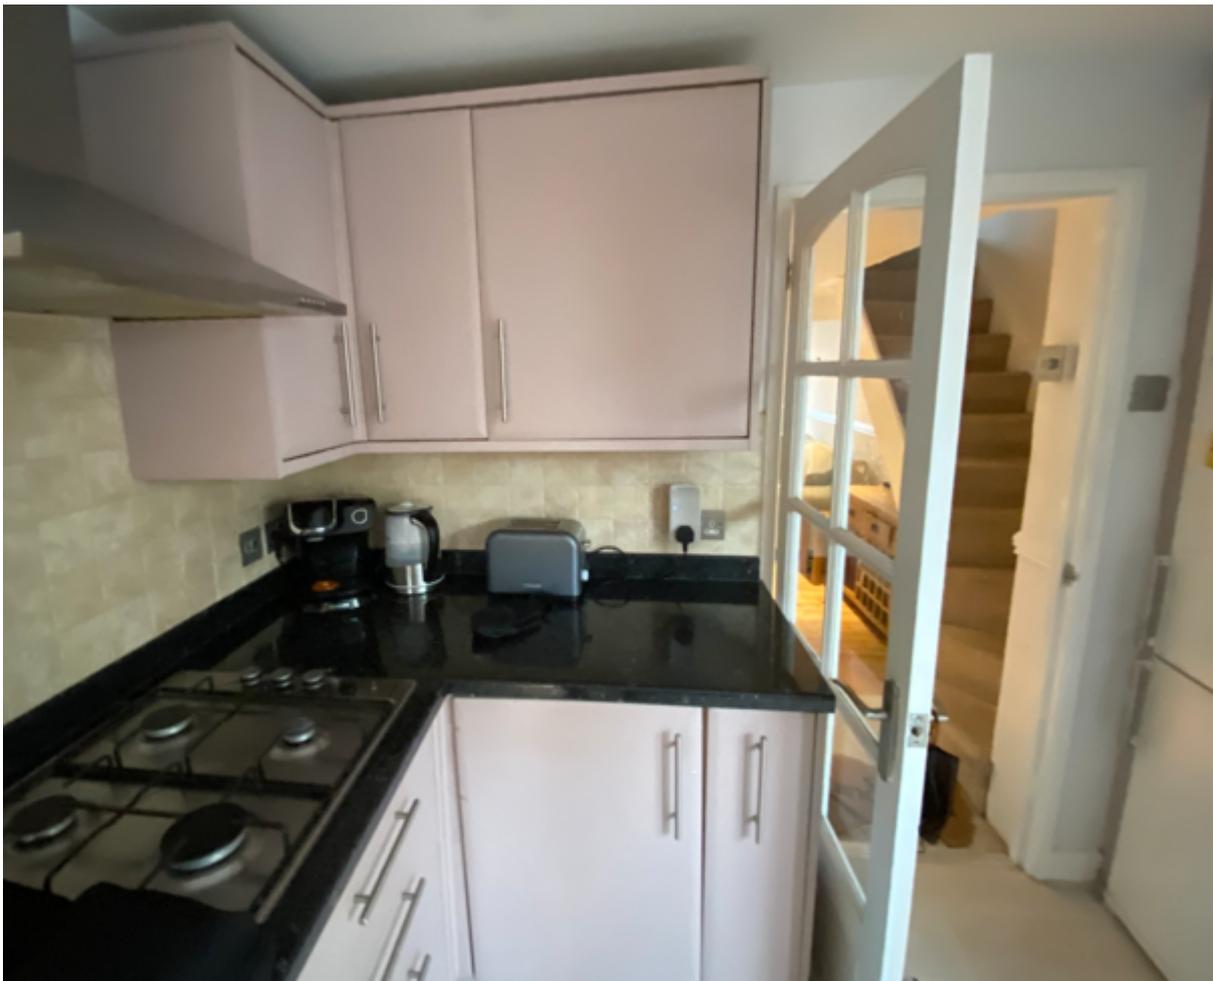
Ground floor kitchen door is a timber framed, single-glazed type. The glazing does not appear to be safety type. Safety glass is recommended as it is tougher and more robust than normal glass and prevents shattering and smashing which can be used through the normal operation of the door.

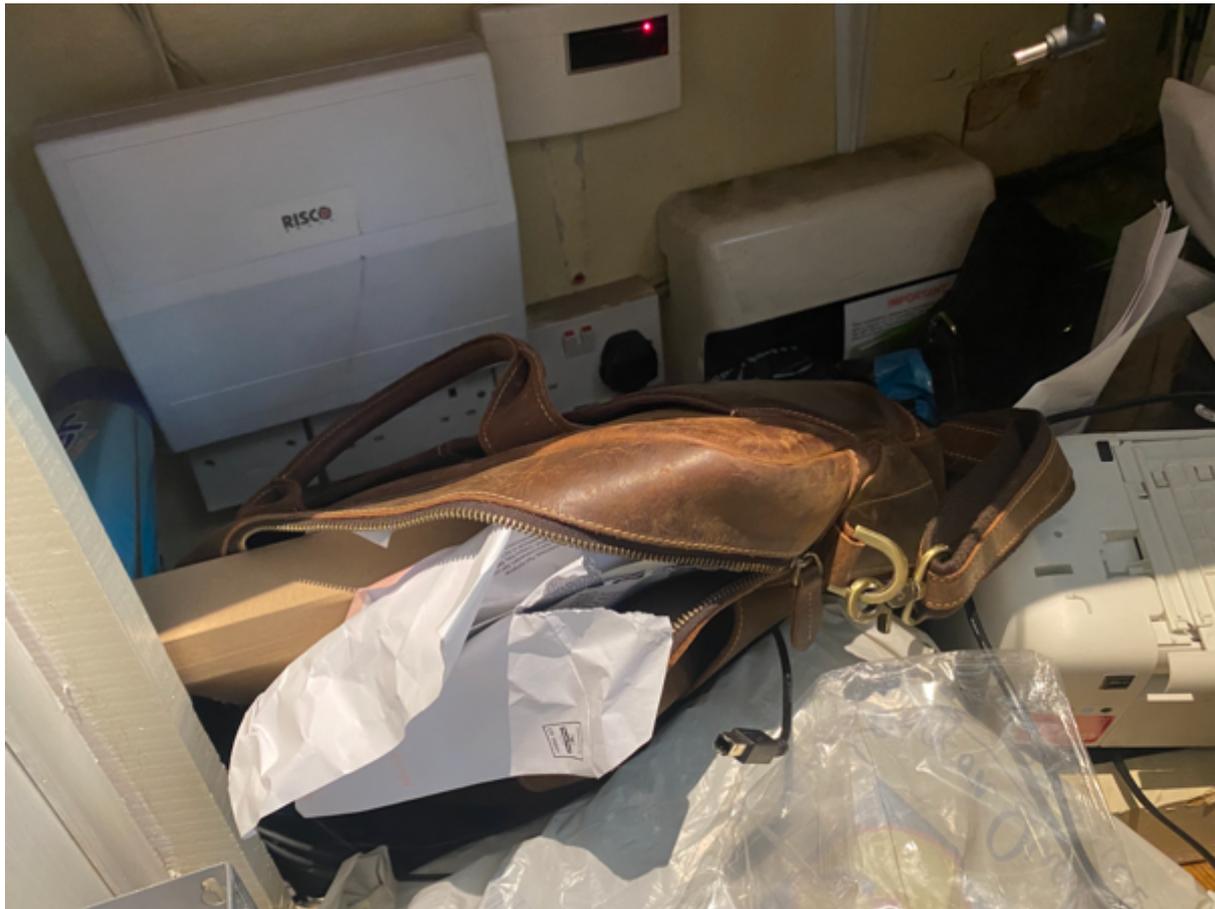
The electricity meter and RCD unit are located to the right of the ground floor chimney. At the time of inspection, this was heavily obscured by stored goods. The door to the unit itself, whilst it opens and operates smoothly, it does bind on the chimney hearth, which could prevent full access for a service engineer.

I would suggest that this cupboard is kept clear of stored goods, as effectively, if there is an issue or emergency, you will want to be able to access this quickly and without delay.
