## RICS Home Surveys RICS HomeBuyer Report

## **RICS HomeBuyer Report Contents:**

Surveyor's Name:	Surveyor Name
Surveyor's RICS Number:	000000000
Company Name:	Stokemont
Date of the Inspection:	00-00-0000
Report Reference Number:	SR00000
Related Party Disclosure:	None
Full Address and Postcode of the Property :	Address of Property
Weather Conditions when the Inspection took place:	Sunny and Clear. At the time of inspection, it was dry.
The status of the Property when the Inspection took place:	Tenanted and unoccupied.

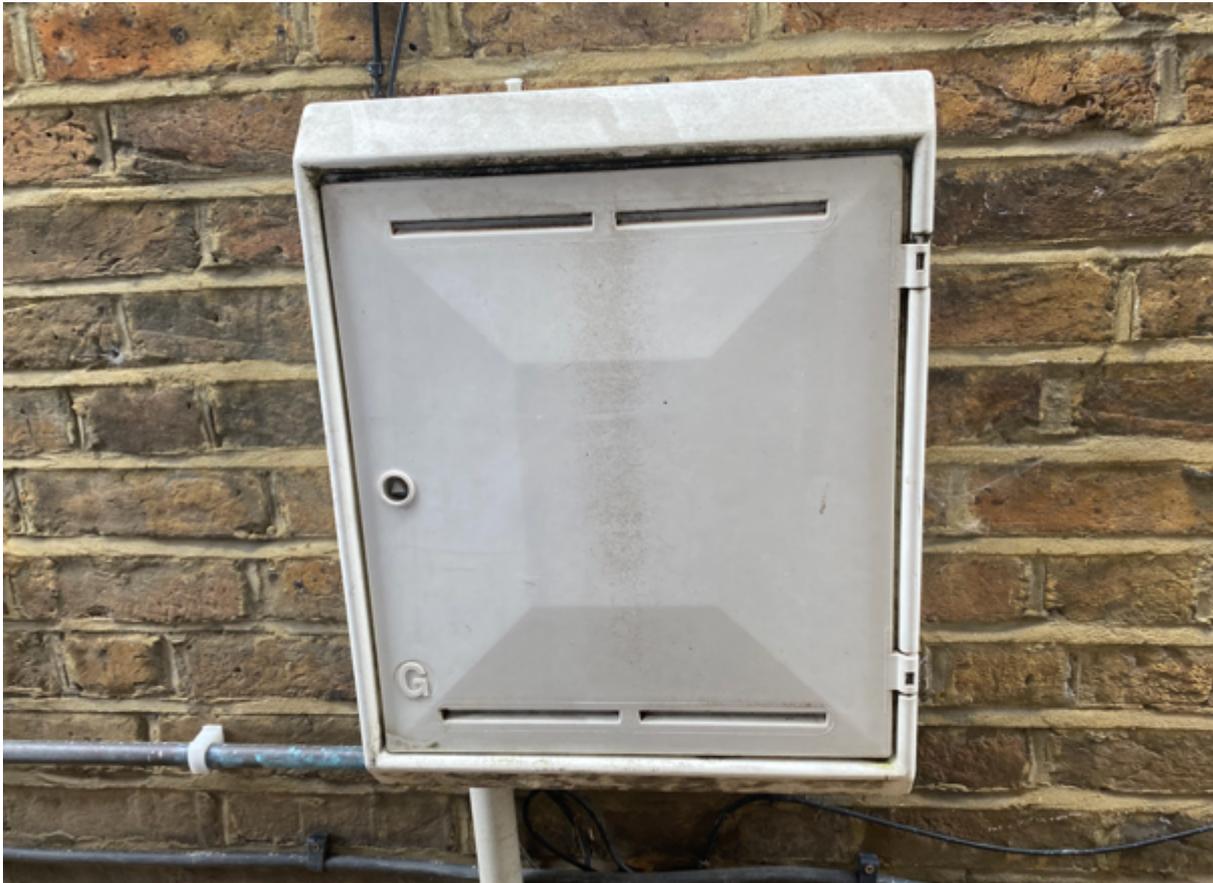
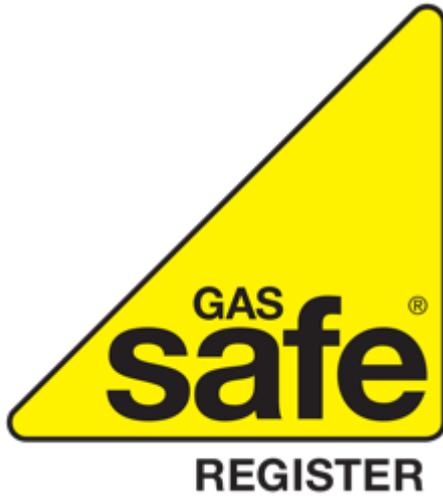
The gas meter appears to be located externally, on the flank of the building.

At the time of inspection, the meter cupboard was locked and we were unable to open this.

I would advise that a Gas Safe engineer visits to ascertain if the installations are in accordance with current health and safety and Gas Safe standards.

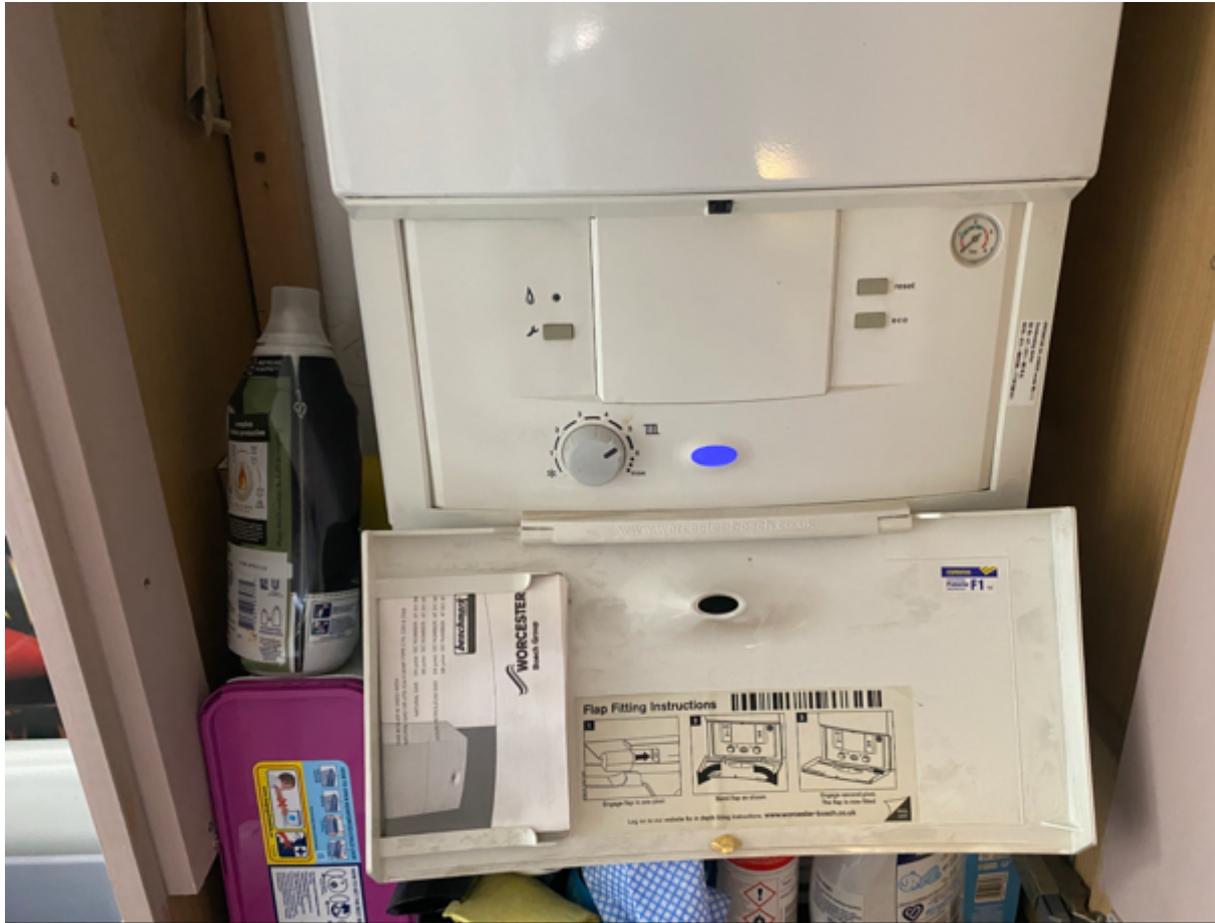
The pressure bar of the boiler was on zero at the time of inspection, and there were no service records present.

I would advise that you have a Gas Safe Registered Engineer fully inspect the boiler to ascertain that it is indeed fully operational and free from any issue. There is a Hive thermostat located to the flank of the kitchen door.

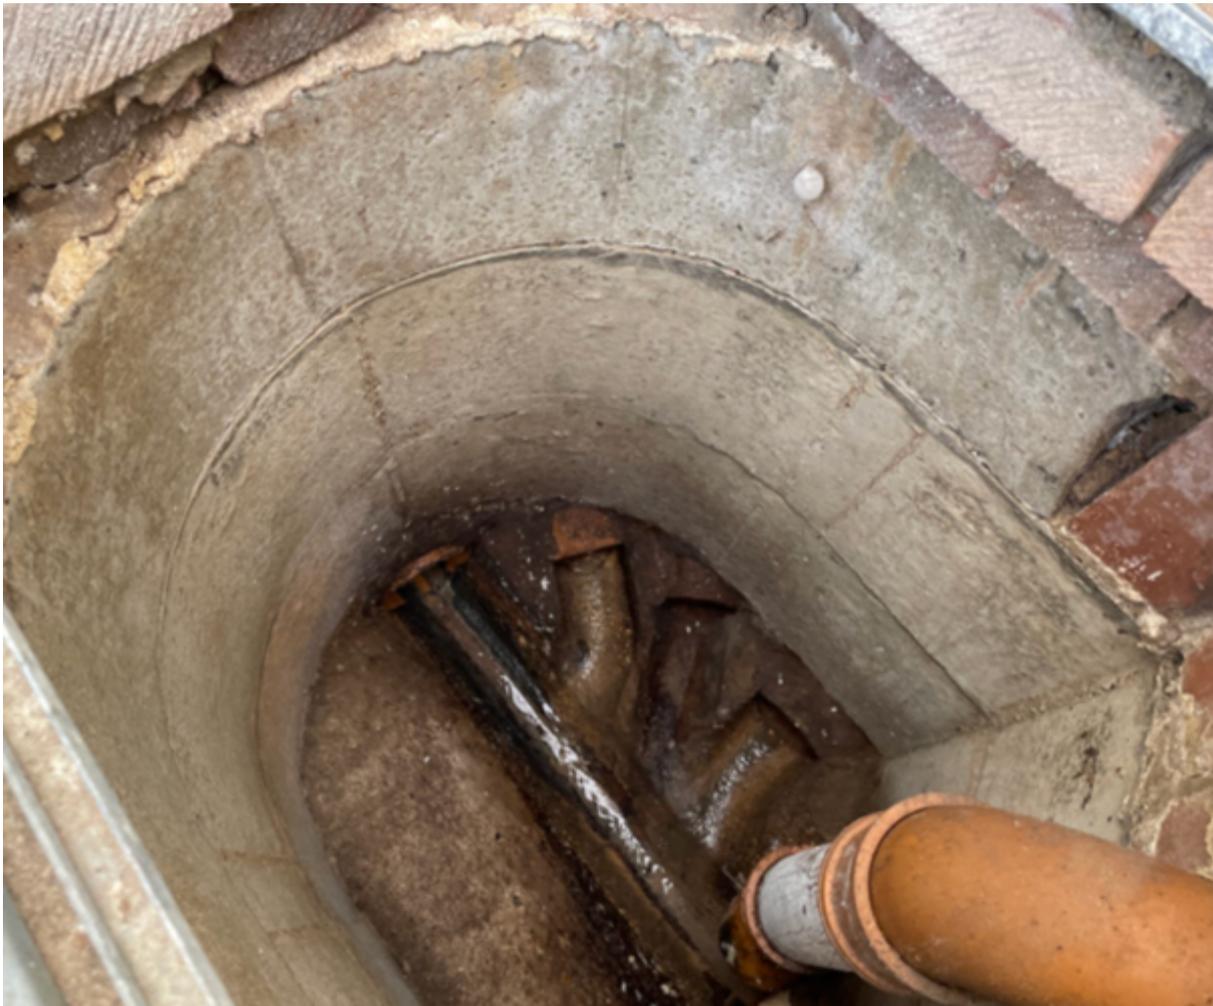
All taps were turned on and water appeared to drain efficiently, without any build up. It may be sensible to have a CCTV drain survey undertaken in advance of proceeding with the purchase to ensure that you are fully aware of the condition and state of the drains, thereby ensuring there are no ruptured issues.

The bathroom drain, when emptying, did return with a gurgling sound. You may want to have this inspected by a plumber to rectify the issue.

The bathroom toilet, when the flush is operational, it does not appear to be that strong, and it could be that the cistern is defective. You may wish to consider having a plumber look at this to ensure that when the toilet is in operation and use, that there is sufficient pressure to remove waste.

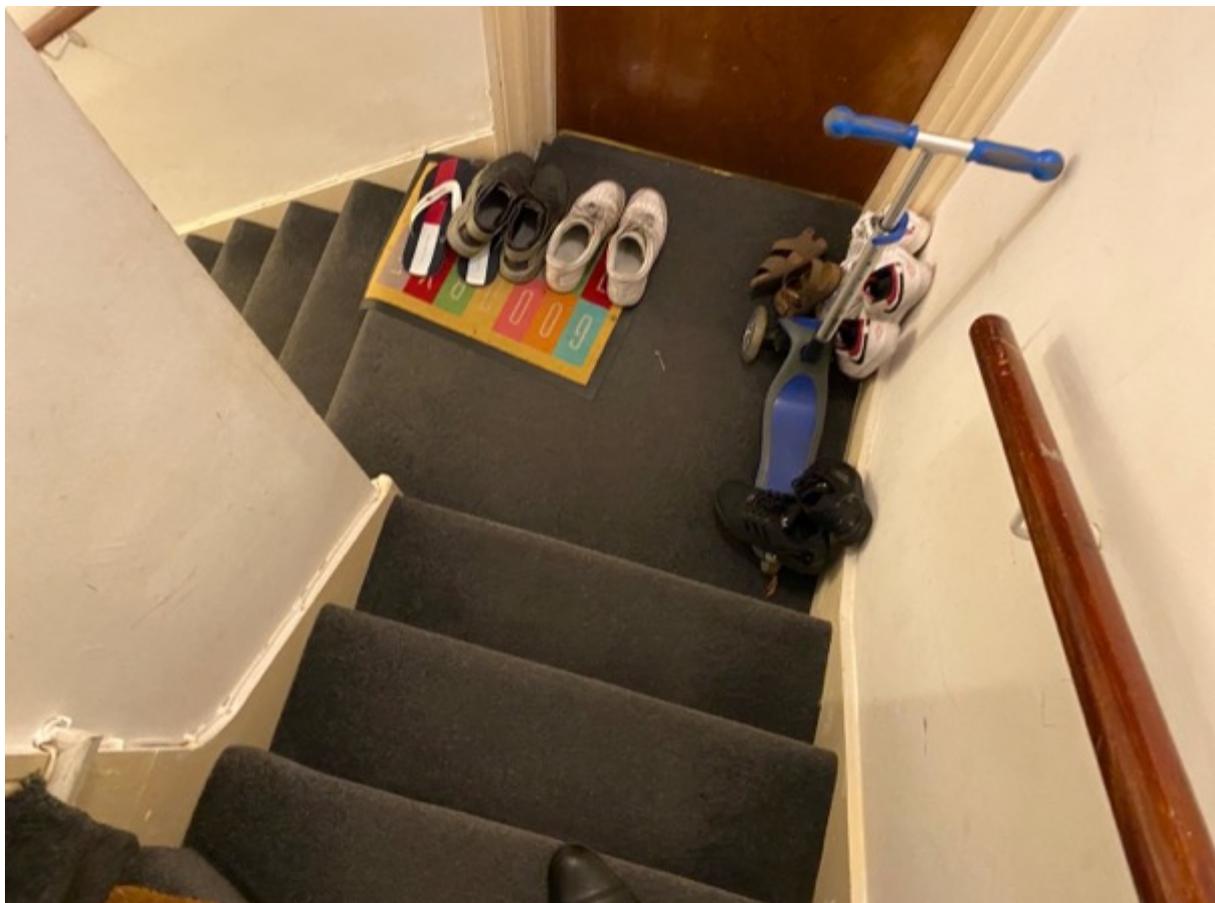
Within the communal areas running up to the flat itself, there were a number of other flat and occupant items including shoes and bicycle scooters. I would advise that you make enquiries as to whether these have the right to be there, as dark at night it could be a sign of a tripping hazard, as well as generally being towards the unsightly end of the spectrum.
