Building Survey Report

Building Survey Report Contents:

About the Inspection:

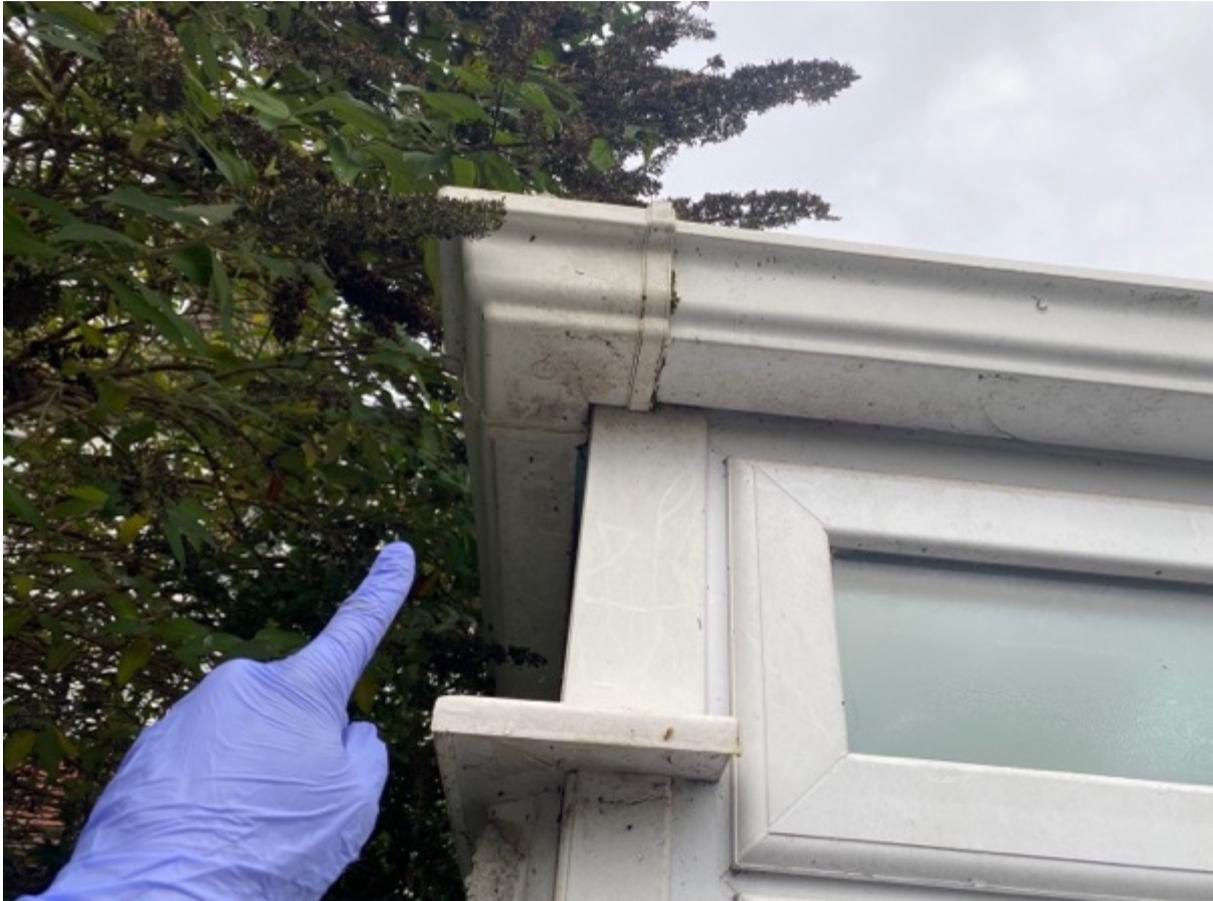
Rainwater Pipes and Gutters:

Towards the front of the property the gutters are uPVC half moon type. These appear to have been recently installed. All gutter clips were intact and neatly spaced.

The uPVC downpipe towards the junction of the property likewise appears to be recently installed and are modern type.

As there was moss growth noted to the roof it is likely that some of this moss may have fallen into the gutters themselves and could be causing a build-up of detritus within the gutters and therefore, prior to proceeding, I would recommend having a competent roofer inspect the gutters to confirm if they are blocked or have a build-up of detritus and arranging for them to be cleared respectively.

The upper clip screws have pulled loose from the wall itself and this will need to be re-secured to ensure that it is firmly screwed against the wall itself so that in the wetter months there is not an overflow of the gutters or that the gutters do not miss the hopper head and discharge water onto the wall itself.

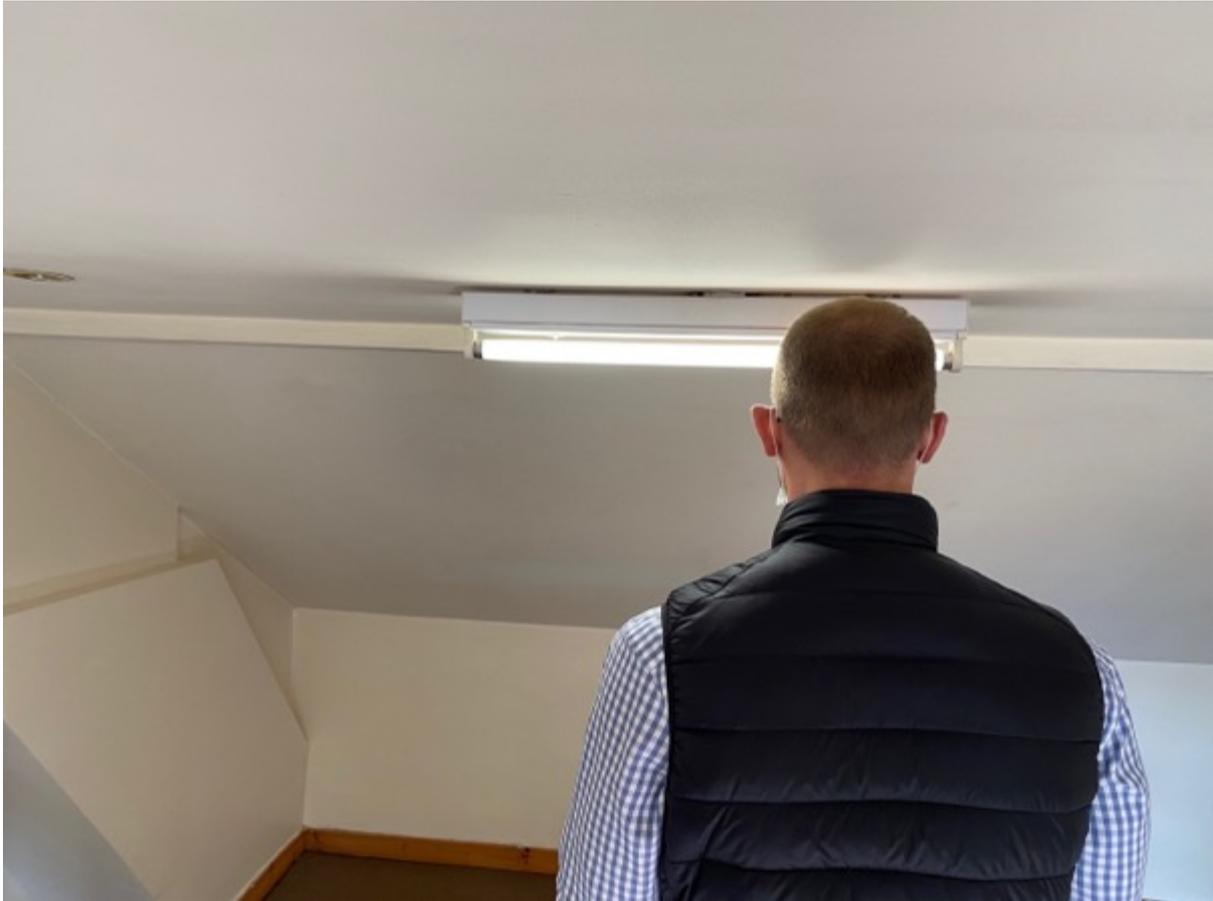
It is also worth noting that the light fitting towards the centre of the room projects from the ceiling itself meaning that for anyone in the region of 1.7m to 2m high they will have to lower their head, or travel around this light fitting.

I suspect that this could be a health and safety requirement as the bulb itself is not covered over and therefore could shatter or smash should it be knocked by an individual.

Should you proceed with the property you will need to replace this electrical fitting with a pendant/ceiling light with a larger perimeter fixing so that the historic paper is obscured from view.

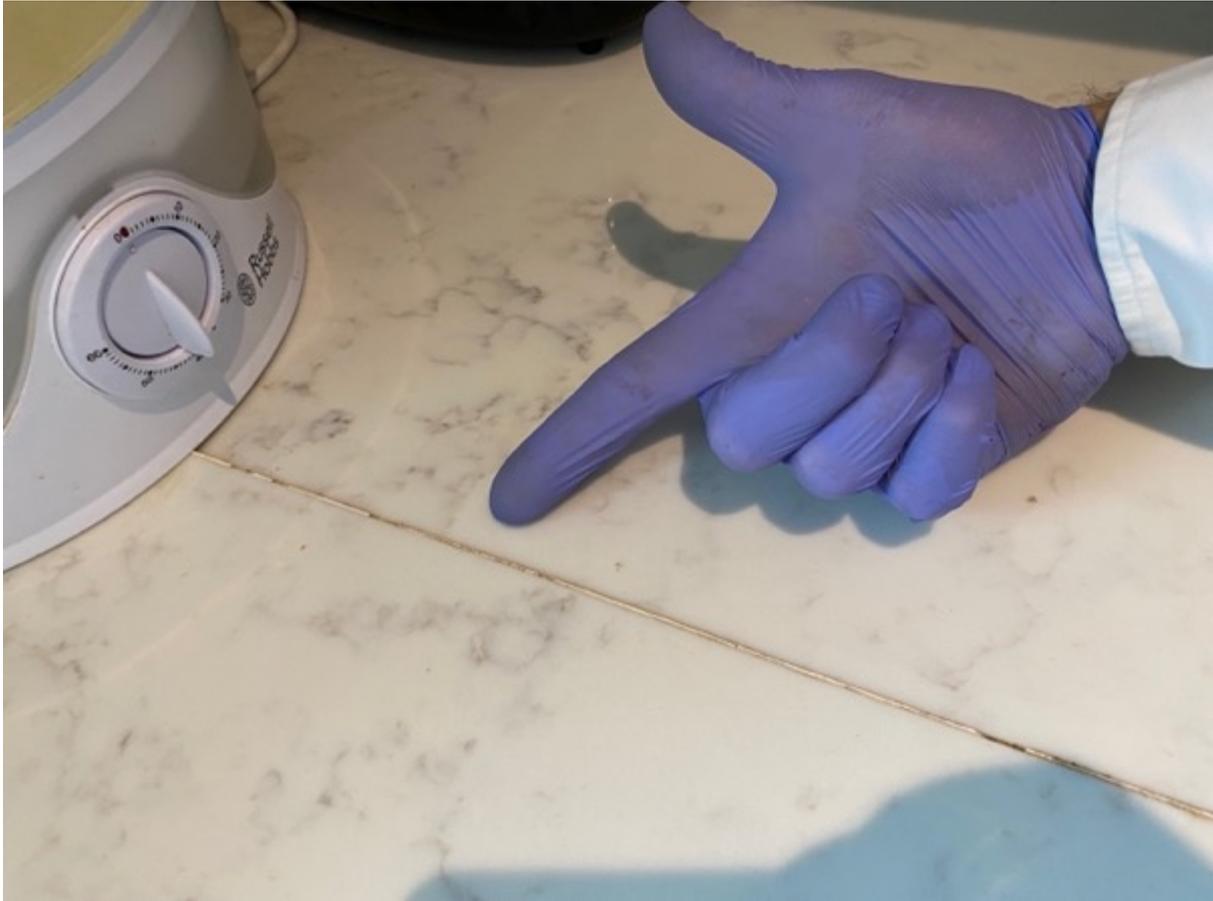
The kitchen worktop is a quartz Carrera imitation marble type.

Overall, it was free from any staining, however, the junctions of one section of the quartz finish to another are raised and sit proud which will result in a dirt build-up at the junctions and you therefore may want to consider having a kitchen specialist and worktop specialist revisit to level out the installation of the worktop to ensure that this does not happen in the future.

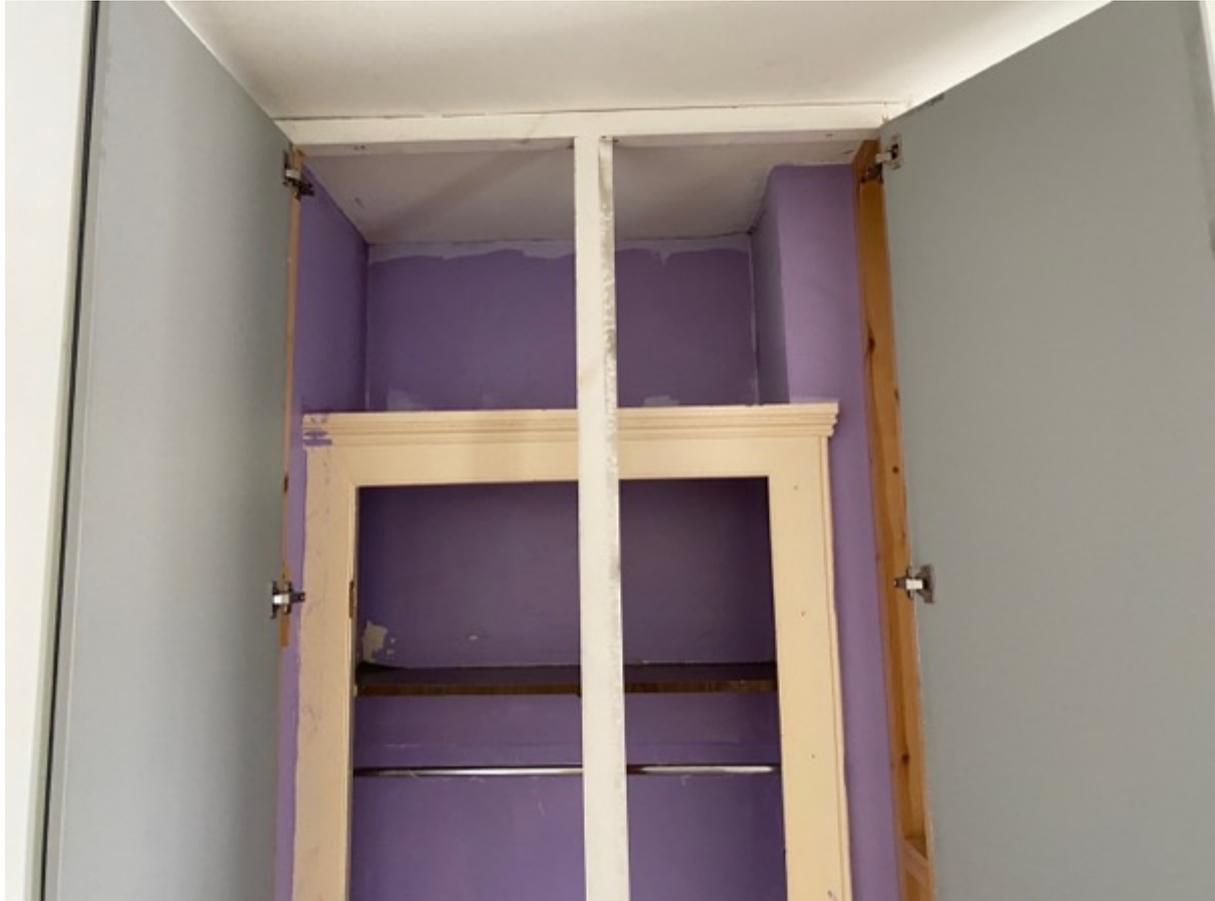
Within the bedroom areas there are two fitted wardrobes installed to both the front and rear of the property.

These wardrobes themselves are crudely installed and actually installed over the older fitted wardrobes so that there is an awkward wardrobe within a wardrobe effect.

Should you proceed with the property I would advise that the older wardrobes are removed and that the fitted wardrobes are replaced with a neater and sounder fit to maximise the storage space within the property.

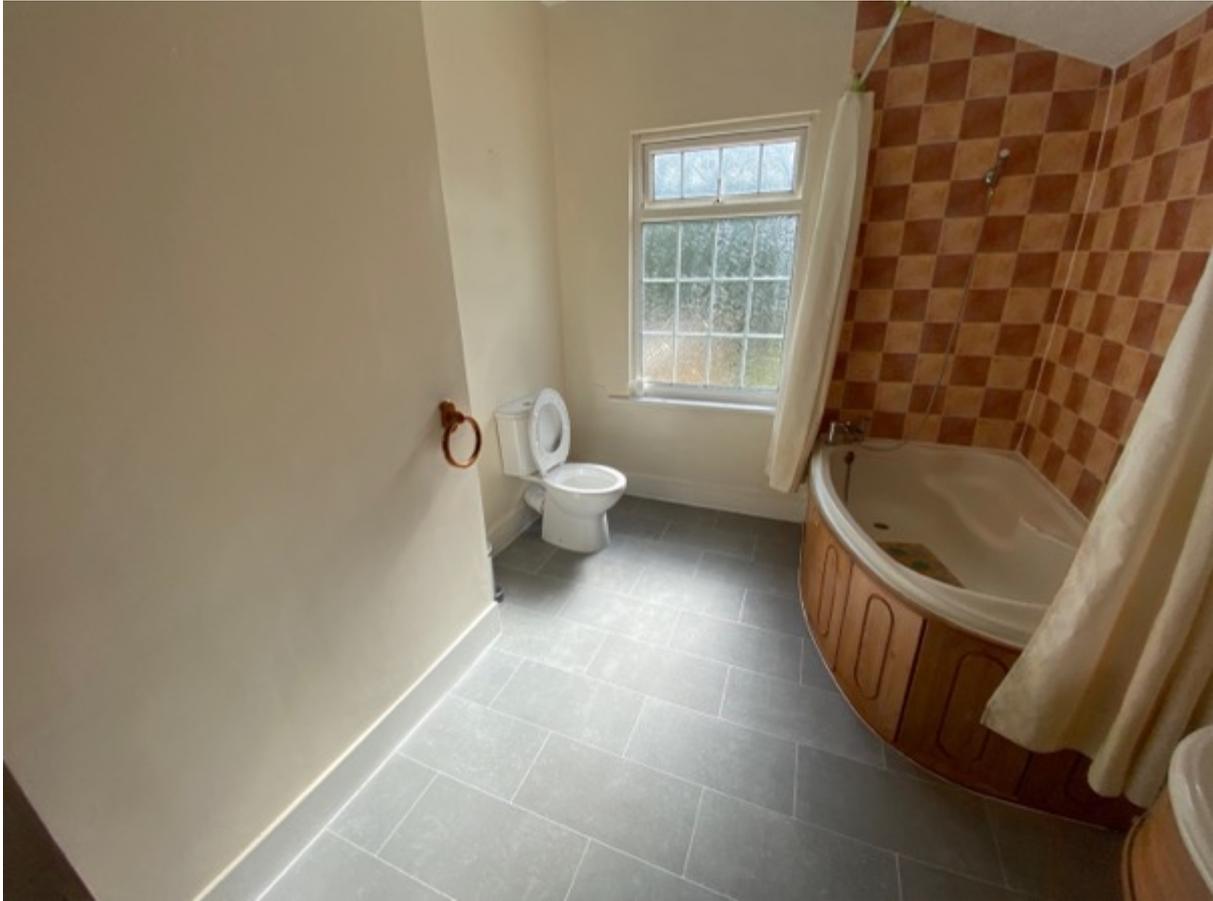
There is one main bathroom within the property itself which is located within the first floor rear addition area. The bathroom itself is slightly dated and is a very large area for the space that is being used.

You could likely comfortably fit a freestanding bathtub and walk-in shower within this area as well as a his and hers sink and therefore, should you proceed with the purchase, I would advise making better use of this space.

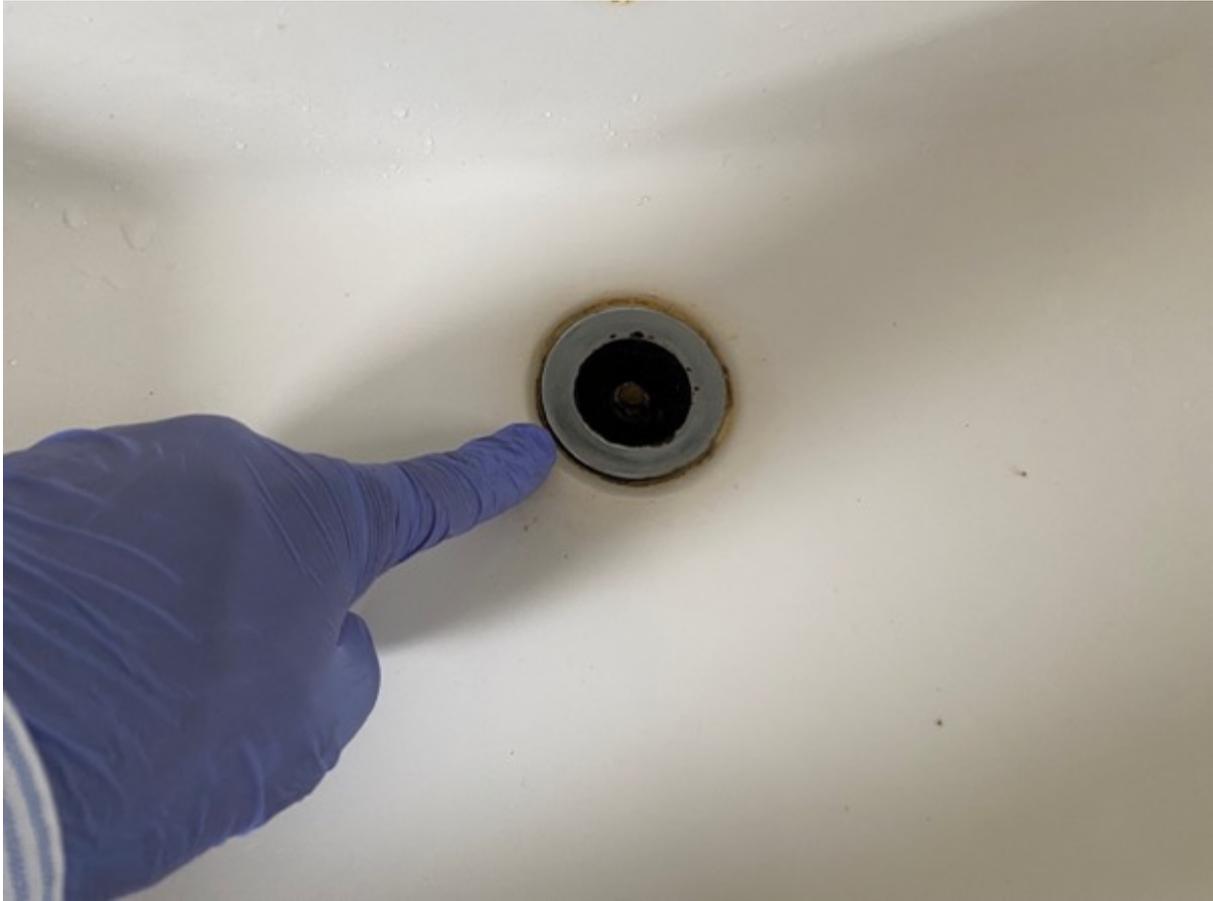
The shower pressure was tested and appeared to be a good reading. Both his and hers sinks are missing the sink plughole covers and these will need to be reinstalled to ensure a neat and smooth finish.

To the bathroom installations themselves there didn't appear to be anything wrong with these, however, you likewise may want to consider boxing in the boiler so that it is a neater finish.

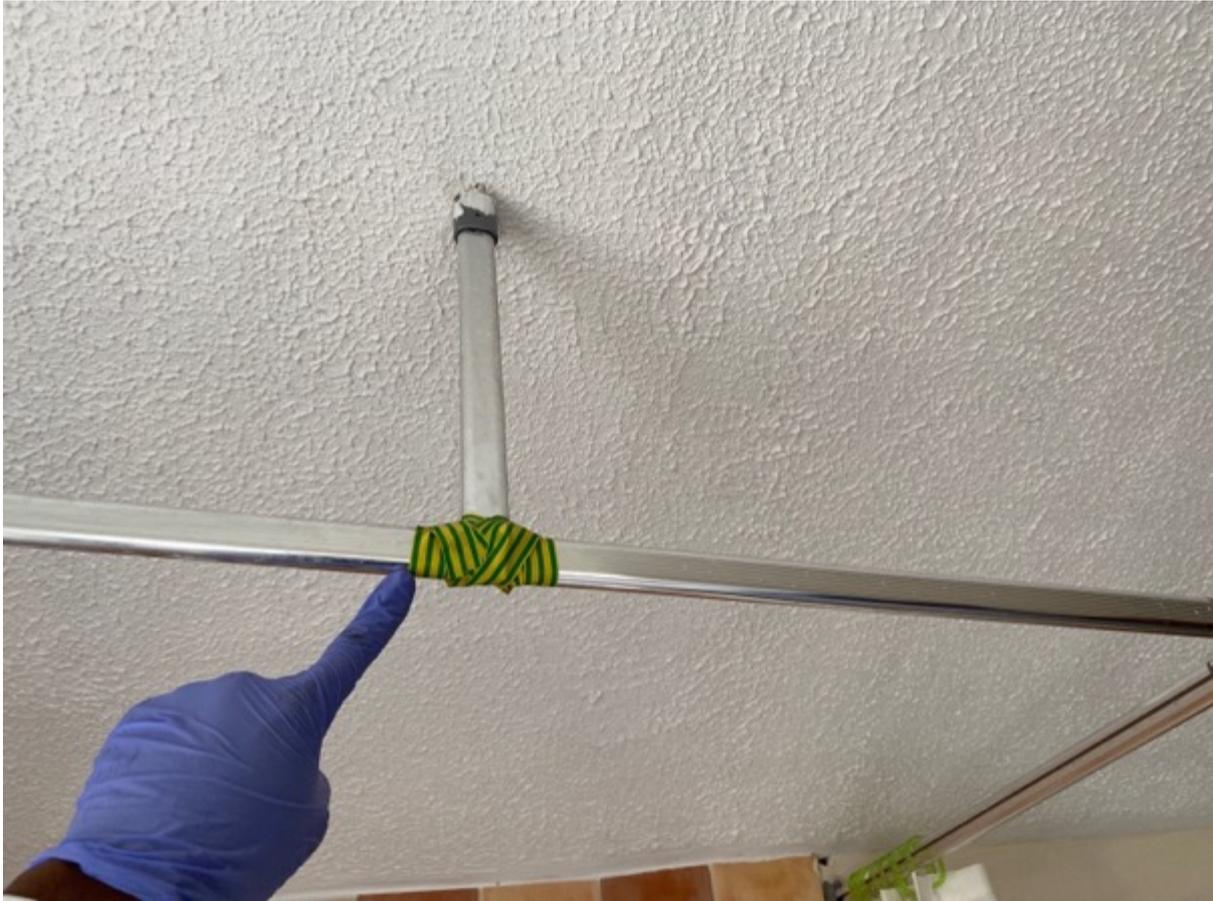
The shower curtain was crudely held in place with electrical tape and is defective and at the end of its useful life and will need to be replaced.

The toilet pipe is running at an odd angle protruding from the rear wall and generally speaking should run against the party wall itself so that it is not projecting into the room itself.

It is also connected with a uPVC expanding pipe which generally speaking is prone to leaking and defect and therefore, given that this is the only toilet that services the entirety of the property, I would advise upgrading this to a more sufficient fitting to safeguard against the toilet going out of use and emergency plumber's costs, visits and repairs.

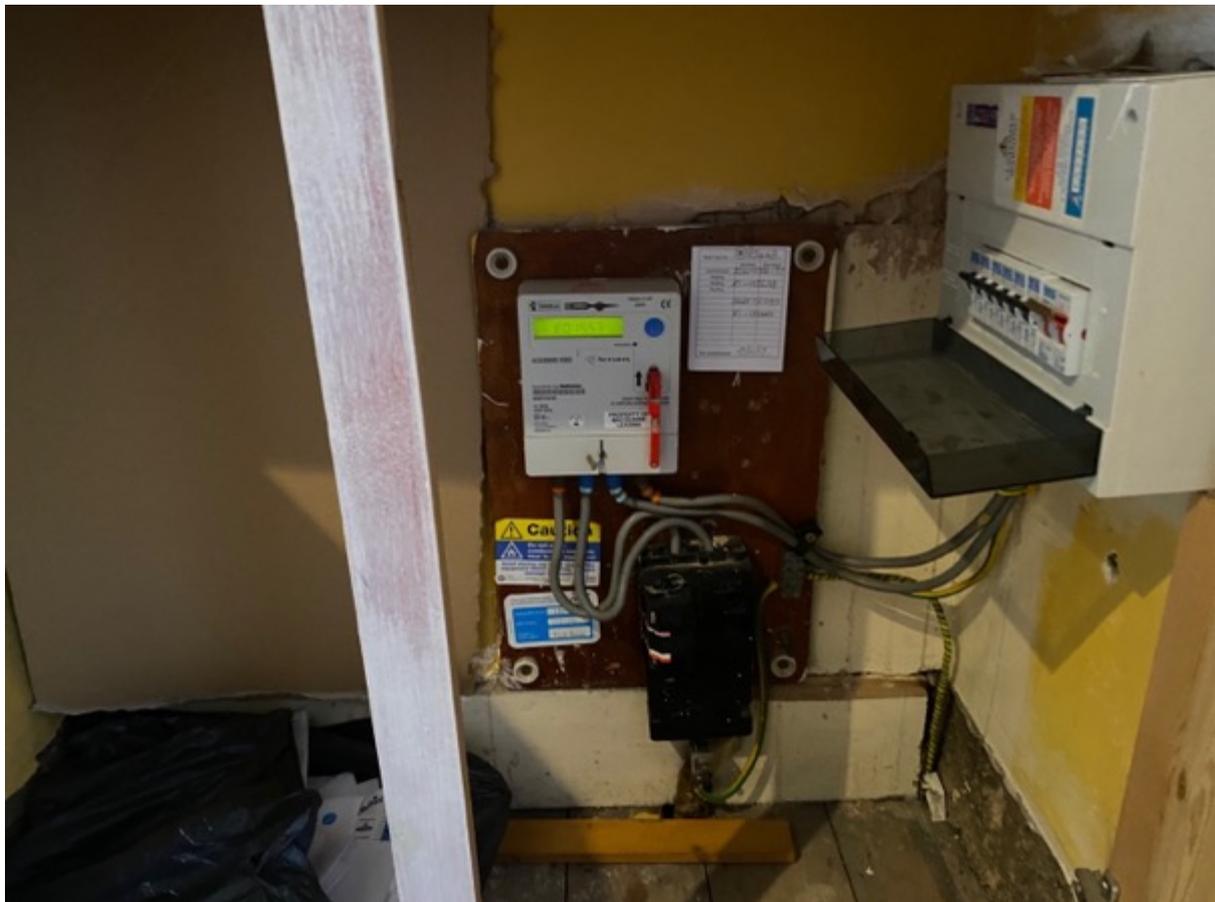
The electrical meter is in the ground floor reception room area as is the residual current device unit.

There was a card pinned to the electrical unit itself confirming that the last date of installation was 2017.

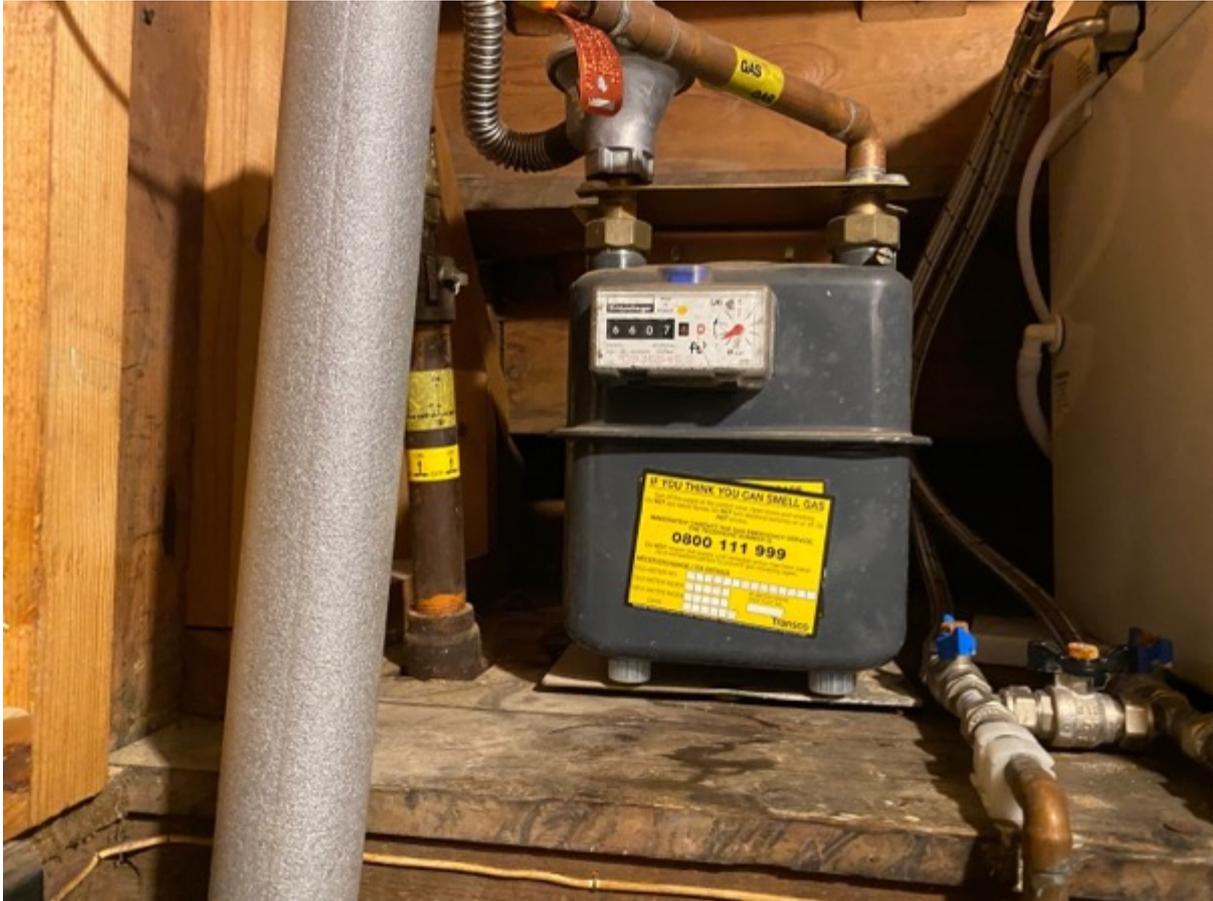
The gas meter was located in the sub-floor void area.

There were no signs of any service records in that regard.

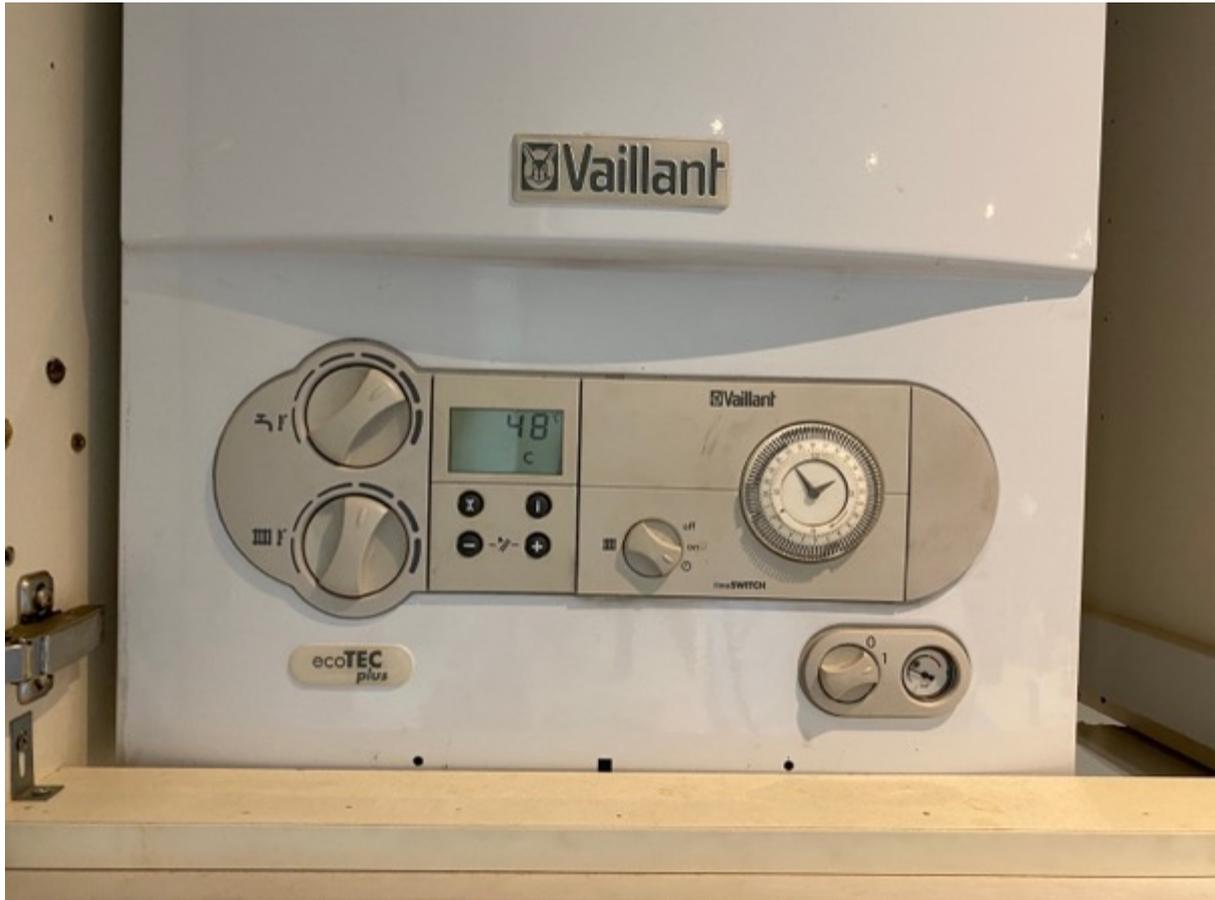
Water Heating:

The property is mains gas connected with the heating being provided by a Vaillant boiler which is installed within the kitchen area.

The boiler itself at the time was effective and the heating was working. Hot water was also present when tested.

I would advise that the gas boiler is inspected by a Gas Safe engineer to ensure that it is fully operative and up to current health and safety and Gas Safe requirements.

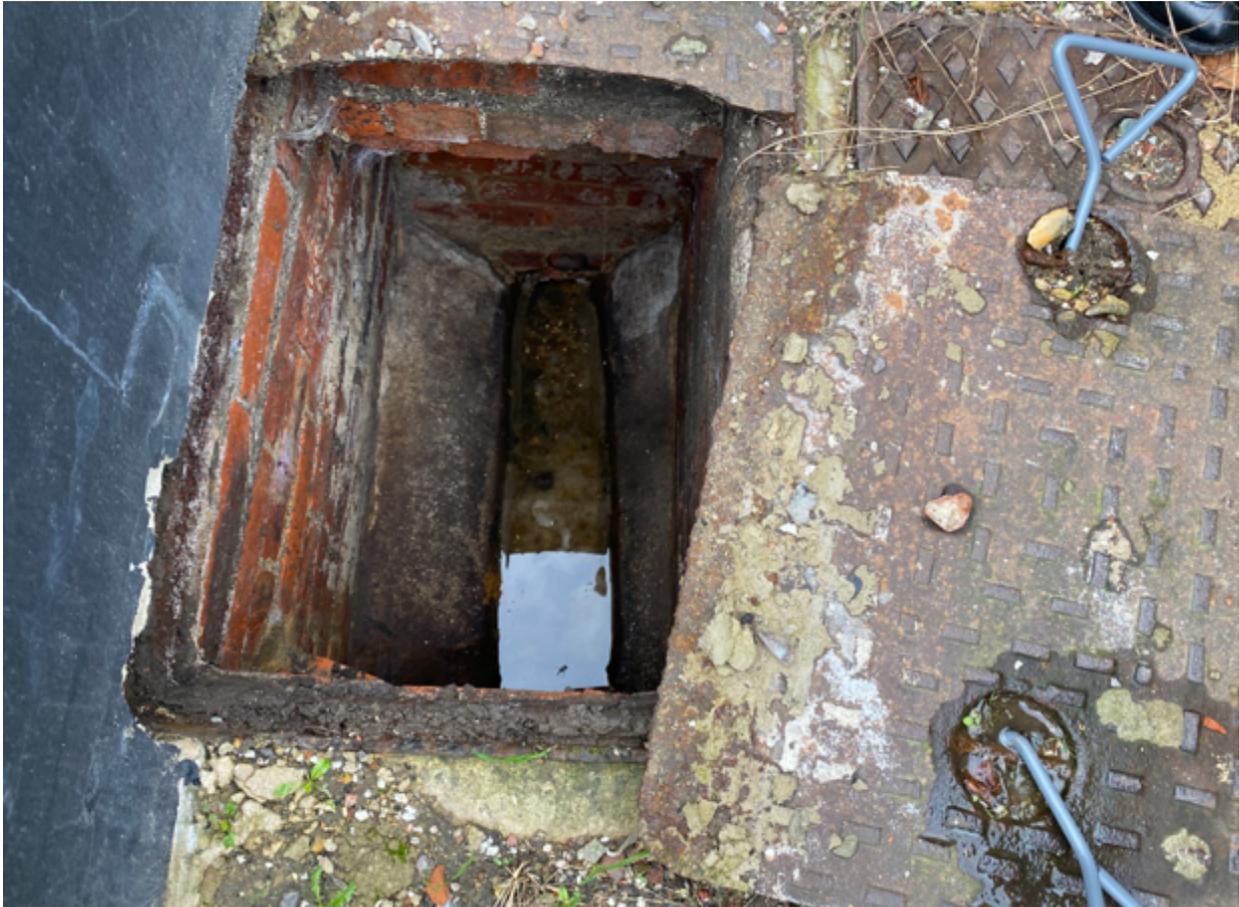
Drainage:

The drainage within the bathroom appeared to be sufficient and the taps did not back up and likewise in the kitchen area.

Towards the rear of the property the drainage and downpipes at the junction where they run into the rear drainage gullies was covered over with a concrete paving slab.
