## RICS Home Surveys RICS HomeBuyer Report

## **RICS HomeBuyer Report Contents:**

Surveyor's Name:	Surveyor Name
Surveyor's RICS Number:	000000000
Company Name:	Stokemont
Date of the Inspection:	00-00-0000
Report Reference Number:	SR00000
Related Party Disclosure:	None
Full Address and Postcode of the Property :	Address of Property
Weather Conditions when the Inspection took place:	Sunny and Clear. At the time of inspection, it was dry.
The status of the Property when the Inspection took place:	Tenanted and unoccupied.

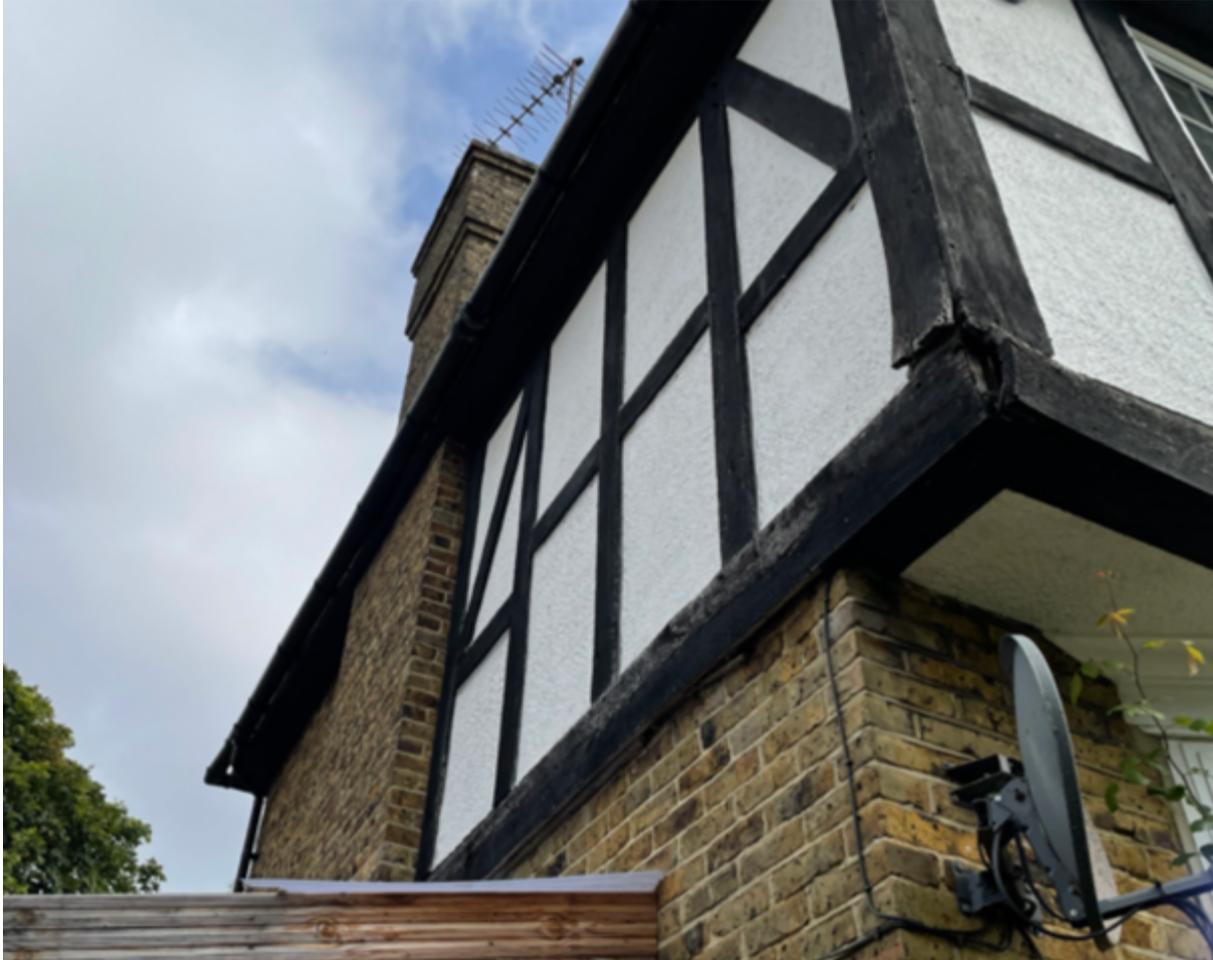
## E4 Main Walls:

Main walls are brickwork London stock solid construction.

The brickwork appears to have been repointed with a weather struck style of pointing which is appropriate for the type.

To the flank wall there appears to be an area of replaced brickwork, whereby it would appear a new window has been installed. This could have also potentially been a door in years past, and you may want to enquire with your solicitor as to whether any structural alterations have taken place within the property.

The window itself has a concrete lintel above and appeared to be in a fair and reasonable condition at the time of inspection and free from any defects. You may wish to enquire with the Local Authority and Building Control to ensure that if this was an addition, that it has the necessary Planning and Building Control sign off.

The rendered plinth on the flank wall is weathered, and at the front section of replaced air vent, it is debonding and splitting/stripping away. This will need to be replaced in the immediate future and necessary budget should be taken into account for this.

I would recommend that a retrospective injection damp-proof course is installed along the perimeter of the walls or alternatively, the ground towards the flank passage of the house is lowered to ensure a minimum of 200-300mm gap, thereby ensuring that damp and water cannot penetrate on the internal property itself.

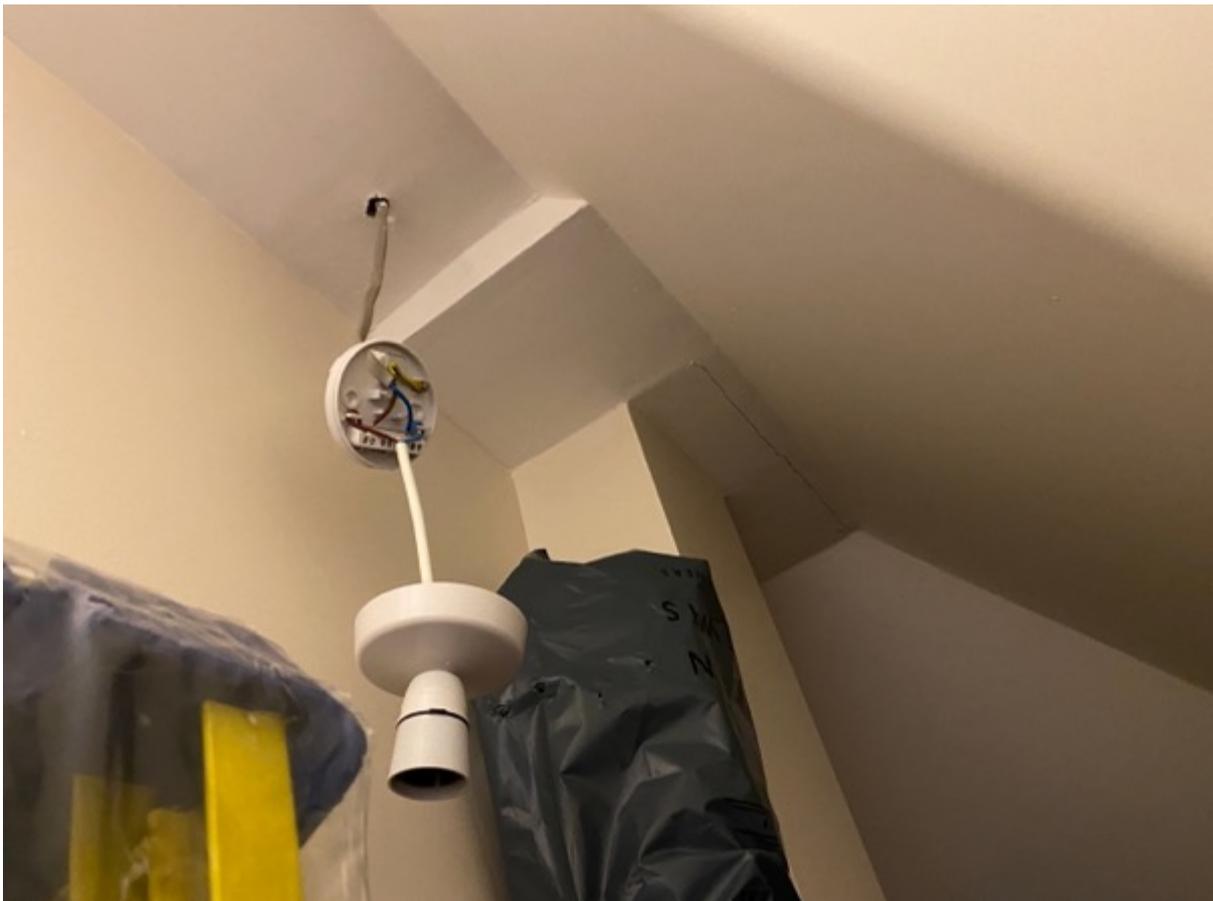
## F2 Ceilings:

Ceilings are a mixture of plasterboard, skimmed and painted, and embossed paper and painted. Overall, the ceilings appear to be in a relatively fair condition. They could do with slight decorative upgrade.

Within the kitchen, there were intermittent scuff marks noted to the ceilings. This is likely through general wear and tear and usage of the property.

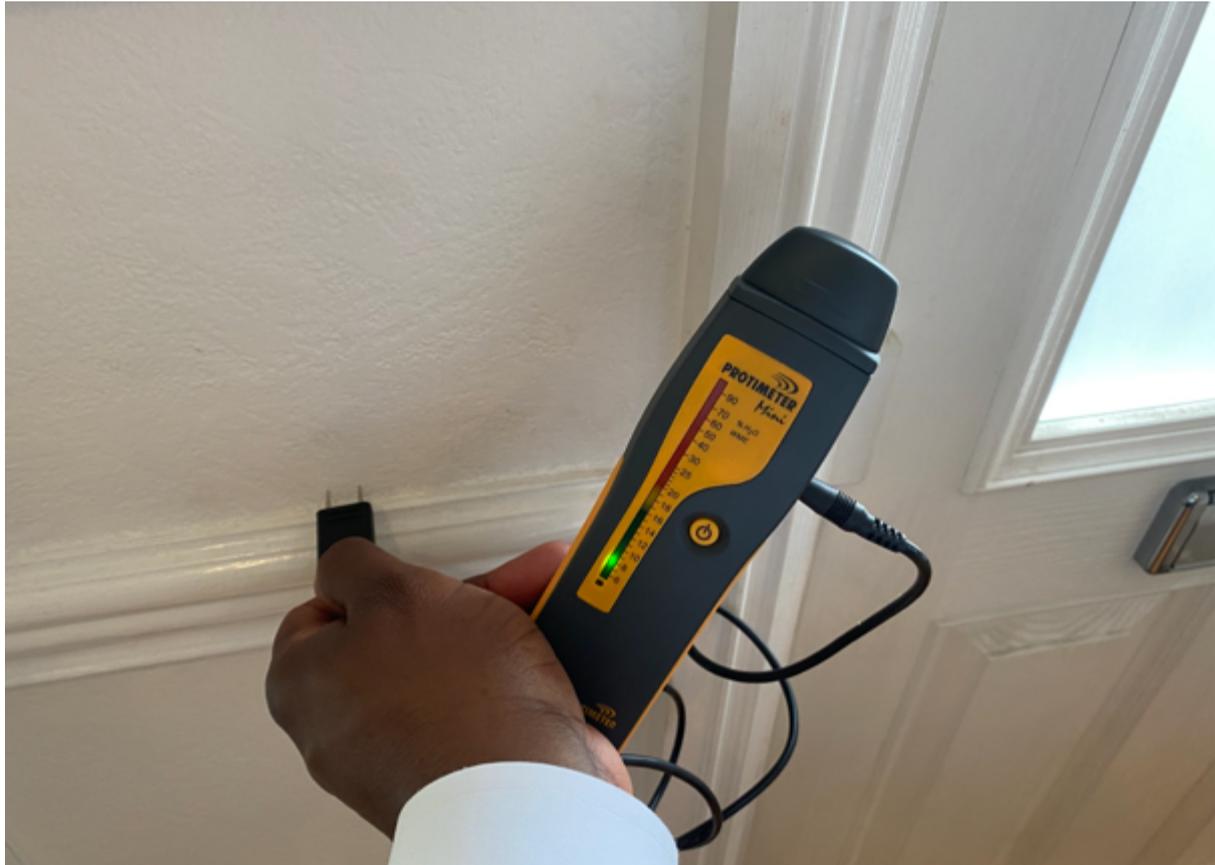
Walls are a mixture of plasterboard and solid construction. These also have a covering of decorative paper and lining paper, painted, as well as embossed paper.

Generally speaking, walls are showing signs of normal wear and tear. Overall, aside from the light wear and tear, and scuff marks noted throughout, the walls are in a fair condition.

Damp meter tests were taken to the perimeter of the property and walls throughout, at low, mid and high level. All readings returned with a green reading, which is effectively a dry damp meter reading, and the result we would look for as surveyors.

Within the rear bedroom at first floor level there is a diagonal crack to the lower right corner of the windowsill.

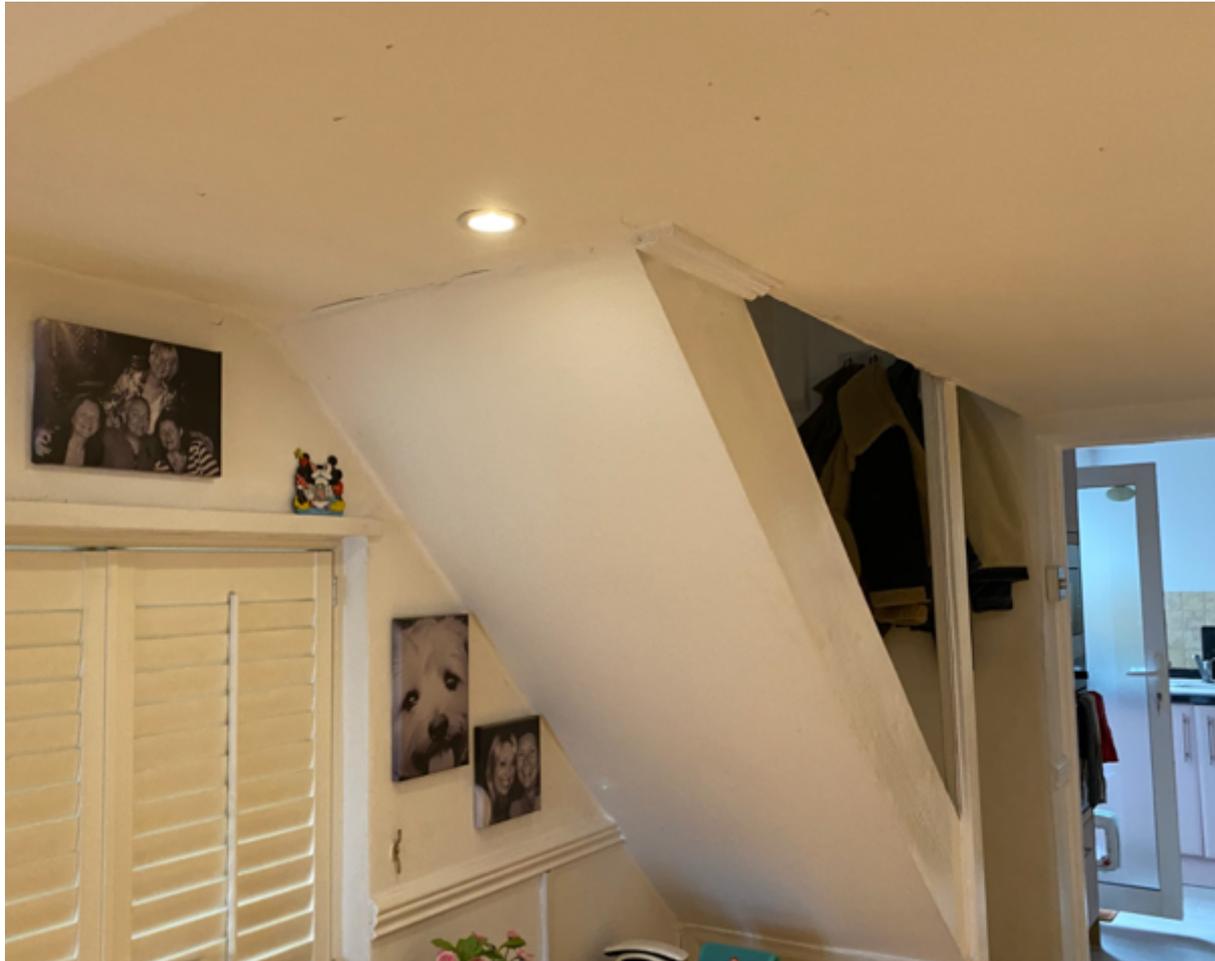
## F7 Woodwork (e.g. Staircase and Joinery):

### Staircase

The staircase is a timber type. There are no spindles running down the flank of the stair which could be a safety issue for smaller children.
